# THE WALL PAINTINGS OF AHHICHTRAGARH, NAGAUR:

Report on the Investigations and Treatment Undertaken in  
February - March 2006 and Proposals for Future Conservation

STEPHANIE BOGIN, CHARLOTTE MARTIN DE FONJAUDRAN, SIBYLLA TRINGHAM

CONSERVATION OF WALL PAINTING DEPARTMENT, COURTAULD INSTITUTE OF ART,  
UNIVERSITY OF LONDON

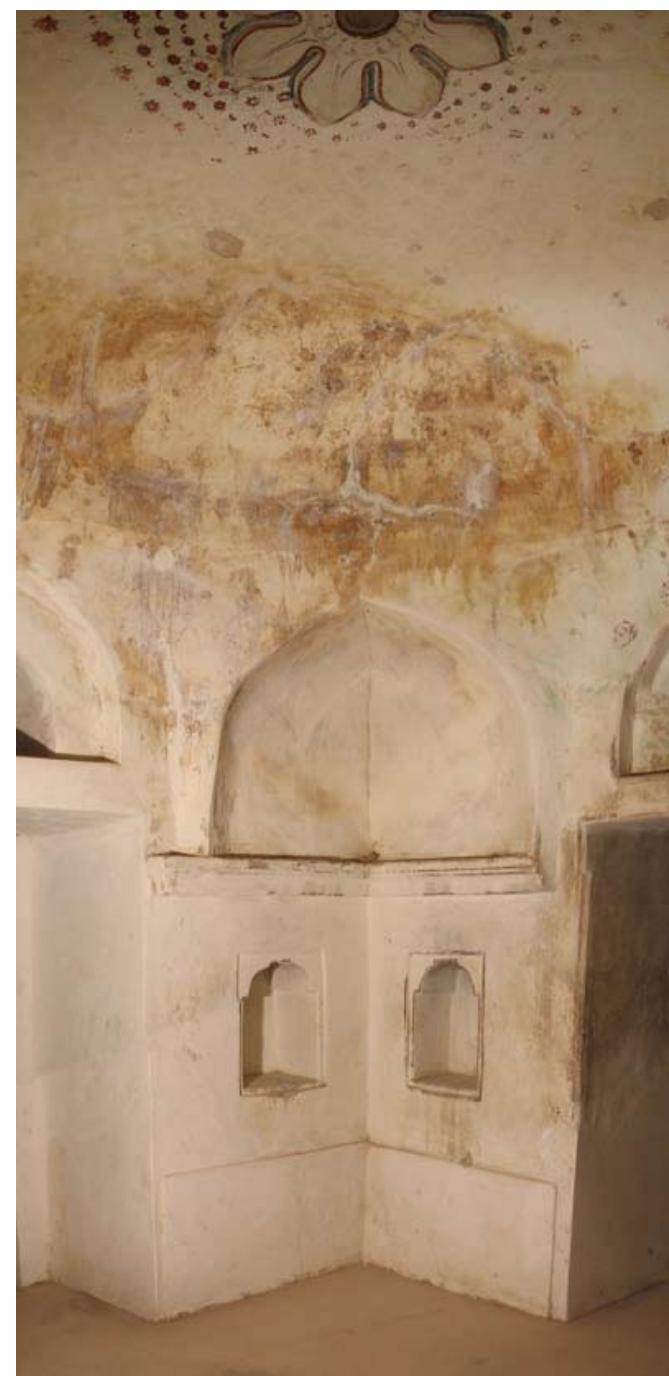
In summary, the results for this interior room (and adjacent corridor) demonstrated that the occurrence of liquid moisture within the walls is very irregular. On the north wall, samples taken at high level (1.95 and 3.00 m) were wet for the first 4 cm, corresponding to the obvious staining. By contrast, most samples taken at low level were dry.

*The north-east corner of the Hammam shows evidence of water infiltration: staining, plaster loss and salt efflorescence. This area was chosen as a sampling location for the liquid moisture investigations to determine if infiltration continues in the Hammam.*

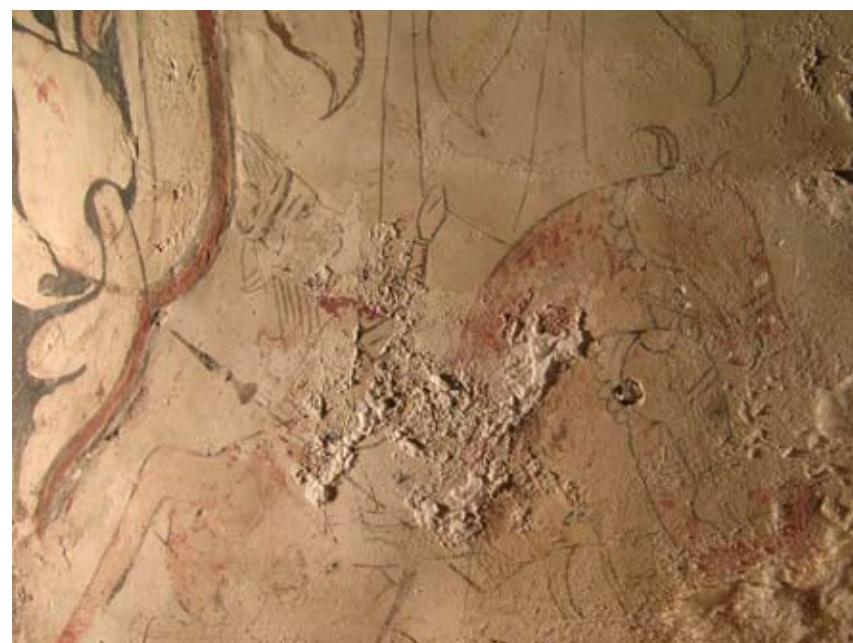
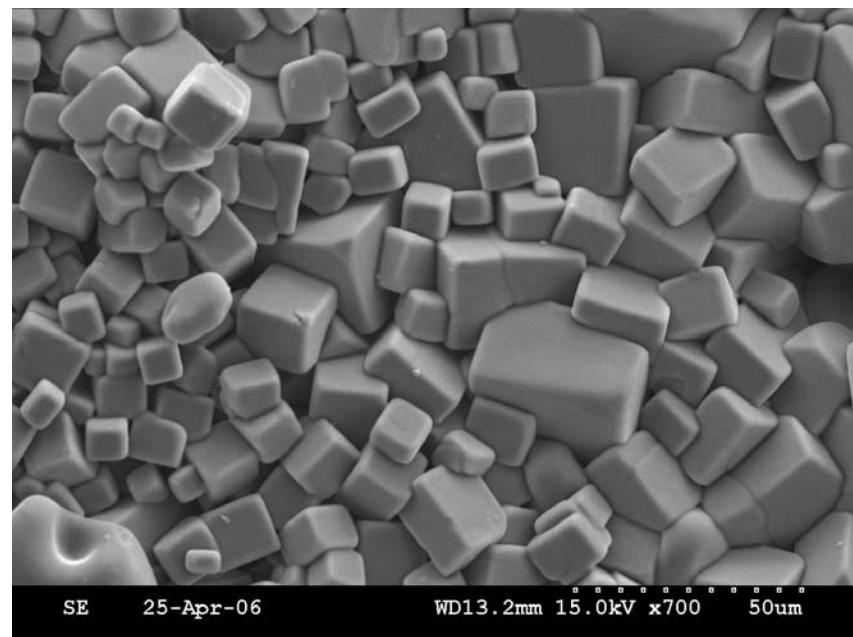
Two areas of salt efflorescence were identified as containing both sodium chloride ( $\text{NaCl}$ ) and sodium nitrate ( $\text{NaNO}_3$ ).<sup>1</sup> It should be stressed that because these two salts have a common ion (sodium), under different thermo-hygrometric conditions the same ions may crystallise as different salts (Sawdy 2003). Almost all other efflorescences contained both chloride and nitrate ions.

Above: area of salt efflorescence from Room 10, the Abha Mahal.  
Below: SE micrograph (secondary electron, 700x) of salt sample (Sample # NAG05-26-11) from the area illustrated above in the Abha Mahal.

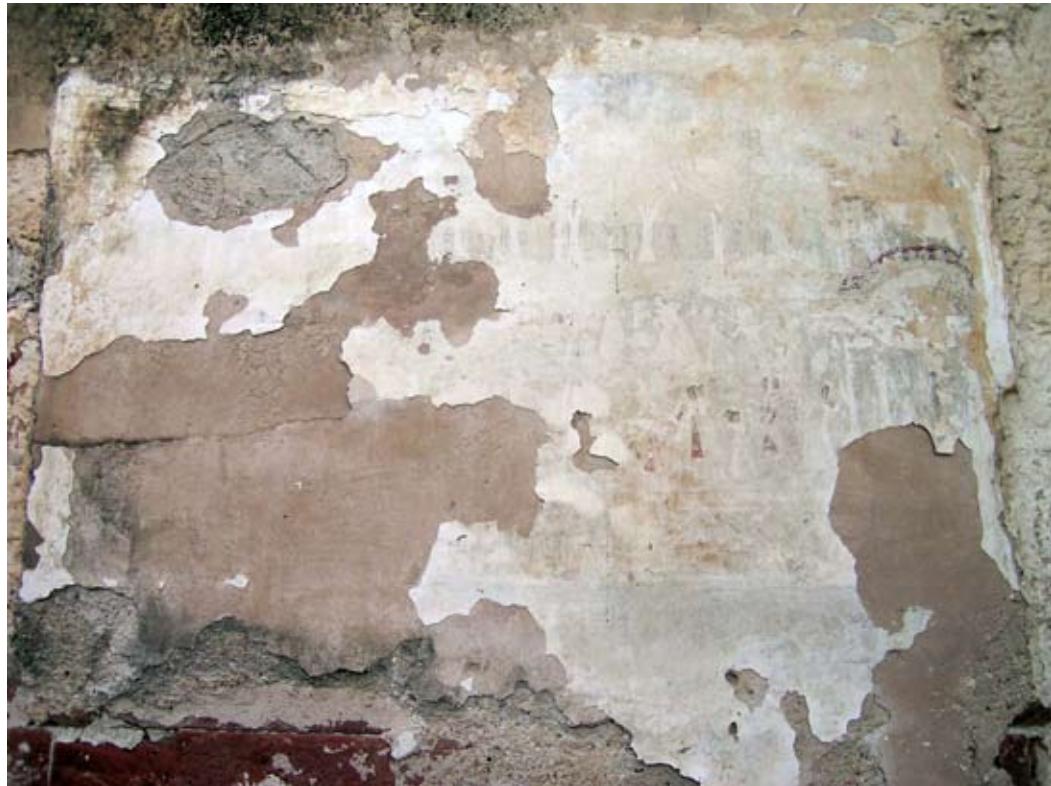
*Above: the fragmentary remains of a severely detached painting on the north facade of the Hadi Rani Mahal before facings were applied.*

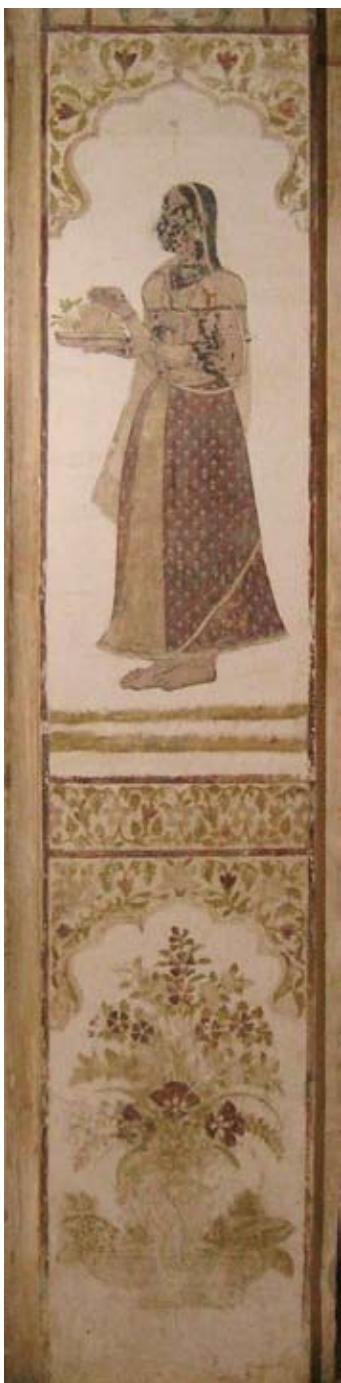
*An area of severe detachment due to salts activity in room 10 of the Abha Mahal: before (above) and after temporary facings were applied (below).*

Stabilisation should not be carried out until salt-related deterioration has been addressed, and until that time the temporary facings should be monitored.

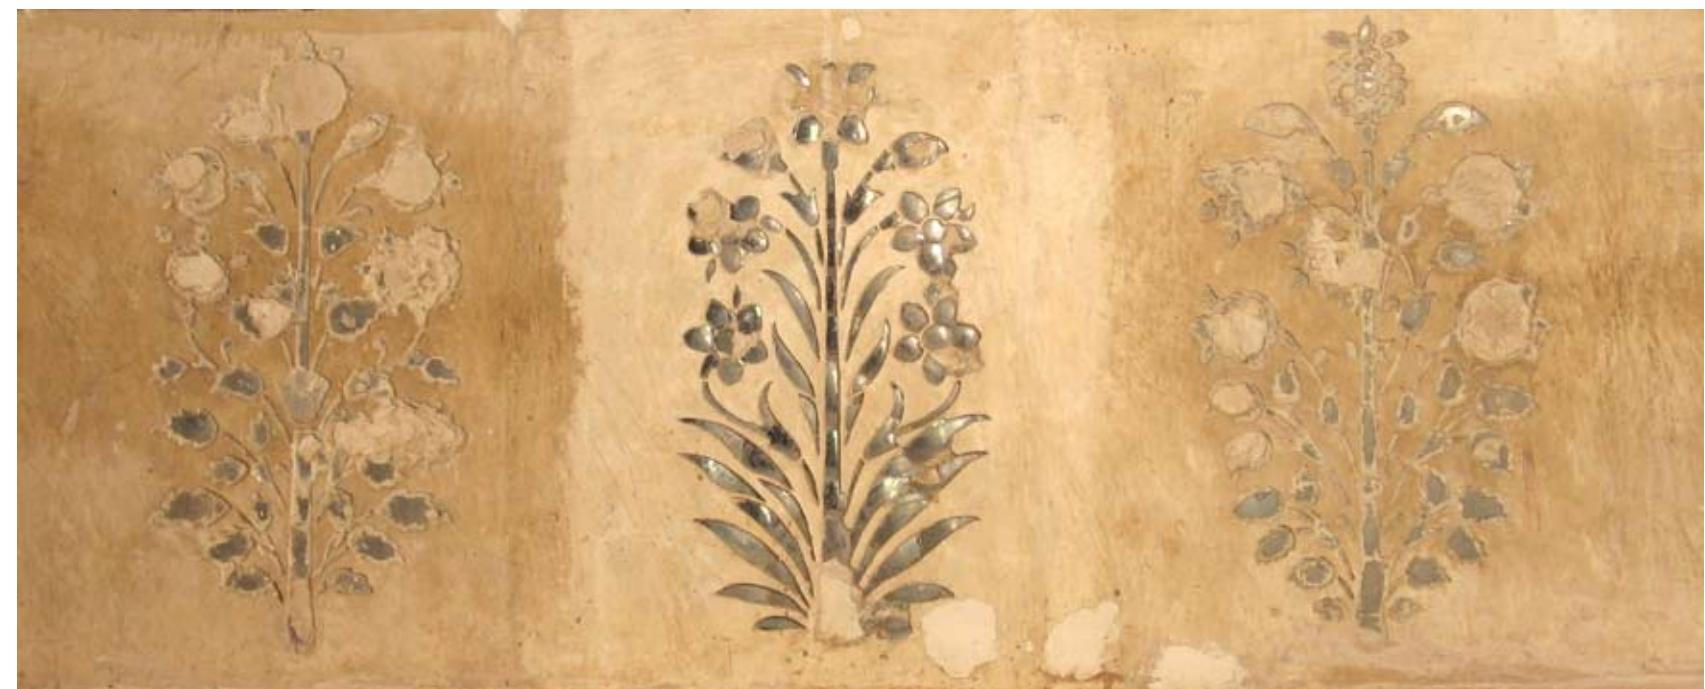
*Left: a cleaning trial in Hadi Rani Mahal, first floor, after removal of a discoloured synthetic coating.*

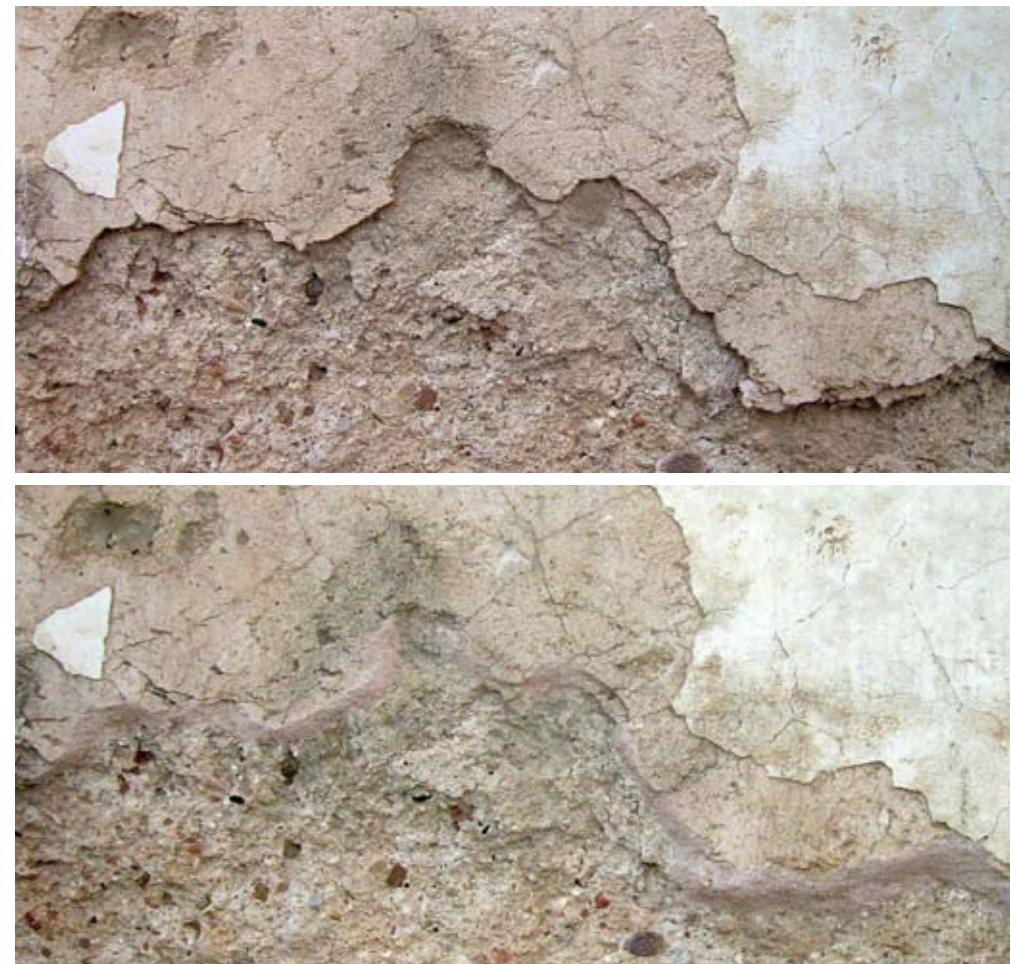
Above: an area of exposed detached plaster on the north facade of the Hadi Rani Mahal before (above) and after (below) the application of a trial edge repair.

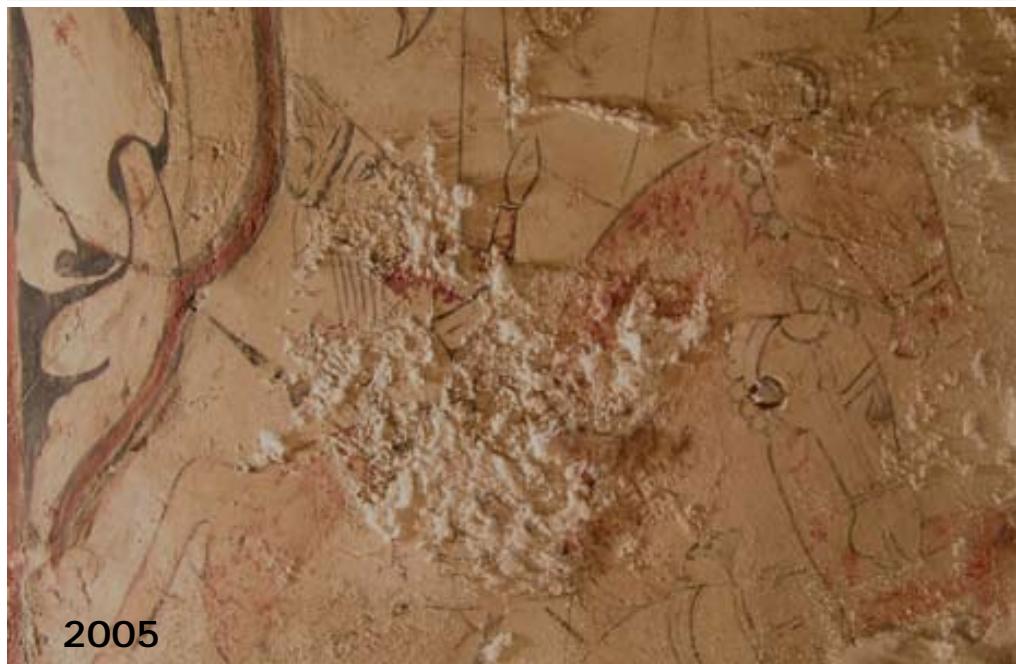
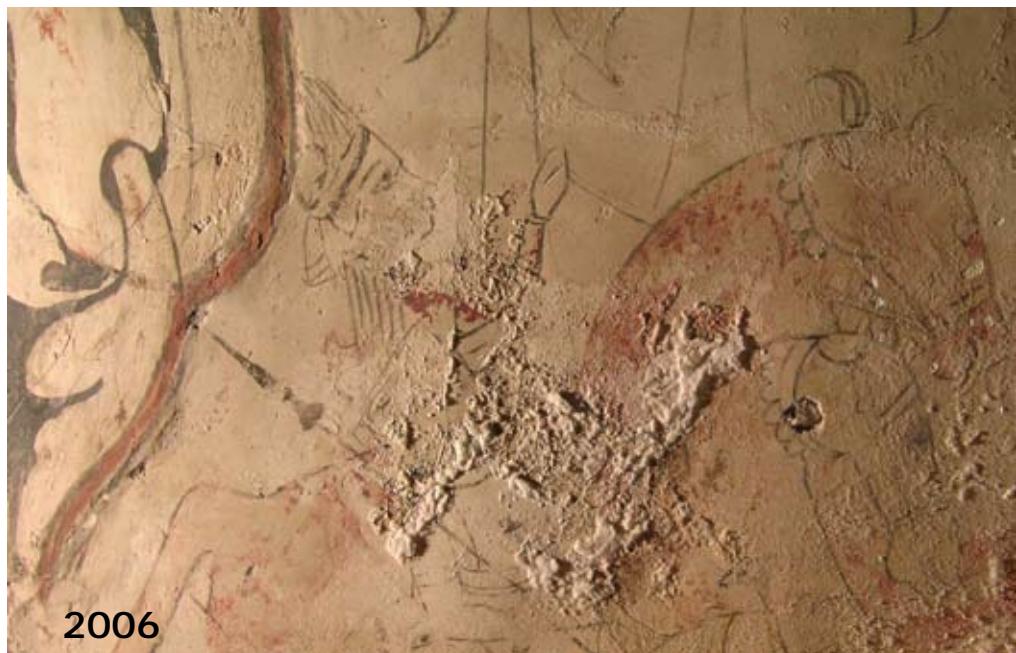
Above: an image of an area with salt-related deterioration in Abha Mahal room 10 taken in September 2005, Below: an image of the same area in March 2006, showing loss due to ongoing salts activity.

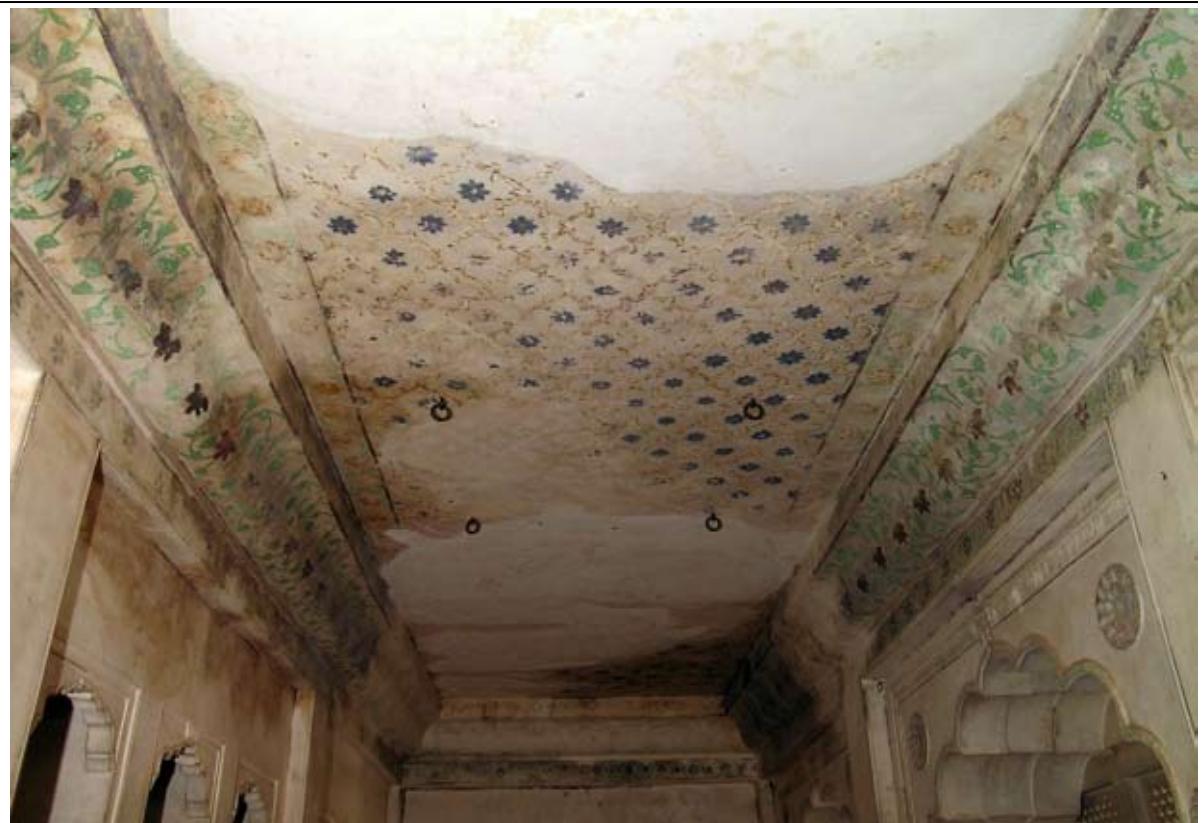
- A substantial portion of the original painted plaster on the ceiling has detached from the support.
- Large areas of the ceiling have repairs, and these seem to be attached, however edges adjacent to the original have started to separate from the support.
- Some large cracks are also present and often correspond to the most severely detached areas; these were also documented.

*A general view of the mezzanine ceiling in the Bakht Singh Mahal*

- Further investigation to assess whether the infiltration of liquid water is being prevented by the recent roof repairs is needed.
- The continued development of a grouting material which would be appropriate for use in this situation.
- The ceiling should be carefully monitored, and the need for a temporary support system considered during the next phase.

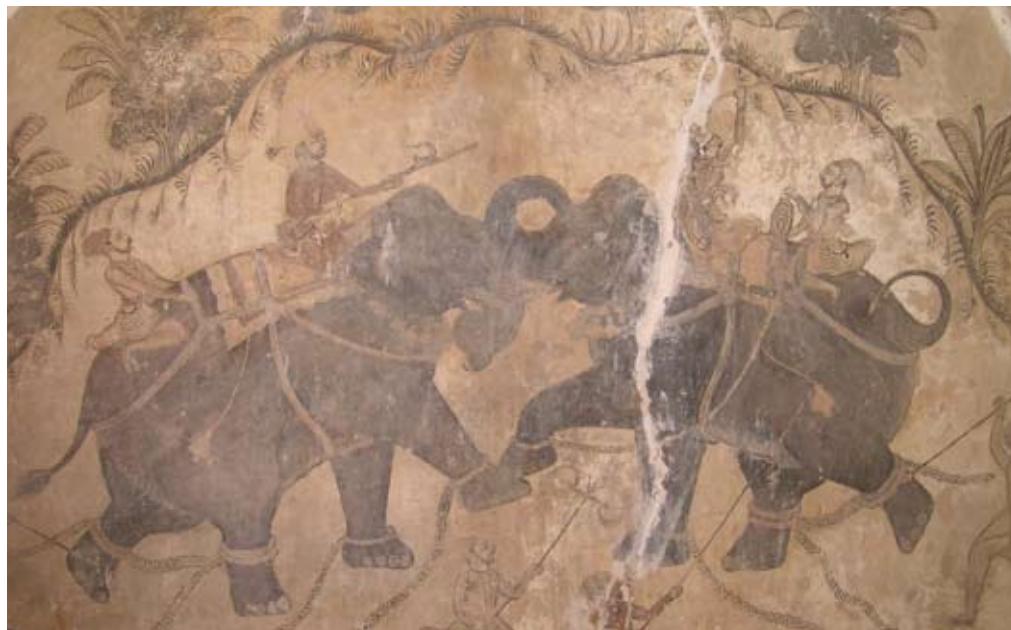
- Of the available cleaning systems none proved successful at removing the various surface deposits in a controllable, homogeneous way.
- Due to the nature of the original materials, aqueous systems are problematic.
- The application time needed for removal of the unwanted non-original materials could not be reconciled with the potential damage caused by mobilisation of the paint.

Above: detail of the ground floor scheme showing deposition and overlapping repair material on the surface of the painting.

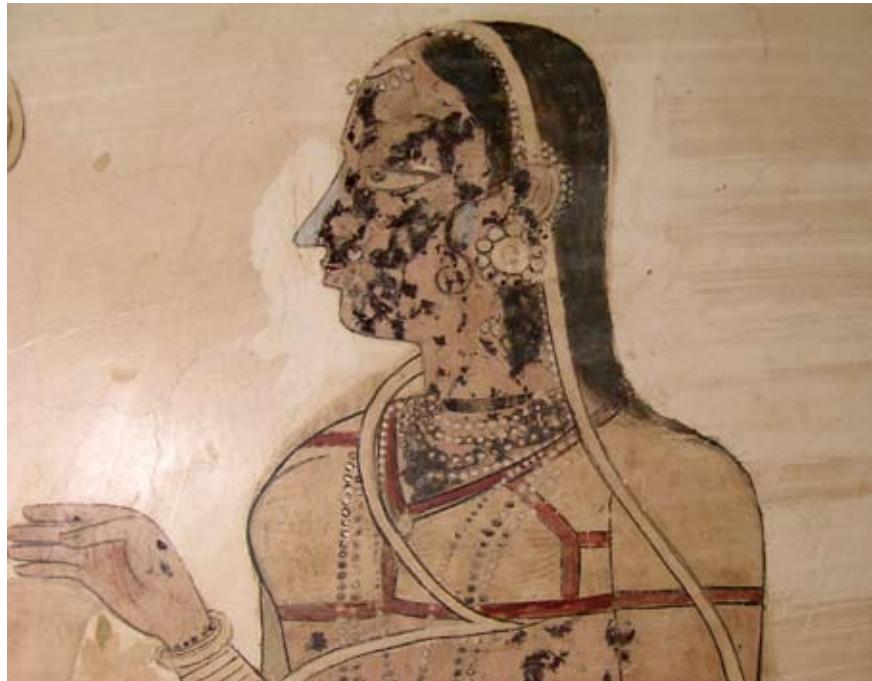
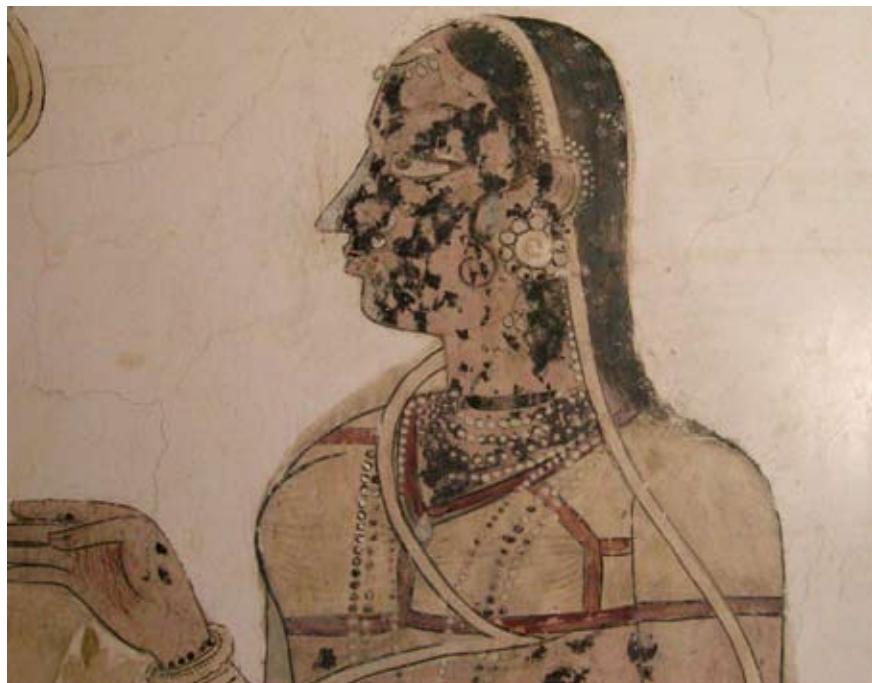
*Above: figures from the first floor of the Hadi Rani Mahal with blackening due to alteration of red lead.  
Below: a cross-section of sample #3787 (200x) showing partially altered red lead pigment particles.*

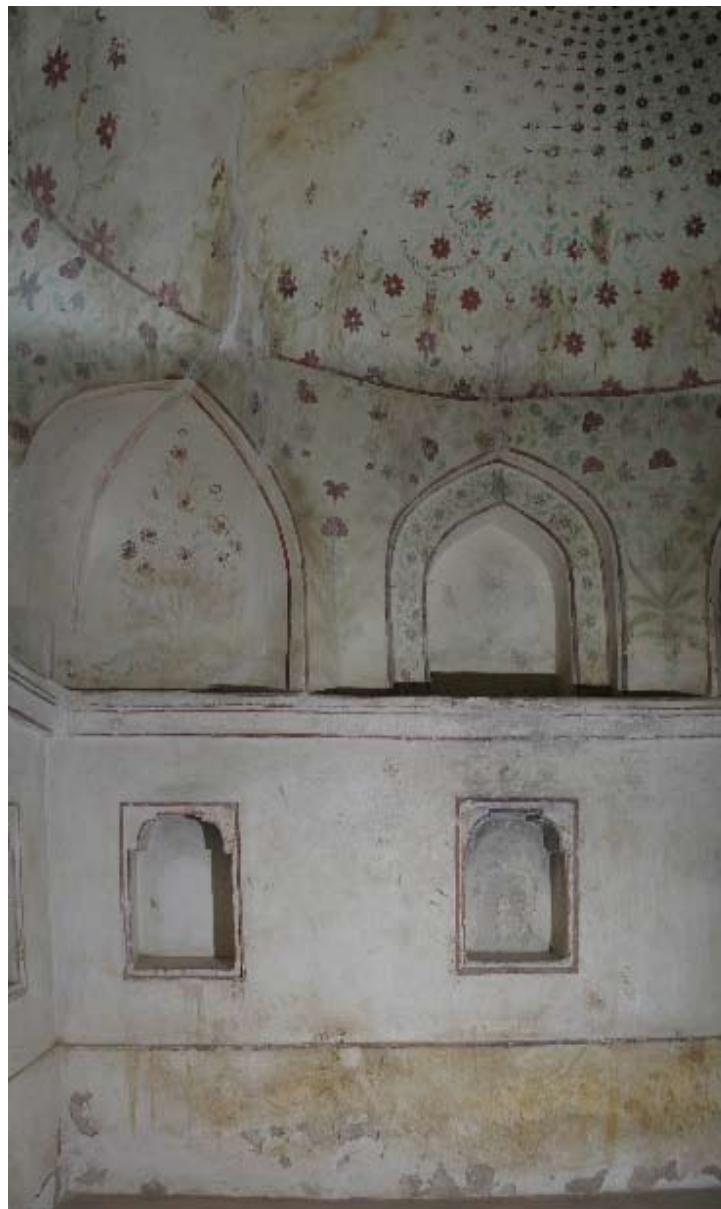
*South wall of the Hammam showing brown staining and pigment loss in the dome area, and plaster loss at ground level. Sample B1 was taken from this wall.*

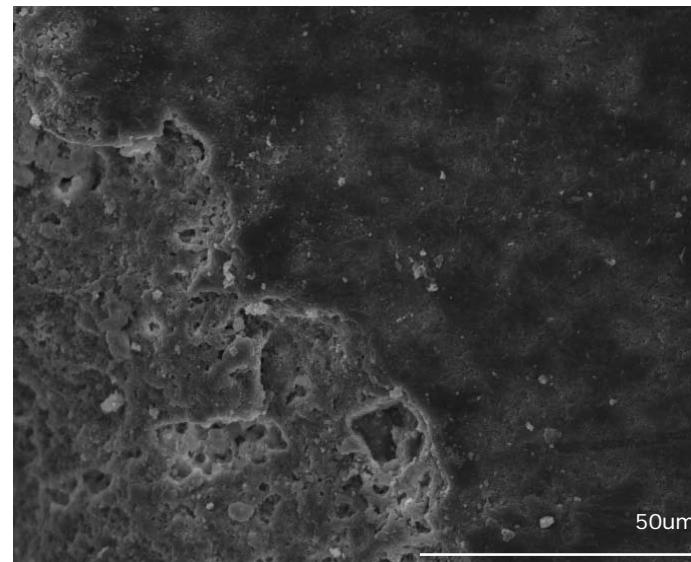
*Top: the same niche after cleaning, the cleaned area within the white line. The coating was removed and the painted surface is matte. A yellow stain remains after cleaning.*  
*Bottom: An SE micrograph (secondary electron image) (600x) of Sample #3801 taken from an area similar to that illustrated above after cleaning. The dirt and amorphous coating have been removed.*

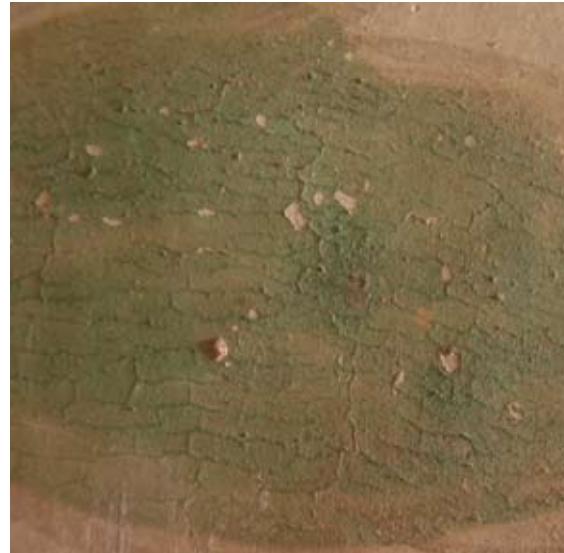
## FLAKING PAINT LAYER: GREEN

Loss of adhesion between green paint layer and underlying layer. It is possibly due to the inherent susceptibility of the pigment and/ or application method. The area illustrated shows characteristic cracking, lifting and loss of paint.

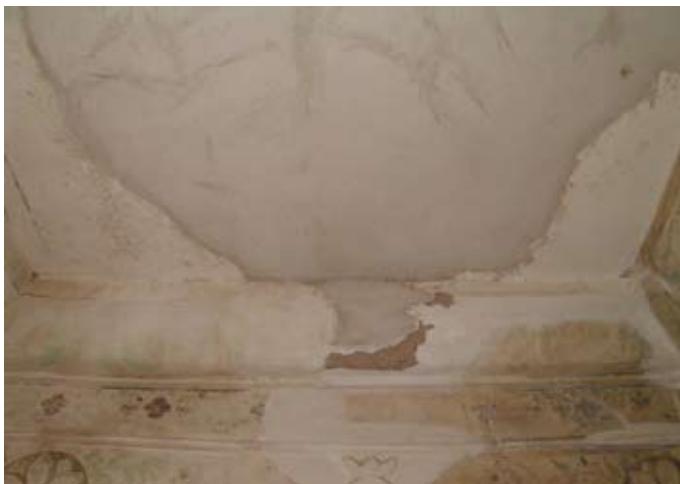
Grey plaster fills in large areas of loss on the ceiling. Over half of the exterior ceiling is lost and this type of repair was applied throughout.

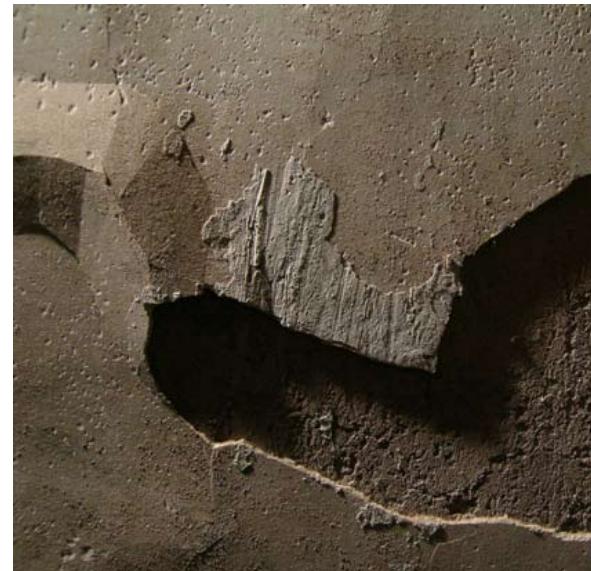
Loss of adhesion between plaster layers (shown here between the uppermost layer and secondary plaster layer), and/or between plaster and stone support.

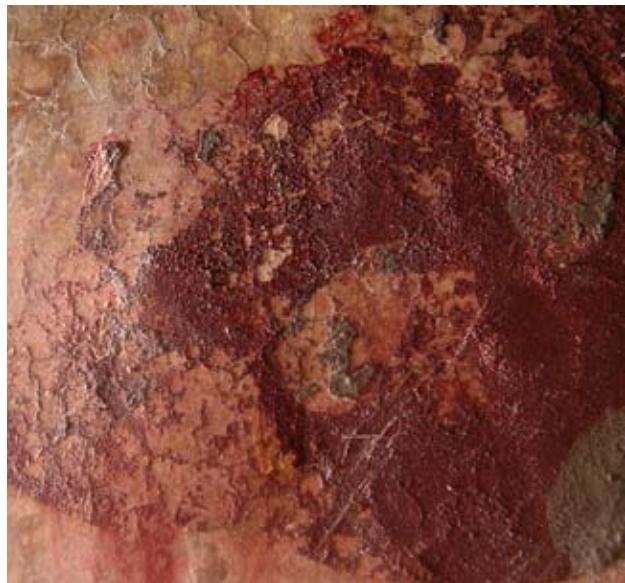
Lack of cohesion in the paint layer resulting in loss. Powdering paint is localised to areas of salt efflorescence and is not widely distributed.

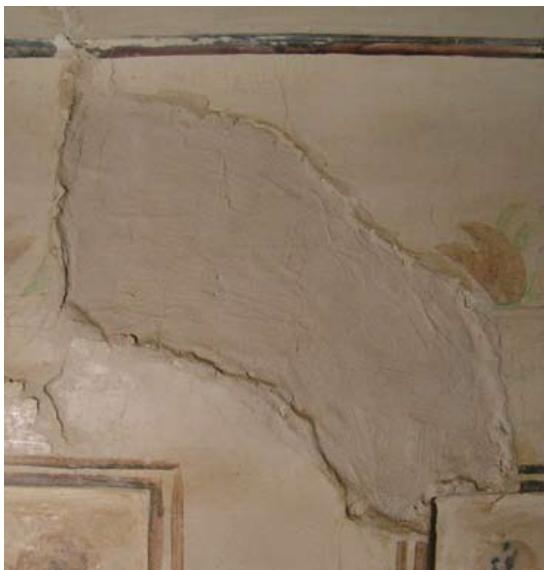
Lime-based plaster fills applied with recessed surface and tinted to match the colour of the plaster. These fills tend to be quite small and are present below the roof.

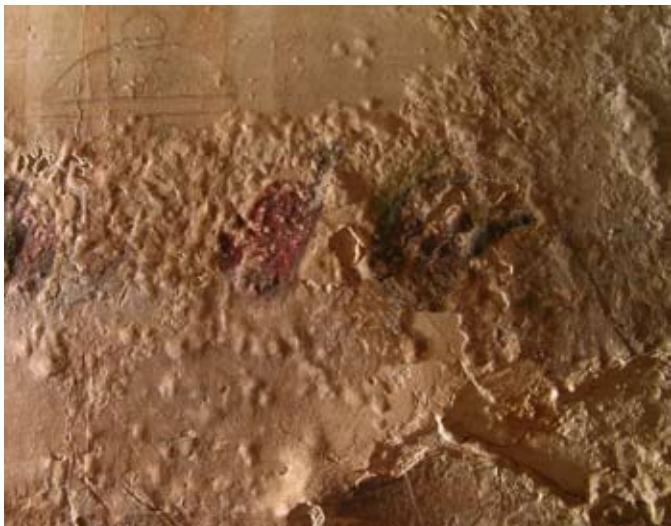
Brown, translucent and shiny coating applied to the surface of the paintings with associated bubbling and lifting of the paint layer.
