# THE WALL PAINTINGS OF AHHICHTRAGARH, NAGAUR:

Report on the Investigations and Treatment Undertaken in  
February - March 2006 and Proposals for Future Conservation

STEPHANIE BOGIN, CHARLOTTE MARTIN DE FONJAUDRAN, SIBYLLA TRINGHAM

CONSERVATION OF WALL PAINTING DEPARTMENT, COURTAULD INSTITUTE OF ART,  
UNIVERSITY OF LONDON

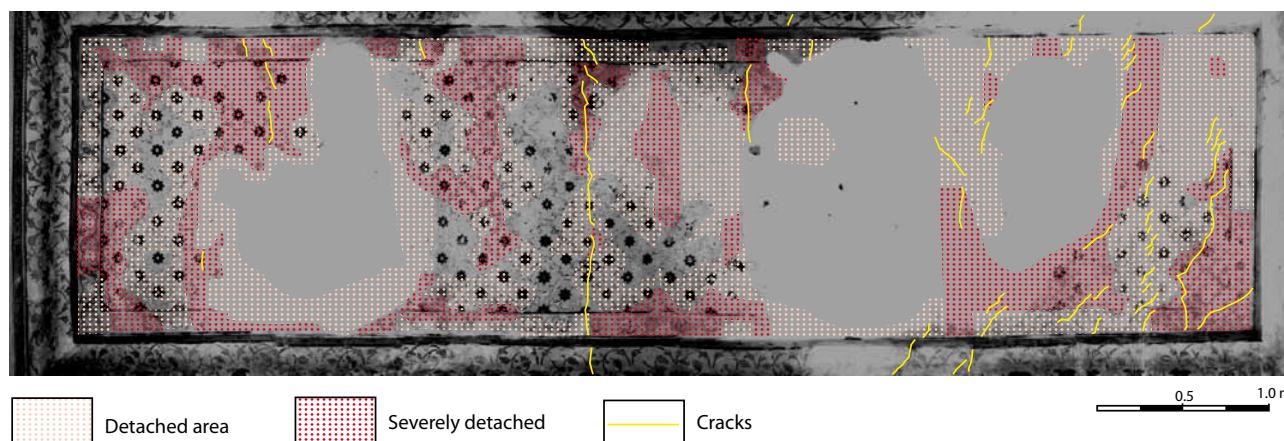
*Above: an example of graphic documentation showing areas of detached plaster on the mezzanine ceiling of the Bakht Singh Mahal (for full version see Appendix 2b ).*

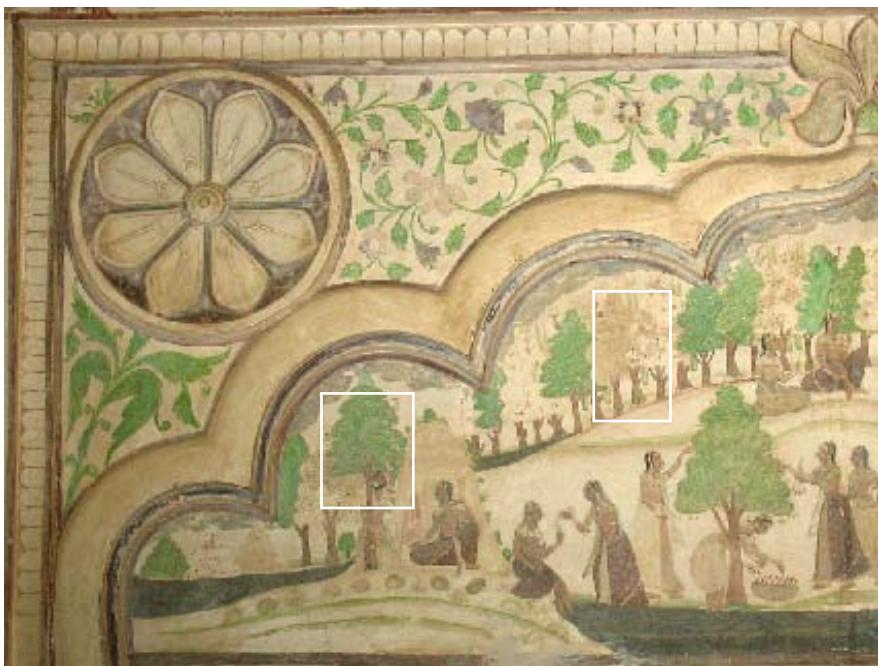
Above: a section of the first-floor scheme of the Hadi Rani Mahal. The palette is predominantly bright green and beige, the latter the result of the fading of organic colorant.

Below: the cross-section shows a sample taken from the beige-coloured tree (similar to the one located above) from the first floor scheme in the Hadi Rani Mahal (Sample #3789), showing two layers of paint, yellow over blue (200x). The upper section of the yellow paint layer has faded, resulting in the present beige colour.

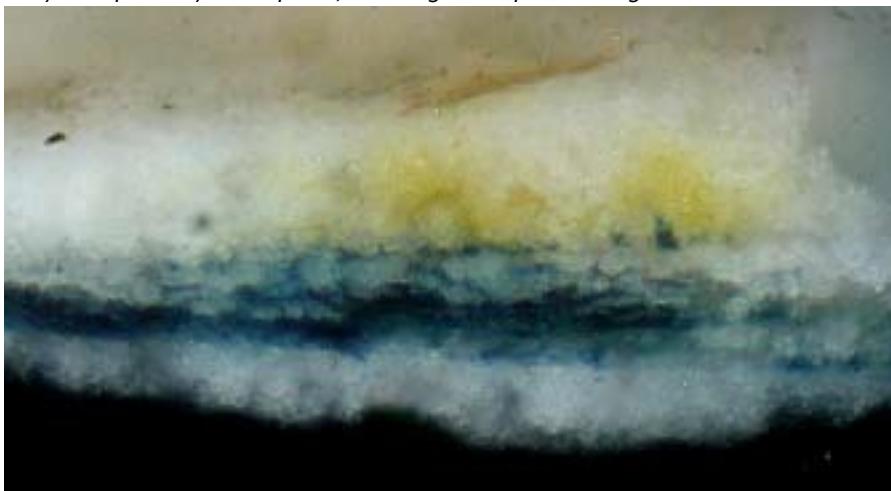
Right: cross-section of sample (Sample #3788, 200x) of the bright green trees in the Hadi Rani first-floor scheme, illustrated left). The pigment was identified as a copper chloride.

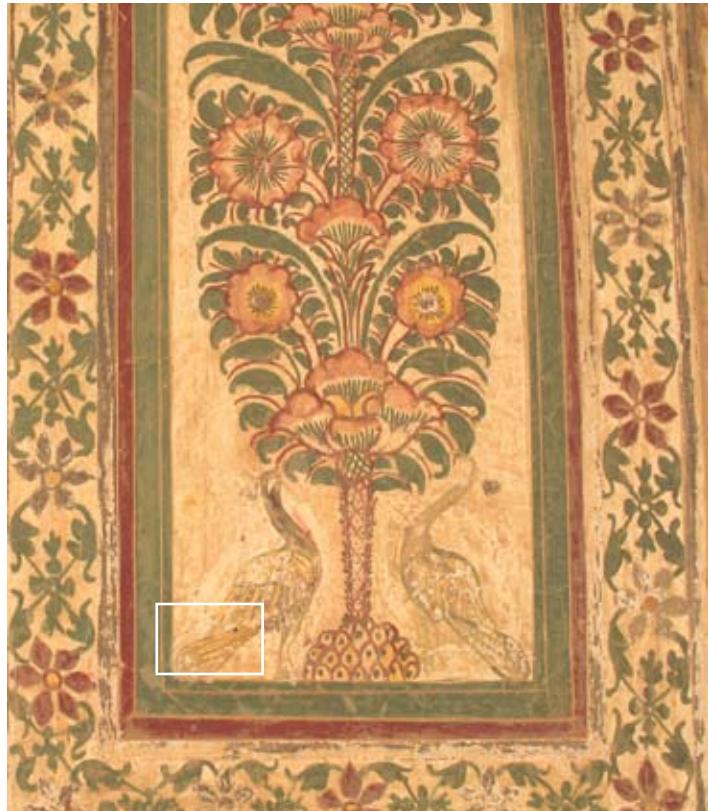
Although it had been hypothesised that the preferential loss of the yellow pigment on the exterior east wall of the Abha Mahal was due to the fading of an organic colorant, it has been shown that the pigment is yellow ochre and therefore not subject to fading (illustrated below). Deterioration might be related to the clay content of the earth pigment or to its binding medium, and exposure to extreme and fluctuating environmental parameters (temperature from direct sunlight, humidity and rain water).

*Left: the exterior of the Abha Mahal has few areas of yellow pigment remaining. Below left: cross-section (200x) of a yellow sample (Sample #3784) from the exterior of the Abha Mahal. The pigment was identified as yellow ochre.*

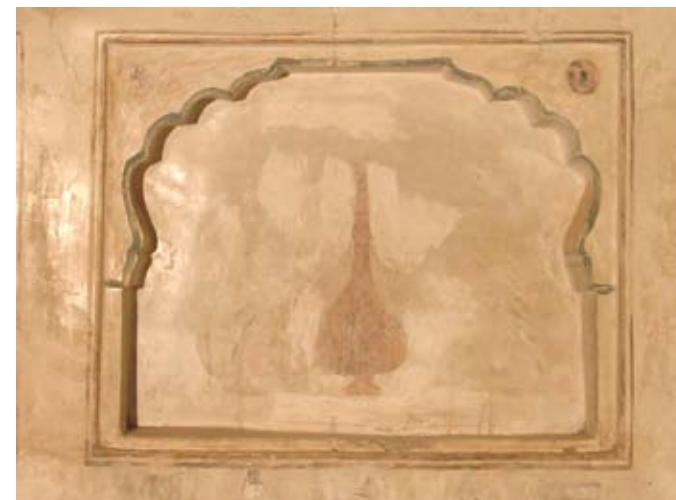
Synthetic coatings have been widely applied on the paintings at the site and are most notable on the interior of Hadi Rani Mahal and both the interior and exterior of Sheesh Mahal. Polyvinyl acetate is documented as having been applied on the interior of Sheesh Mahal (Agrawal 1989). Imaging with SEM confirmed the presence of a smooth polymer coating on these paintings of varying thickness (illustrated below). There may be additional undocumented and unidentified coating(s) and further characterisation of these material(s) is required to better define the scope for their removal.

Left: a niche in the Sheesh Mahal with discoloured, shiny coating.  
Below: SE micrograph of Sample #3805 (250x) from the interior of the Sheesh Mahal before cleaning, showing a smooth amorphous coating above the lime plaster.

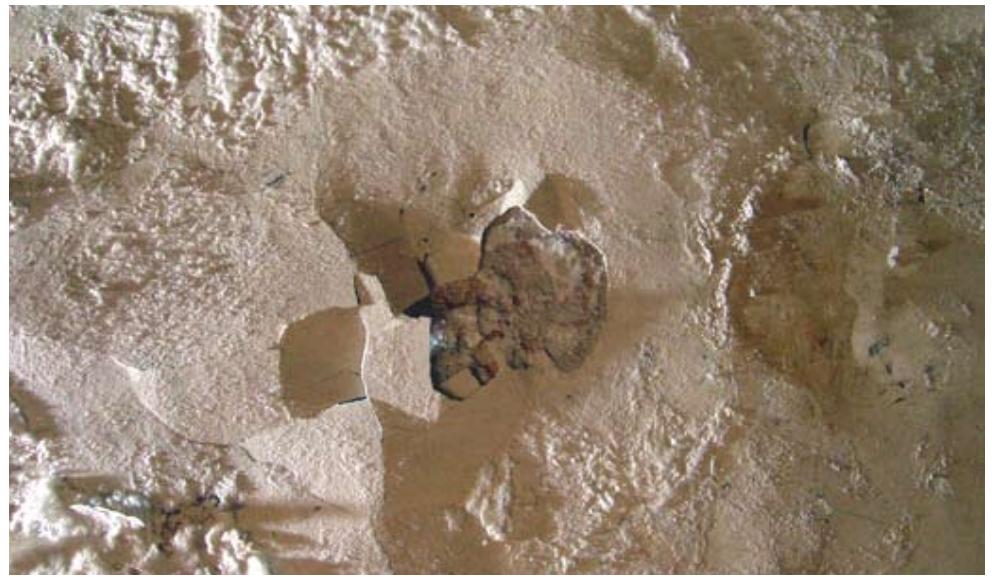
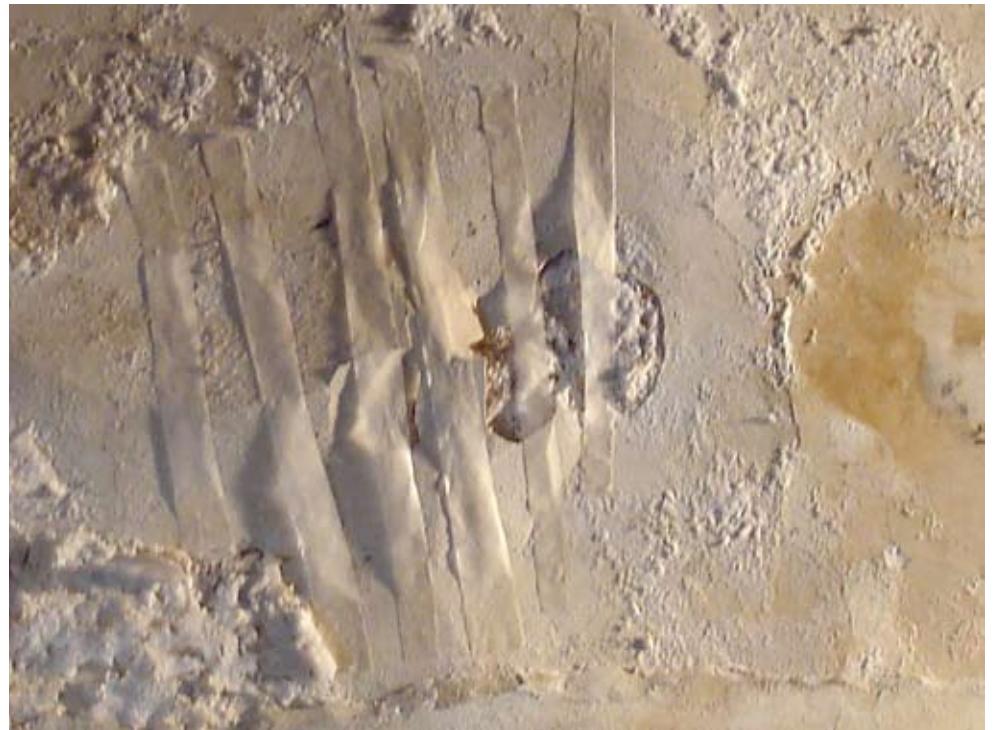
*An area of severe detachment due to salts activity in room 10 of the Abha Mahal: before (above) and after temporary facings were applied (below).*

During this phase emergency treatment was carried out to provide interim stabilisation of areas considered to be at imminent risk of loss. Temporary facings were applied to localised areas of detached plaster on the north façade of Hadi Rani Mahal, the interior of Abha Mahal, and the interior courtyard of Sheesh Mahal. Performance criteria for this stabilisation included compatibility, durability over the anticipated time, resistance to biodeterioration, and complete removal of the temporary materials. Monitoring will be required to ensure that these measures are effective and it is desirable to implement a long-term approach to stabilising these areas as soon as possible.

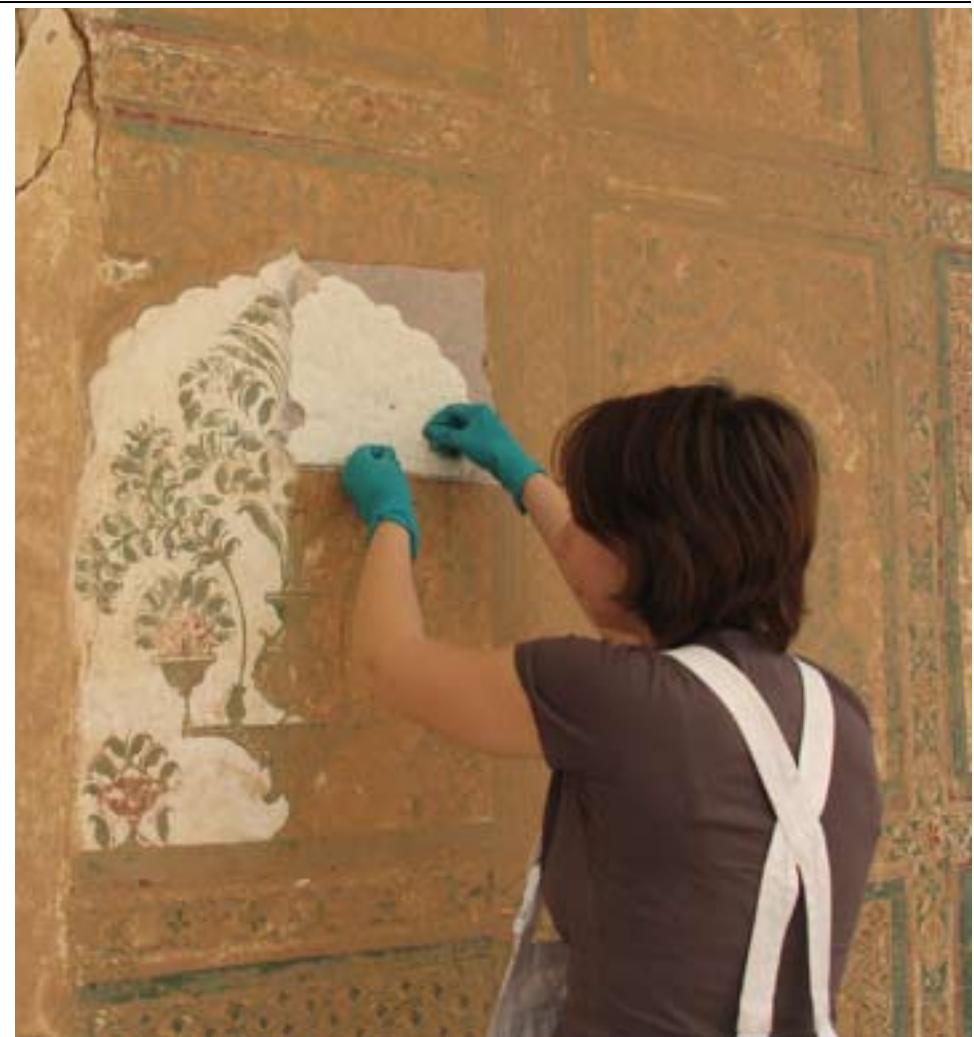
*Above: Stephanie Beguin (Courtauld Institute) applying a sorbent during cleaning trials to remove the heavy deposition of dirt which obscures the exterior scheme on the east facade of the Abha Mahal.*

The exterior painting on the east façade of the Abha Mahal is covered in a thick uneven deposit of dirt. Loss has occurred at the base of the walls, and large vertical cracks occur in several locations. Detached plaster and earlier losses are often associated with these cracks. However, the plaster is generally stable, and the main issues are the visual disruption caused by the dirt and potential problems resulting from exposure to the weather. Recently, a temporary shelter was installed with the intention of directing rainfall away from the base of the wall. Before developing an approach for the conservation of the scheme, investigations and treatment trials were required to assess the inherent susceptibility of the original materials as well as to assess the feasibility of safely cleaning the painting. Additionally, requirements for appropriate long-term protection were considered.

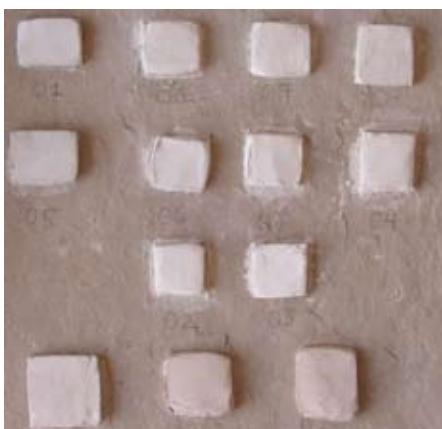
Plaster tests used in the development and selection of a suitable repair material.

Several repair formulations were developed, tests applied to a stone slab and assessed (see below). Those which best met the criteria were then applied in an area of unpainted plaster and a final selection made of two formulations. The first was applied in the first floor of Hadi Rani Mahal to losses in the dado of the east wall to replace bright white repairs from a previous intervention. The new repairs are both more sympathetic visually and more compatible. The second was used in the emergency stabilisation of the exterior scheme of Hadi Rani Mahal as an edging repair to replace previous unsightly and overlapping materials (see right). Monitoring these trials over the coming year will assist in the final selection of repair materials. Details of the trials are found in Appendix 5b.

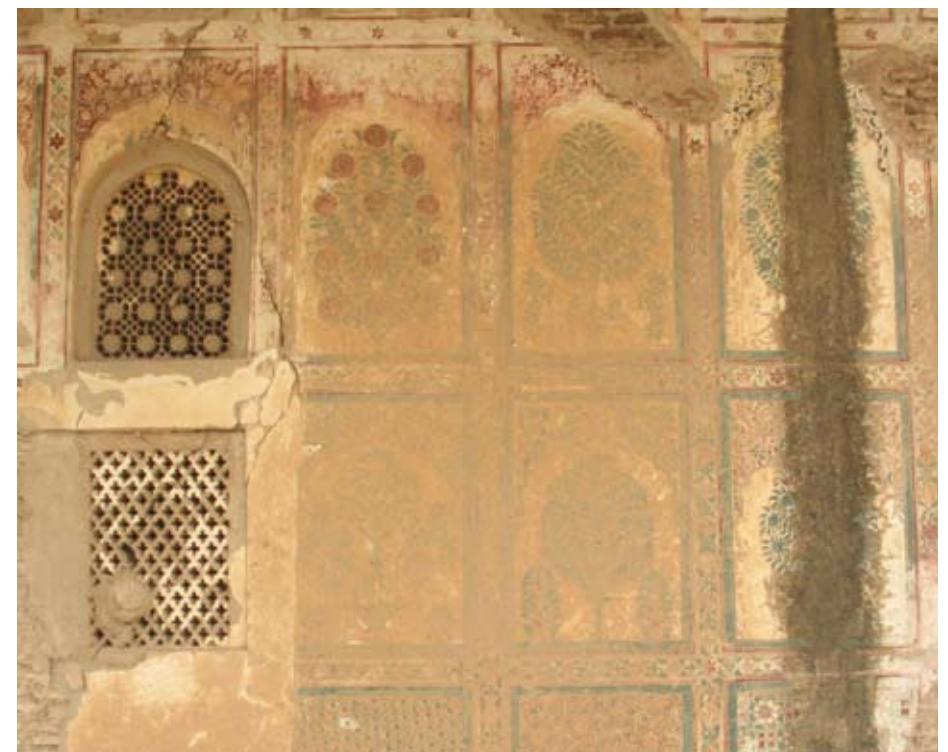
*Left: view of the East facade of the Abha Mahal.*

*Above: the painting scheme on the East facade is obscured by a heavy deposition of dirt.*

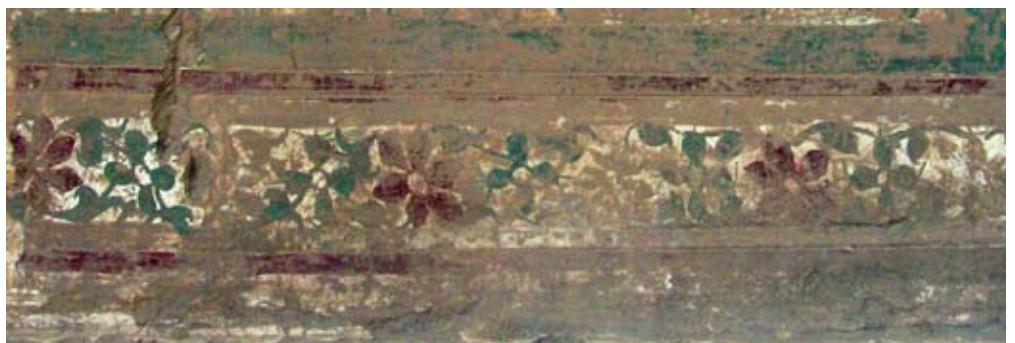
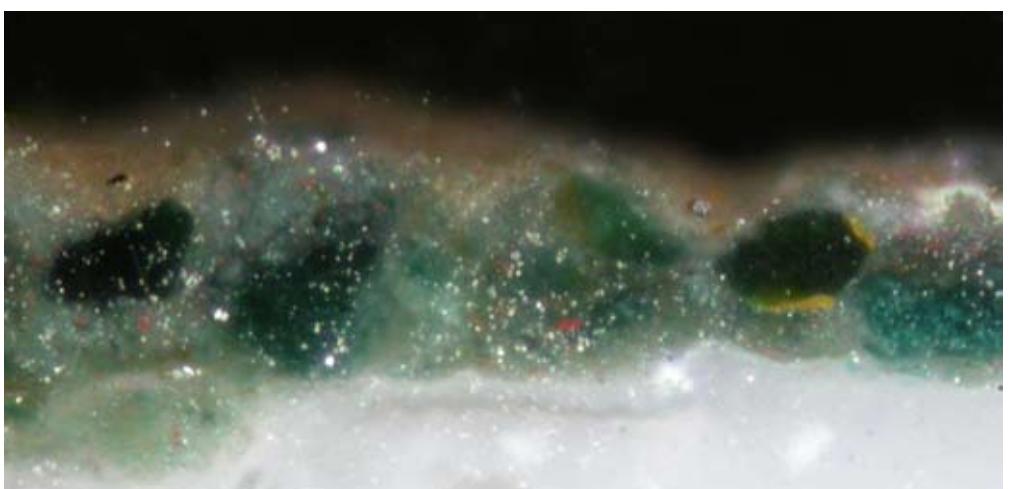
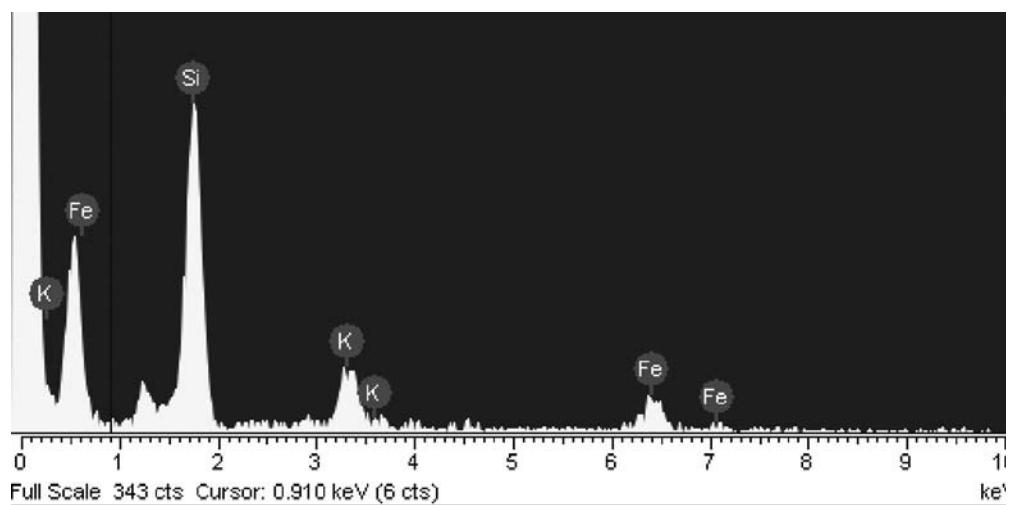
Examination of the green pigment (Samples #3802/#3803) with PLM and SEM-EDS identified it as green earth. Although sampling of the red and black pigments would also be desirable in the future, it does not appear that the exterior scheme includes any organic colorants which would be subject to further deterioration as a result of future cleaning.

*Above: context of sampling location for sample #3802.*

*Centre: cross-section of sample #3802 (200x) showing large particles of green earth.*

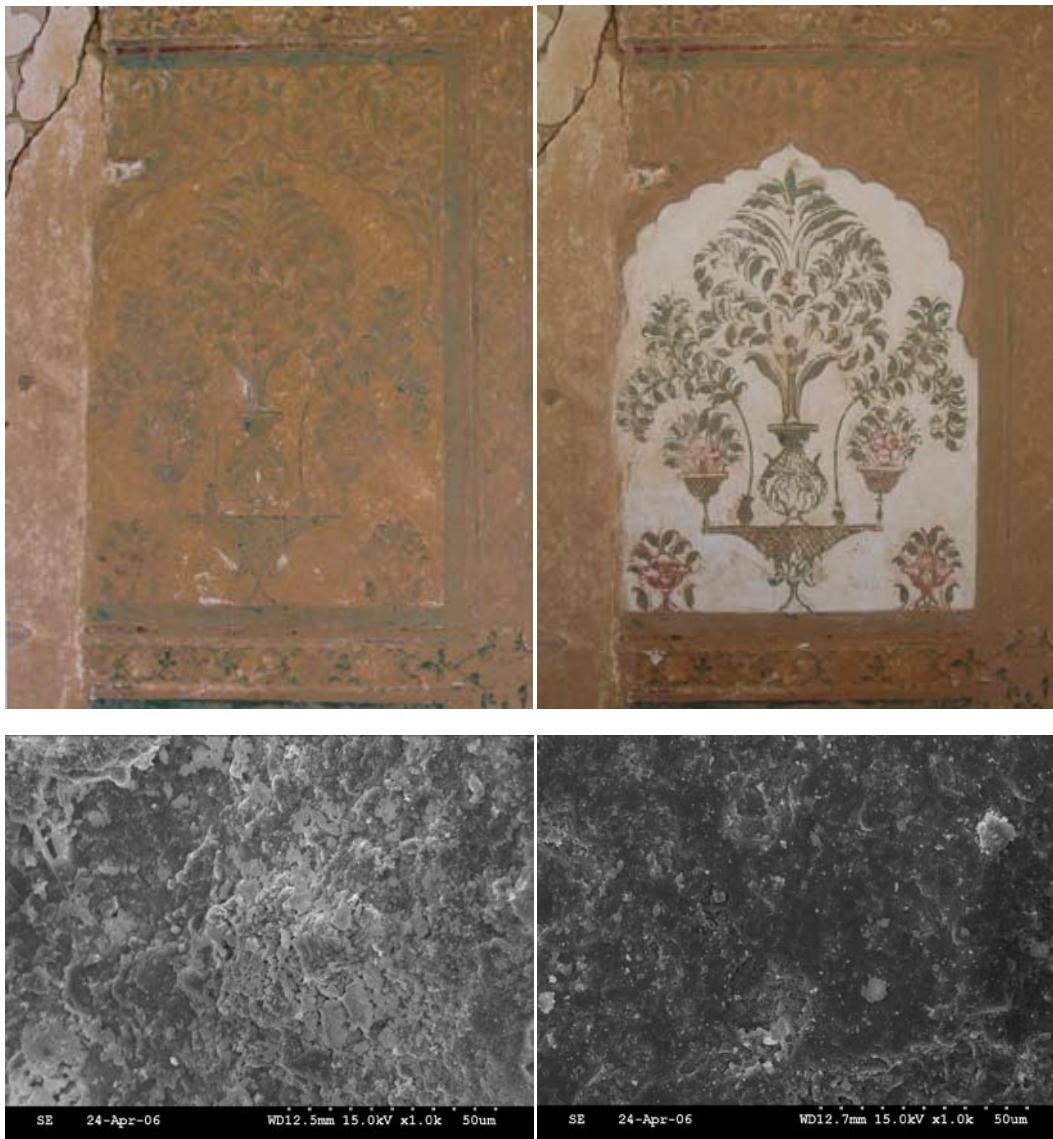
Samples (#3802 / #3803) were taken before and after cleaning and examined using SEM to assess results. Micrographs showing the area before and after cleaning at 1000 x magnification indicate that no damage was caused to the paint layer, and that removal of the dirt was successful (see images below).

The trial made a substantial visible impact and indicated it will be possible to reveal the currently obscured scheme. Although these results were satisfactory, varying conditions will require adjustments. In addition, some mobilisation of the paint layer indicates that limiting exposure to water would be desirable. Moreover, because these paintings are external, some means of long-term protection needs also to be considered.

Above: before (left) and after (right) cleaning on the exterior east facade of Abha Mahal.  
 Below: scanning electron micrographs (1000x) of sample # 3802 and #3803, showing the surface of the paintings before and after cleaning.

Investigation into original materials and treatment trials have indicated it would be possible to successfully clean this exterior scheme. However, since the intervention would primarily be intended to improve the legibility of the painting (which does not require major stabilisation), it is not currently a priority. Risks to the painting are largely environmental, and assessment of the current shelter and determination of long-term protection needs are instead priorities.

Therefore, a monitoring exercise has been put in place to assess the rate of redeposition of dirt, as well as the effect of the current shelter. Repeatable photographs of the cleaning trial window will be taken four times throughout the year, and the dirt deposited on the cleaned area will be examined. Additionally, observations will be made during periods of heavy rainfall to assess if the current shelter is successfully directing water away from the base of the wall.

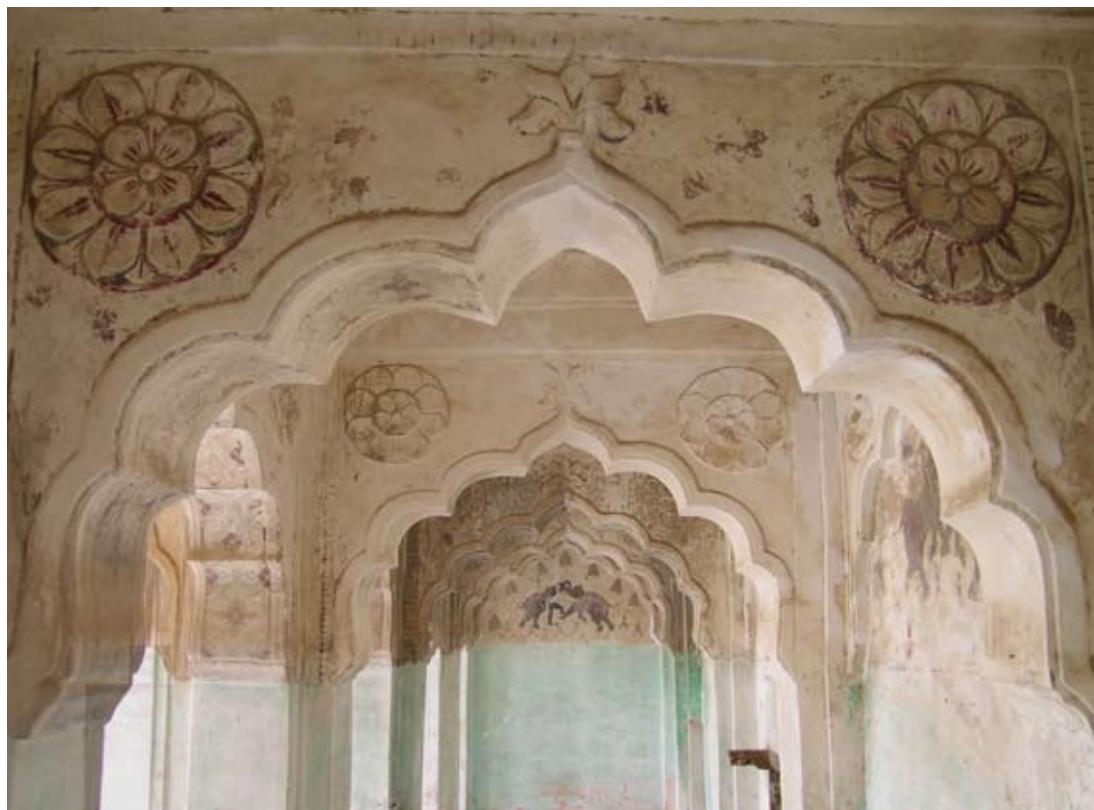
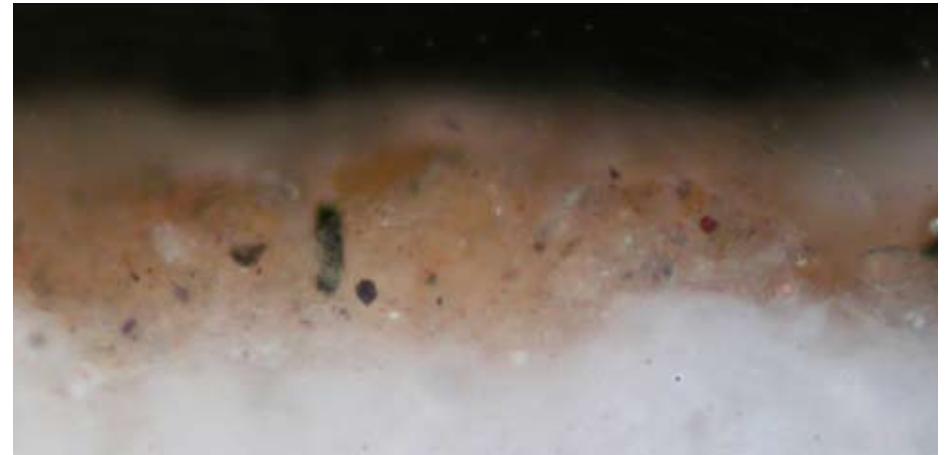
Above: view of the ground floor of the Hadi Rani Mahal.

Right: cross-section of sample #3794 (200x) showing thick deposition on the surface of the plaster.

- A thick uneven deposit is visible on the surface of the cross-section (see above), however further characterisation is needed.
- SEM examination confirmed that no synthetic coating (such as those found in Sheesh Mahal and the first floor of Hadi Rani Mahal) is present on the painting sampled on the ground floor.
- It proved impossible to identify the green with PLM, since no colour or pigment particles were visible in the sample. However, it may well be a faded organic colorant as identified in the first-floor scheme of the Hadi Rani Mahal, so further sampling is necessary.

- Further analysis of the non-original material on the surface and assessment of the nature of the interface between this material and the paint layer.
- Further characterisation of the original materials.
- Further trials using additional cleaning materials not available during the present phase should be undertaken.
- Trials to assess the feasibility/desirability of removal of the large plaster repairs on the lower walls are needed.

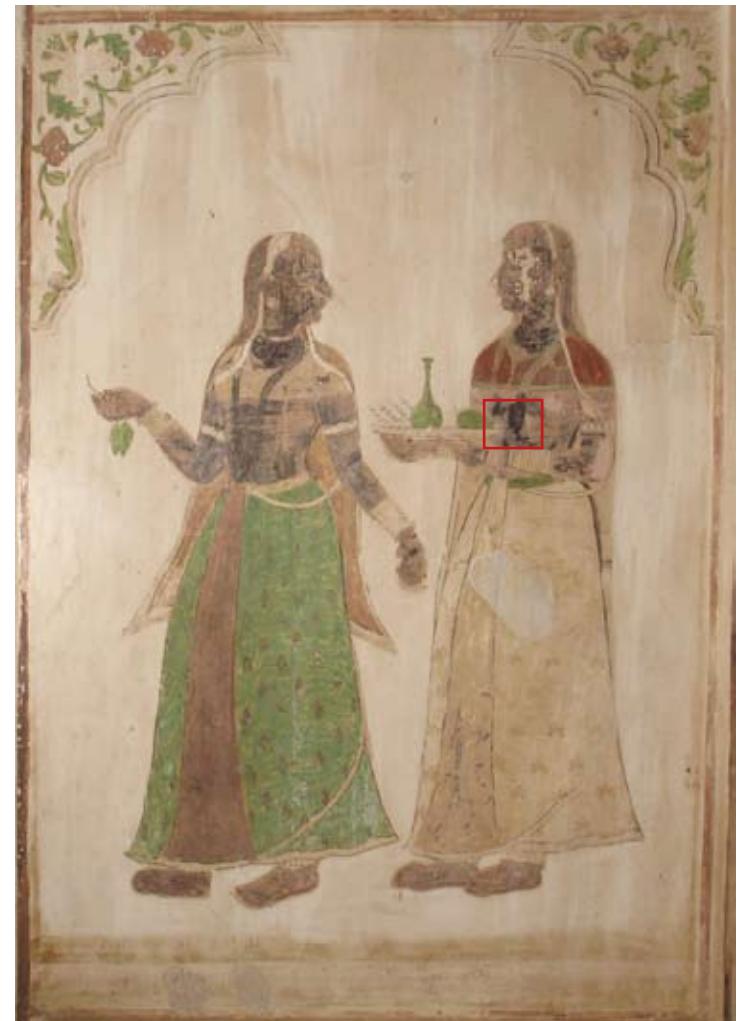
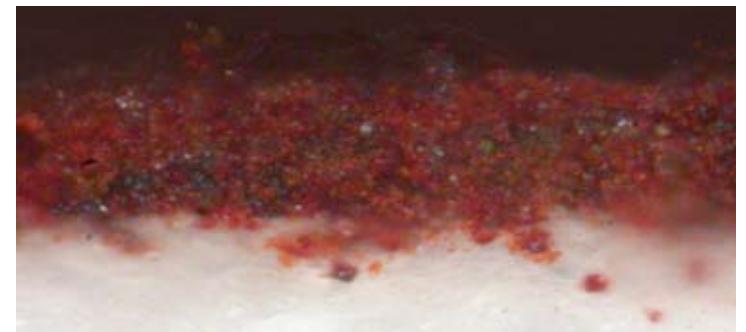
*Above: figures from the first floor of the Hadi Rani Mahal with blackening due to alteration of red lead.  
Below: a cross-section of sample #3787 (200x) showing partially altered red lead pigment particles.*

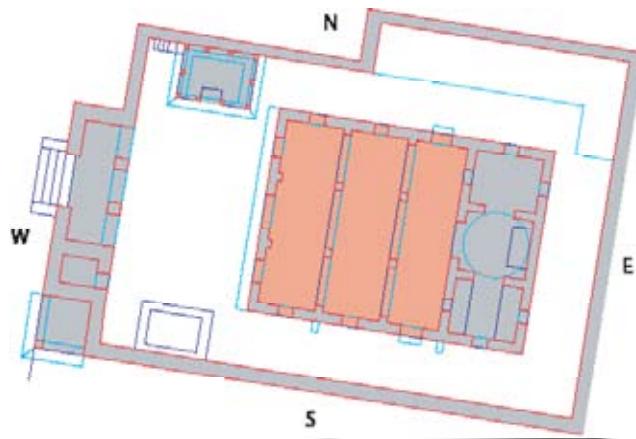
The Krishna Temple is decorated with scenes from the life of Krishna and has recently been architecturally stabilised and a program of wall painting conservation has been undertaken. The wall paintings were uncovered and cleaned and are generally stable. Salt efflorescence was noted on the north wall in 2005 [Bogin 2005:50–52] and appears to be localised to repair material. The efflorescence was analysed to further our understanding of the phenomena.

*Above: west facade of the Krishna Temple.  
Left: plan of the Krishna Temple, the building is marked in pink.  
Right: interior north wall of the Krishna Temple.*

Currently, the salt deterioration is localised to a small area on the north wall, near to and on a repair material. As the salt activity is limited, further condition monitoring is recommended before assessing the need for more investigations or any intervention.

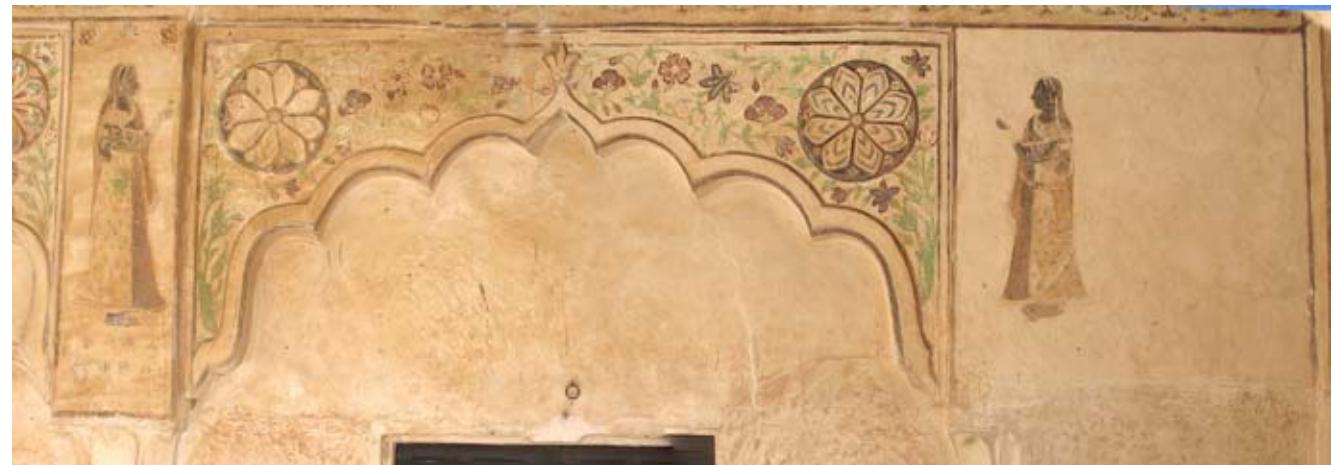
Above: a section of the upper register of the Sheesh Mahal, the left side before cleaning and the right side after cleaning. Removal of the darkened synthetic coating greatly improves the appearance of the paintings.

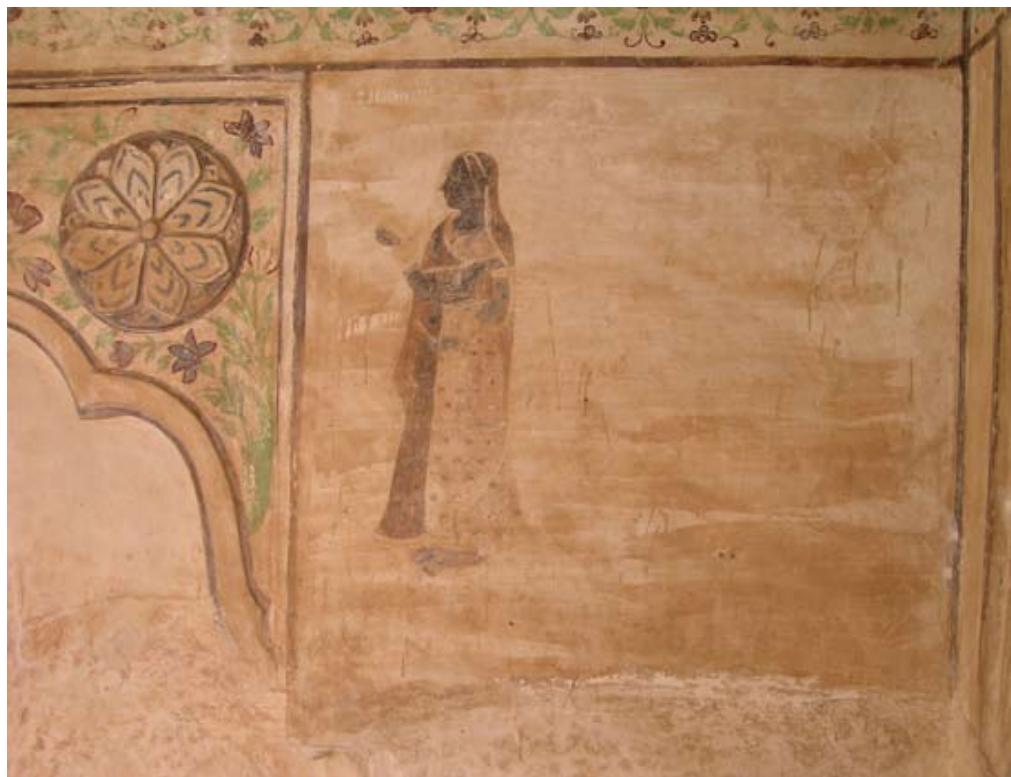
The entire exterior scheme has a brownish appearance due to discoloured coatings (see Visual Glossary) which are also visible in cross-section (see Bogin 2005:23). The coating on the upper register is suspected to be PVAC, as this material was also applied in the interior in the 1989 intervention and the appearance and behaviour are quite similar. PVAC becomes tacky in temperatures over 20°C thereby trapping dirt and is subject to cold flow (Horie 1990: 92), and it may also become insoluble over time, particularly in external contexts (Schwartzbaum 1988). The brown-coloured coating on the lower register is more matte and alters the appearance of the white kody plaster. There is no documentation recording any interventions to the exterior paintings.

Above and right: a figure from the exterior of Sheesh Mahal before cleaning. The painting is obscured by a discoloured coating which is particularly visible as drips and horizontal bands.

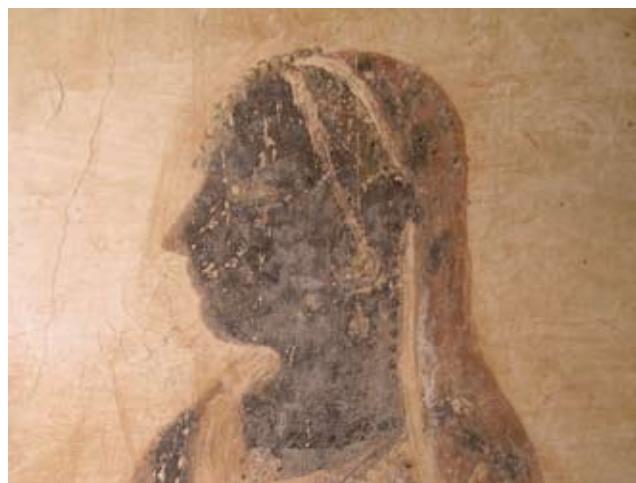
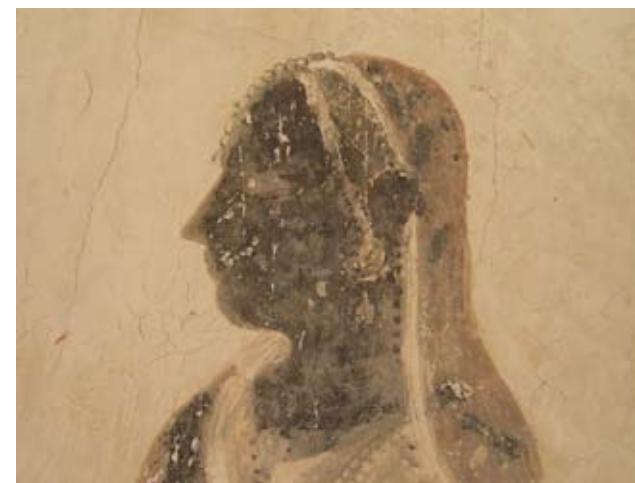
Above and left: the same figure after cleaning. Removal of the discoloured coating reveals many fine details previously obscured. The background is more homogeneous, the colours are clarified and the blanching on the figure's face is reduced.

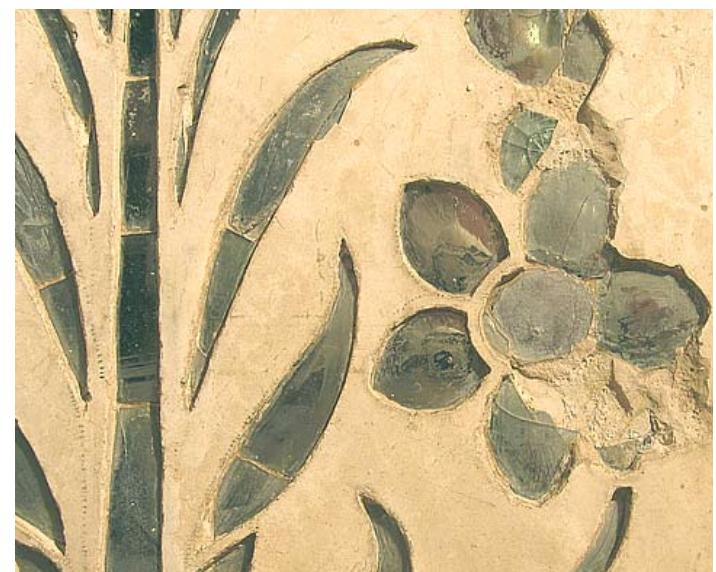
Right: pouncing marks are visible in some areas of the inlaid mirror-work. In this figure around the petals on the left of the flower and the left side of the main stem. After cleaning, some areas retain a white opaque residue which may be lime, visible on the central part of flower motif.

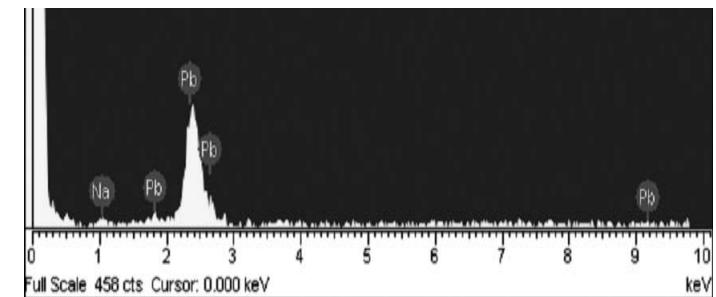
Right: SEM - EDS analysis of Sample #3806 showed that a lead foil backing creates the reflection and grey coloration of the mirror.

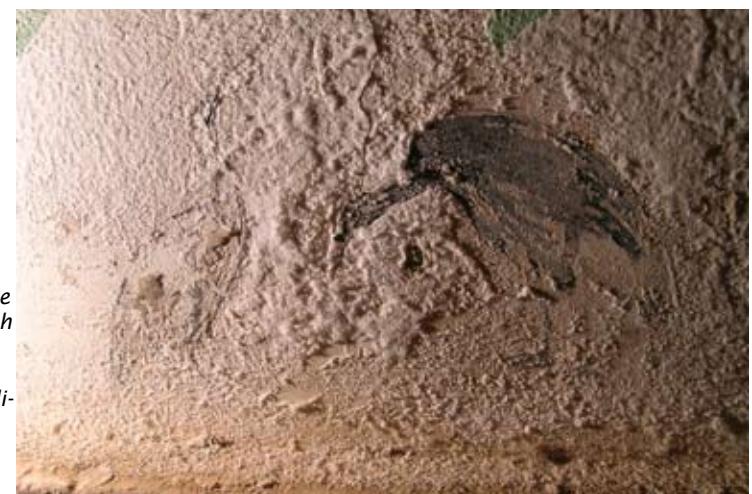
At Sheesh Mahal, the efflorescence corresponds to historic water infiltration, suggested by the brown staining and pigment loss associated with the area. While the new repair materials do not provide a source of potentially harmful ions, historic repairs and original materials may contribute. The new render on the vault addresses the problem of infiltration, however recent fills are failing which suggests continuing movement of water. To determine if the scheme is at risk from salt activity it is necessary to determine if water infiltration and salt efflorescence are active.

Right: salt efflorescence in the Sheesh Mahal has been identified as sodium chloride and sodium nitrate.

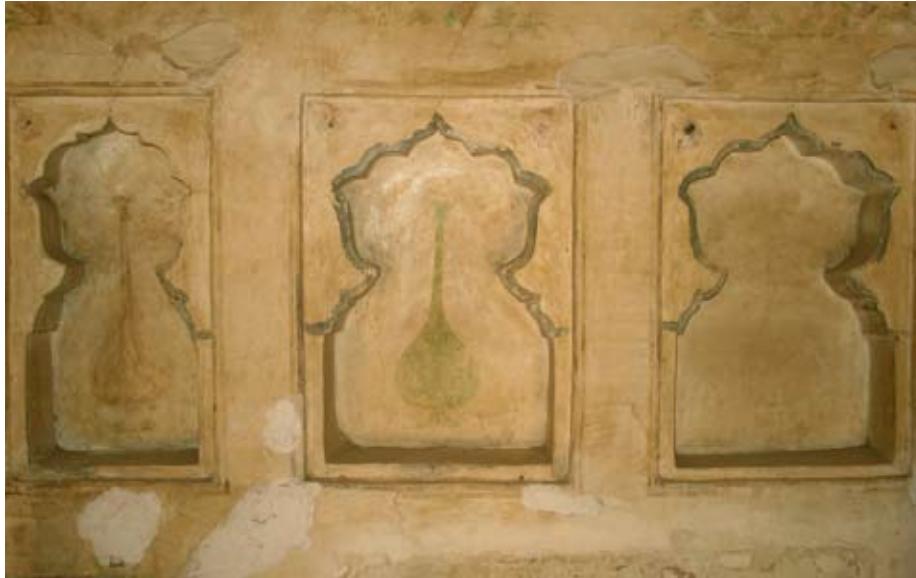
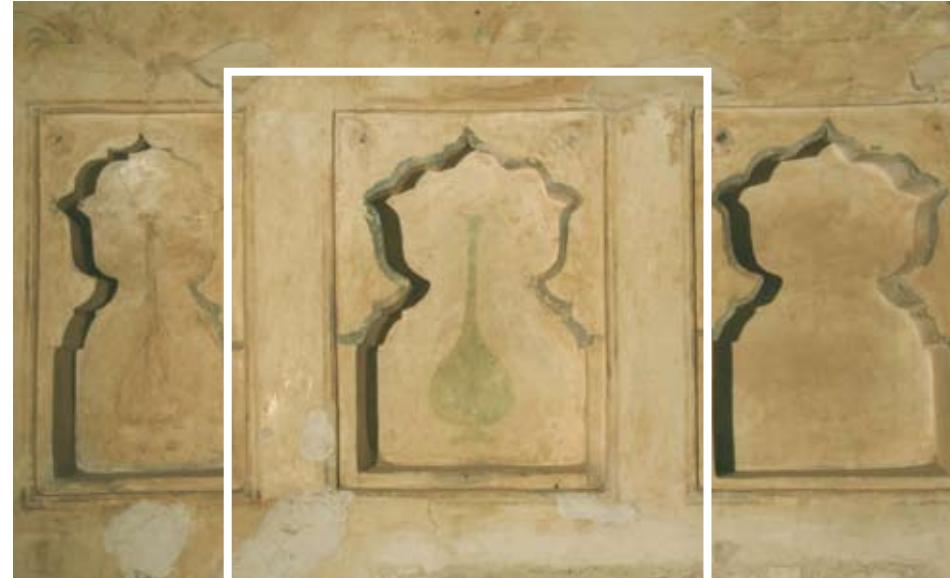
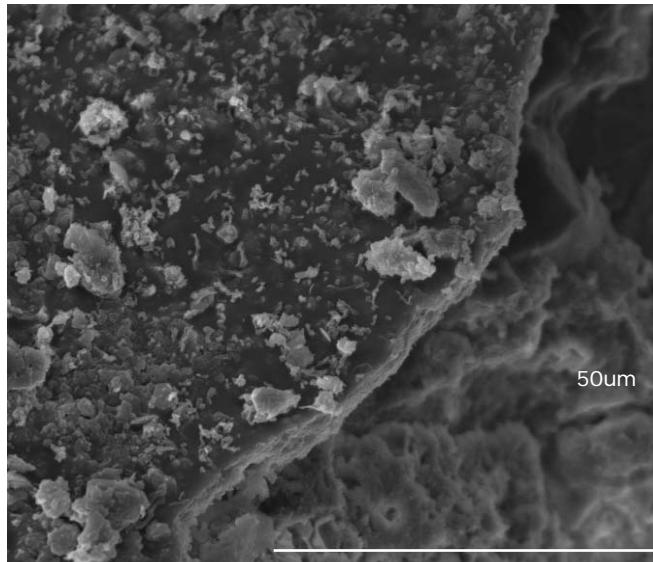
*Top: a niche from the interior of Sheesh Mahal before cleaning. The coating is shiny and discoloured.*

*Bottom: SE micrograph (secondary electron image) (1000x) of Sample #3800 taken from an area similar to that illustrated above before cleaning. The surface coating has a soft and amorphous appearance in which dirt particles are embedded.*

*Top: the same niche after cleaning, the cleaned area within the white line. The coating was removed and the painted surface is matte. A yellow stain remains after cleaning.*  
*Bottom: An SE micrograph (secondary electron image) (600x) of Sample #3801 taken from an area similar to that illustrated above after cleaning. The dirt and amorphous coating have been removed.*

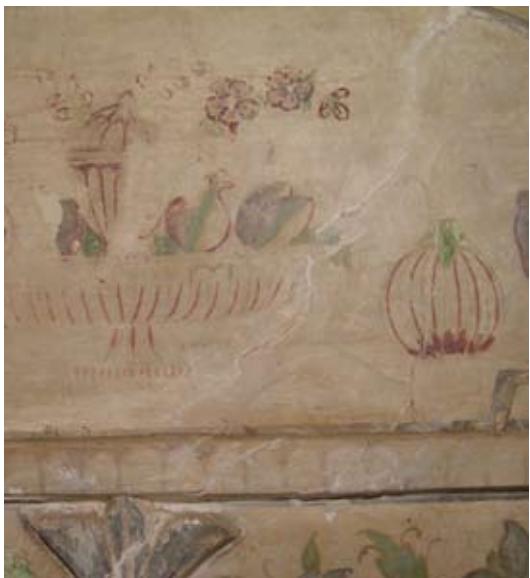
## CRACKS

Fissures or cracks in the plaster are widespread in the exterior scheme. Many cracks have been filled with a fine lime-based plaster.

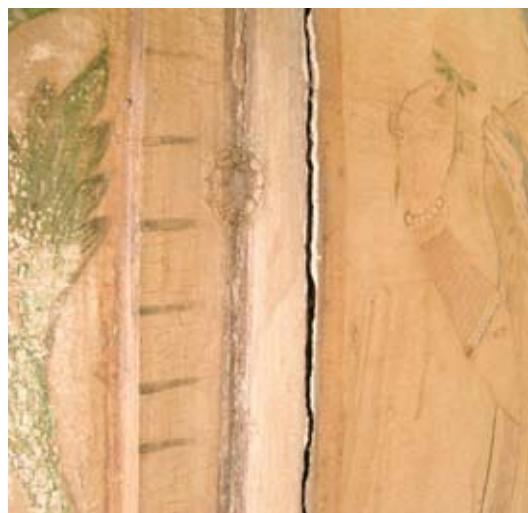
## DETACHMENT

Loss of adhesion between the plaster layers and/or plaster and support. The extent of detachment has not been fully assessed.

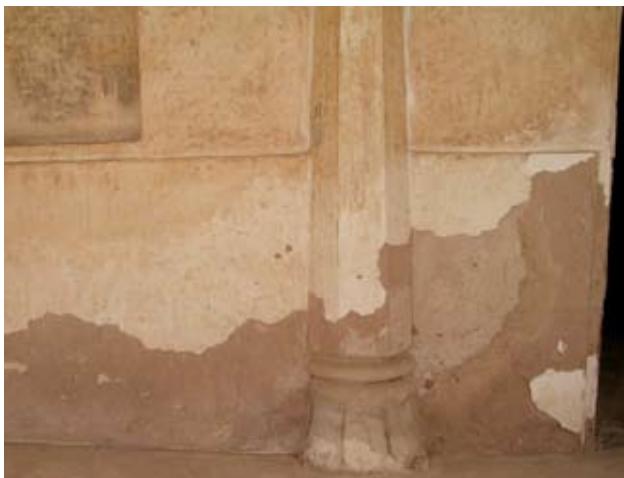
## PLASTER LOSS

Loss of plaster, both upper and secondary layers. Loss occurs in both painted and unpainted areas, and in upper and lower registers.

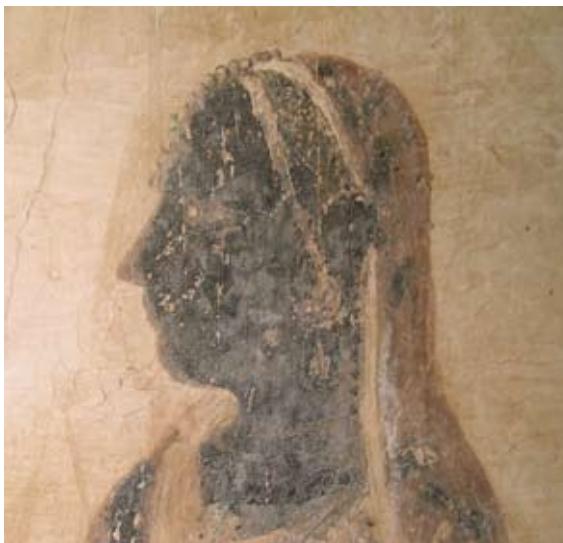
## PIGMENT ALTERATION: TO BLACK

Alteration of pigments to black. This is the same phenomenon as that which occurs on the interior and is mostly associated with flesh tones. Some areas are fully altered, as in this example, in other locations more of the original colour remains.

Pigment alteration to black is probably related to the alteration of lead-based pigments.

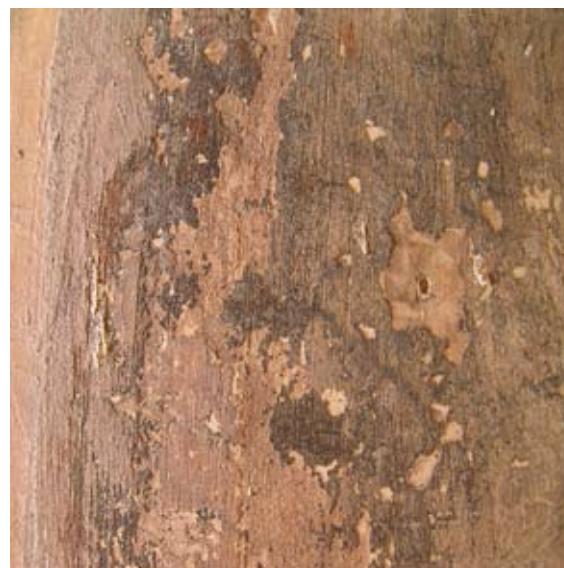
## FLAKING PAINT LAYER: GENERAL

Loss of adhesion between paint layers and/ or paint layers and upper plaster layer. Flaking occurs particularly on the layered paint in the figures' draperies.

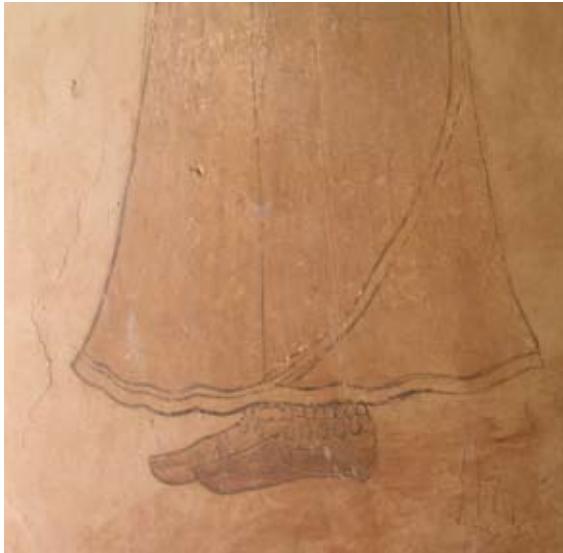
## PIGMENT ALTERATION: LOSS OF COLOUR

Locations where there appears to be little visible pigmentation in the paint layer.

This phenomena is most common on the draperies and thought to be related to the fading of fugitive organic colourants.

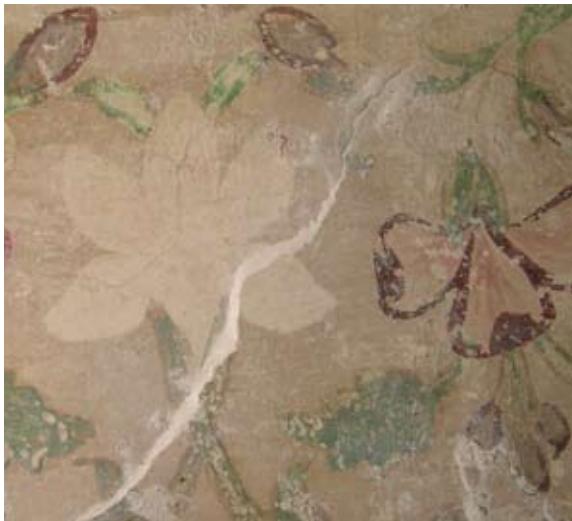
## GHOST IMAGES

A negative image of a decorative motif which is surrounded by colour and/or dirt deposit or a discoloured coating.

It is not yet clear whether this may be due to fading of fugitive pigments or preferential loss.

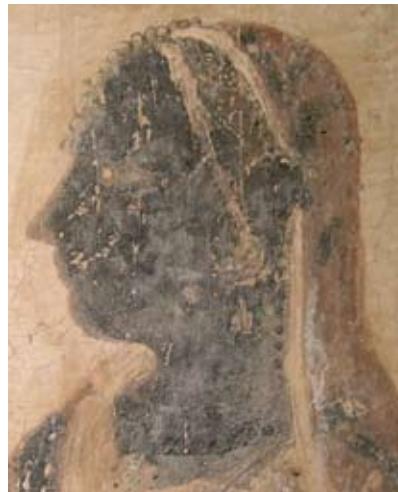
## BLANCHING

White patches on darker areas of paint. The black and brown passages are particularly affected.

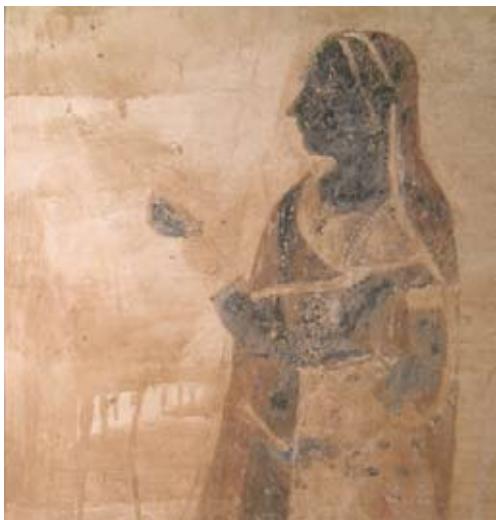
## COATING ON PAINTED PLASTER

Light brown translucent and shiny coating. The coating is applied with wide horizontal brushstrokes and drips are often visible. The coating is applied to all plaster in the upper register on the exterior.

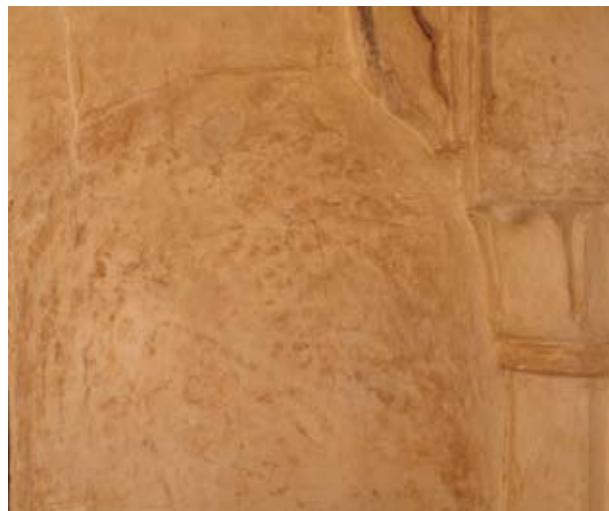
## COATING ON UNPAINTED PLASTER

Brown coloured opaque coating with a blotchy, uneven and matte appearance. The coating is applied to all plaster on the lower register on the exterior.

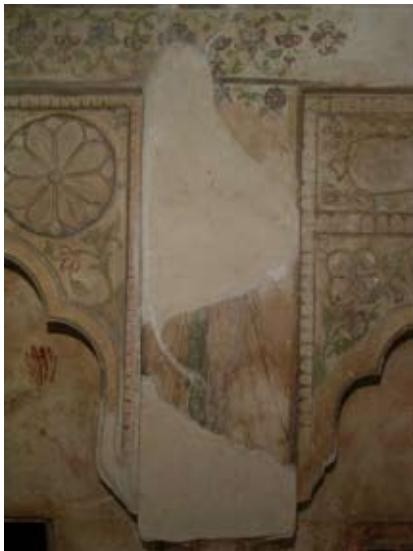
## FILLS: SMALL

Smooth creamy-white plaster fills in small areas of loss on the walls and ceiling. The fills are mostly located on the upper register and frieze- and are similar in appearance to the large well finished fills in interior.
