# THE WALL PAINTINGS OF AHHICHTRAGARH, NAGAUR:

Report on the Investigations and Treatment Undertaken in  
February - March 2006 and Proposals for Future Conservation

STEPHANIE BOGIN, CHARLOTTE MARTIN DE FONJAUDRAN, SIBYLLA TRINGHAM

CONSERVATION OF WALL PAINTING DEPARTMENT, COURTAULD INSTITUTE OF ART,  
UNIVERSITY OF LONDON

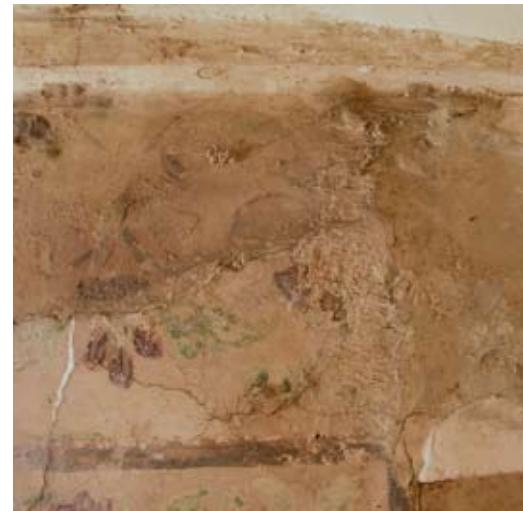
## FILLS: SMALL

Putty coloured, rough plaster fills repair areas of loss on the walls and ceiling. These repairs are not widespread on the exterior.

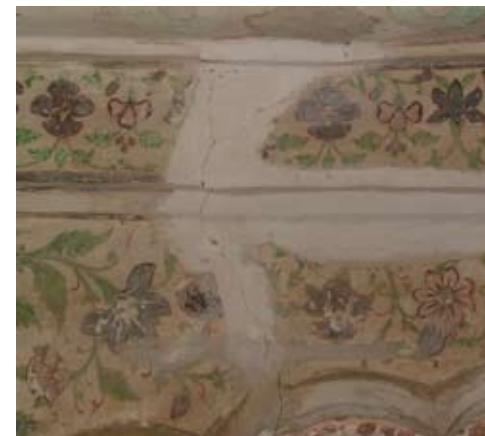
## CRACKED FILLS

Fissures or cracks affecting fills. They are possibly related to ongoing structural stresses or to the inherent susceptibility of the repair material.

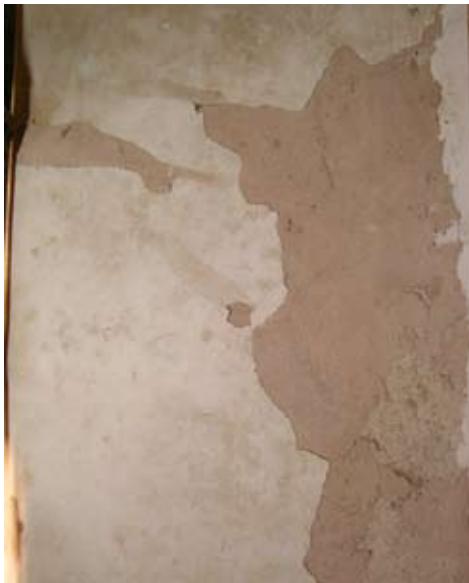
## PLASTER LOSS

Loss of plaster from stone support. Loss may affect all three layers of plaster. Large plaster losses have occurred in the roof area, in the door jambs and on the south wall. Smaller areas of loss are also found in the painted scheme.

Loss may be associated with water infiltration, mechanical action and possibly the inherent susceptibility of the plaster and stresses imposed by structural failure.

Most areas of loss have been repaired, see Fills/ Repairs.

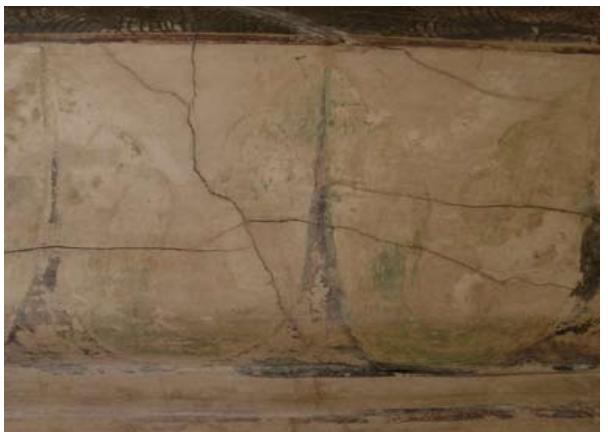
## CRACKS

Fissures in the plaster. The cracks vary in size and width and the largest are generally distributed in the frieze area at the junction of the roof and walls, the corners of the building and on the walls.

Cracks may be associated with structural stresses in the building.

Some of the cracks were repaired with lime and marble dust plaster in the 1989 intervention (Agrawal 1989, 50).

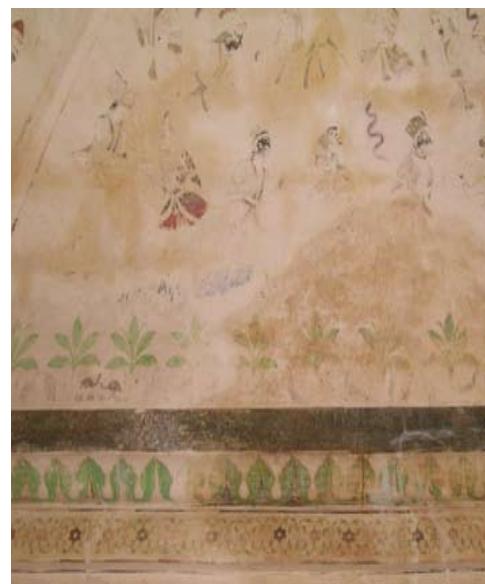
## STAINING

Light brown staining on the surface of the painting. The staining is located in the roof area, and may be associated with water infiltration.

During the 1989 intervention, the staining was reduced by application of ammonium bicarbonate and ammonium carbonate in a sorbent of carboxymethylcellulose.

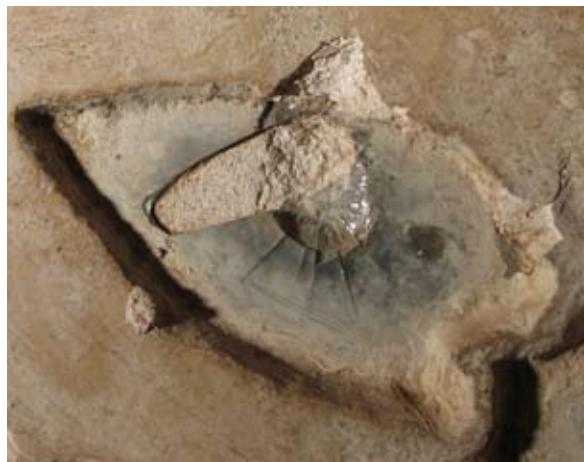
## MIRROR LOSS

Loss of inlaid mirror from the floral motifs in the dado area. Loss occurs on most motifs and appears to be associated with mechanical damage.

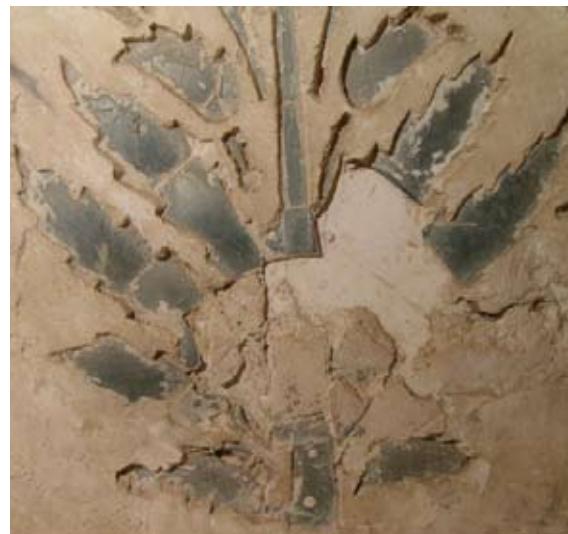
## PLASTER LOSS ON INLAID MIRRORS

Loss of plaster around the inlaid mirror motifs. Loss occurs in both upper and secondary plaster layers (in which the mirror is embedded) resulting in loss of design.

Plaster loss around the mirror work is widespread and may be related to mechanical damage.

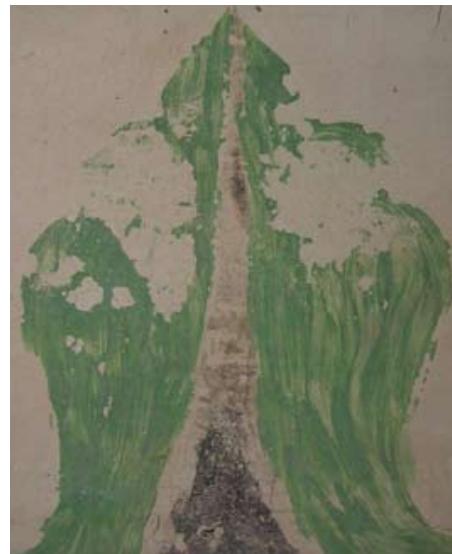
## FLAKING PAINT

Detachment of the paint layer from the plaster, leading to loss. Flaking occurs mostly in the green paint layer and is prevalent in the green border between the walls and roof.

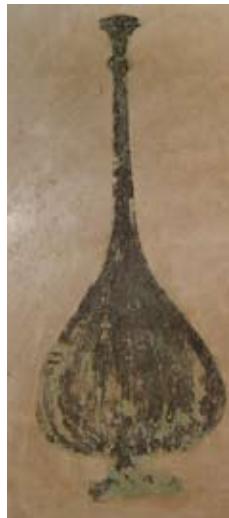
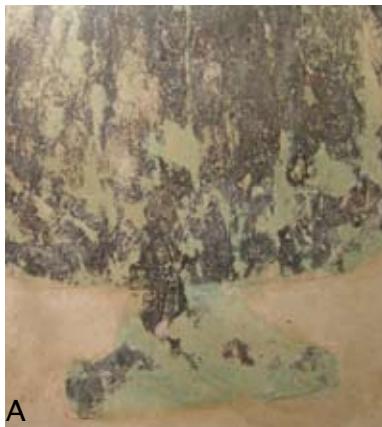
A

A) Alteration of green paint layer to black. This type of alteration occurs on certain types of green such as the wine flasks and green border in the vault. This form of deterioration may be related to the mixing of lead white in the paint layer.

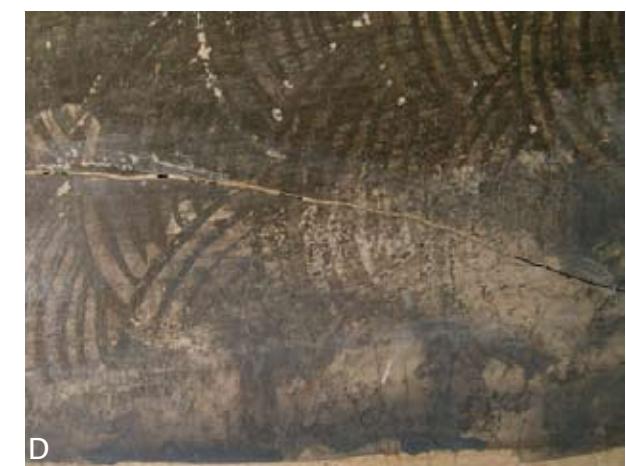
D

D) Alteration of blue to black. This type of alteration is localised to the depiction of water in the paintings located in the roof.

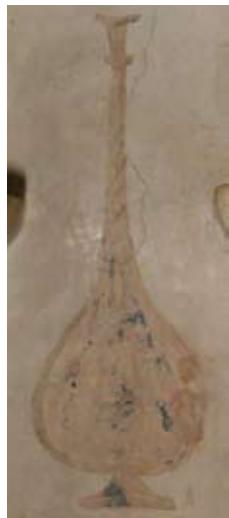
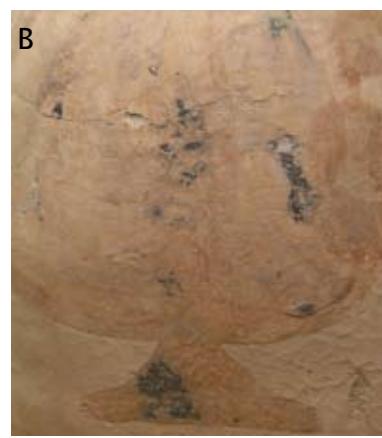
B

B) Alteration of pink paint layer to black. This alteration occurs in the wine flasks, draperies and also in the flesh tones (see E). The alteration occurs in most pink paint layers and may be related to use of lead white in paint layer.

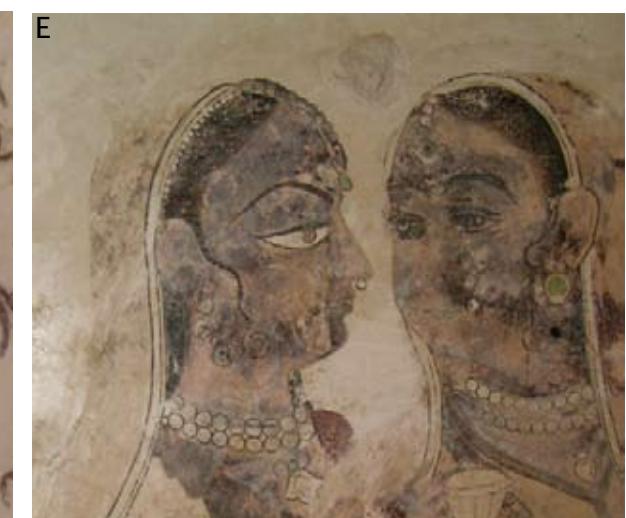
E

E) Alteration of flesh tones to black/ grey. Alteration to black is widespread and occurs in most of the figures in the interior scheme. This type of alteration may be related to use of white or red lead in the paint layer, as in C.

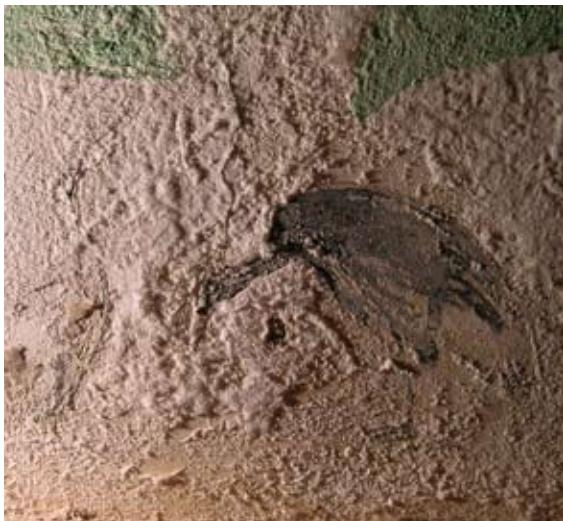
## SALT EFFLORESCENCE

Large white fluffy efflorescence, often forming sheets of crystals.

Salt efflorescence is only located on the north wall, in the roof scheme above the frieze.

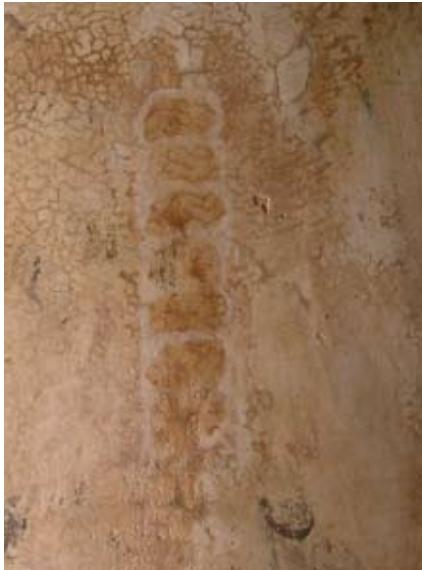
## INSECT NESTS

Multi-partitioned casings patterns resulting from insect nesting. In some examples, the nest has fallen away leaving the shadow on the wall, as illustrated left. Insect nests are not common on the interior of the building.

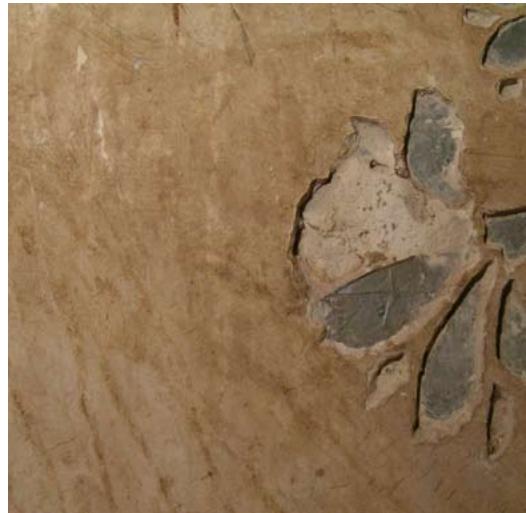
## DIRT

Homogeneous brown surface deposit. Dirt is most heavily and consistently deposited on the dado plaster around the inlaid mirrorwork.

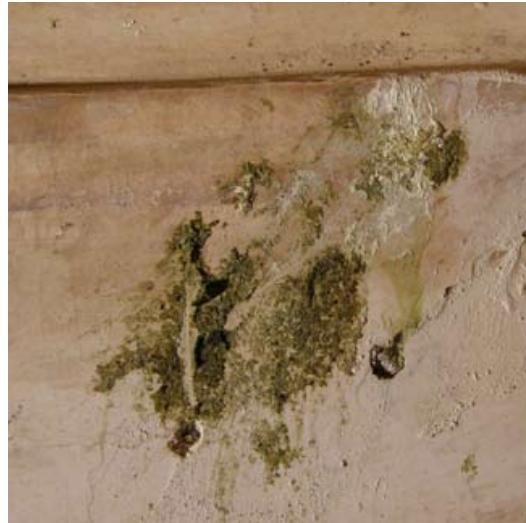
## BIRD EXCRETA

Bird droppings which are found occasionally on the interior wall surface.

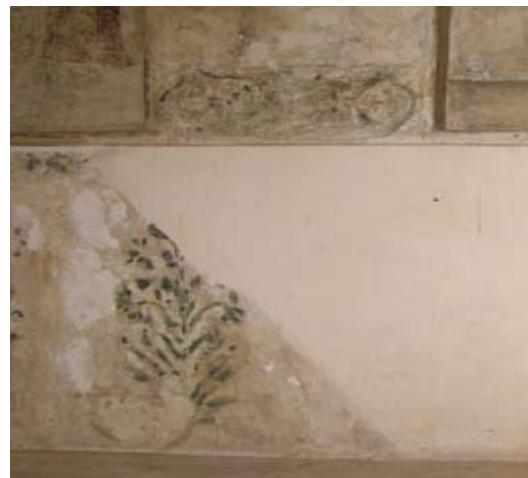
## FILLS/ REPAIRS: DADO RENDER/ LARGE FILL

Larger lime-based fills applied in a technique replicating the original appearance. These fills are well-finished and neat. This type of fill is found in larger areas of loss in the dado, walls and on the ceiling.

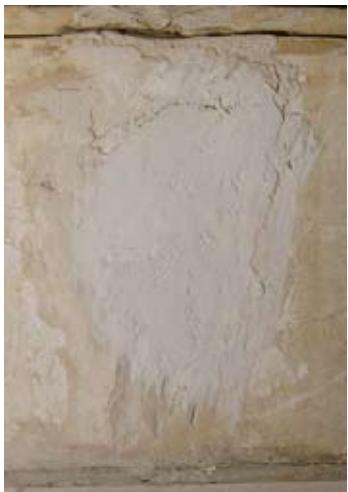
## FILLS/ REPAIRS: MARBLE DUST PLASTER

Fills in white lime-based material. Applied rapidly and often overlap the surface of the original plaster. These fills are small and present below the roof.

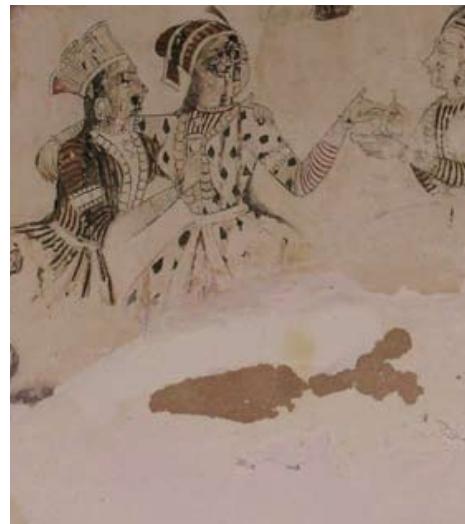
## FILLS/ REPAIRS: LOSS

Loss of the uppermost fine white plaster occurs in the large fills. Loss of material occurs in fills in the roof and on the door jambs and may be related to continuing infiltration and mechanical abrasion respectively.

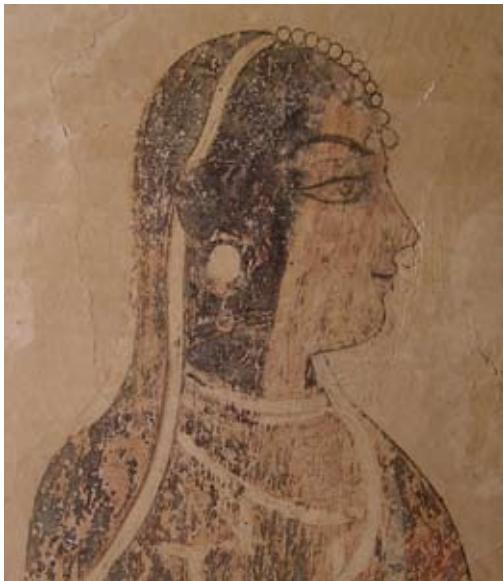
## ATTEMPTED RECONVERSION

Trials to reconvert altered lead pigment from black to white. The trials are minimal.

Reconversion trials are recorded in the 1989 intervention but the methods are not specified.

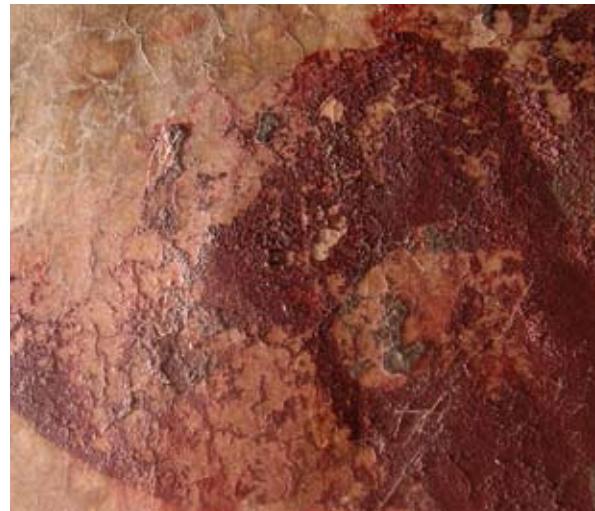
## CONSOLIDATION OF POWDERING PAINT

Recohesion of powdering paint by use of a consolidant. Some areas retain cotton wool on the surface. Consolidation is not extensive.

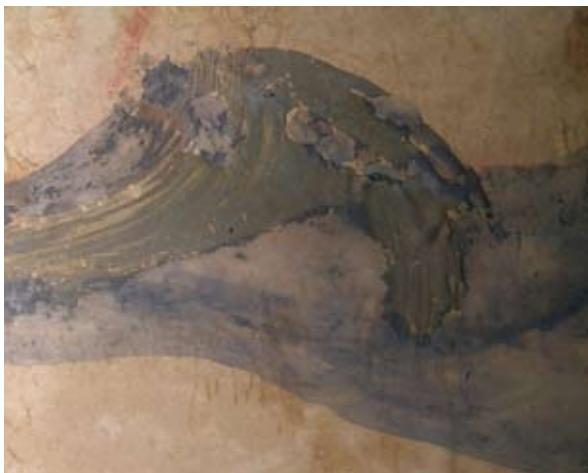
## REPAINTING

Reintegration of losses in the paint layer. Repainting is poorly matched and often extends over the original paint.

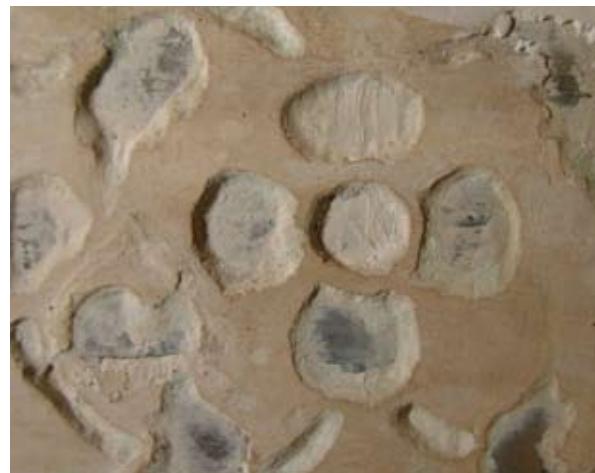
## FILL OVER INLAID MIRROR

Lime-based material filling the mirror work. The consistency and extent of the lime suggests that it was deliberately covered at some point. This filling material is distinct from the lime plaster creating the design.

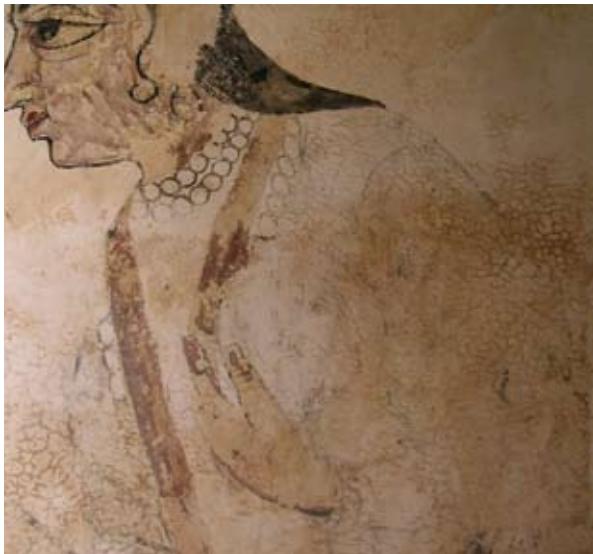
## COATINGS: THIN

Thin, translucent, shiny coating on surface of entire interior scheme. In most places areas the coating has discoloured to brown.

During the 1989 intervention polyvinyl acetate was applied to the surface to readhere flakes and to provide a protective coating. (Agrawal 1989, 49).

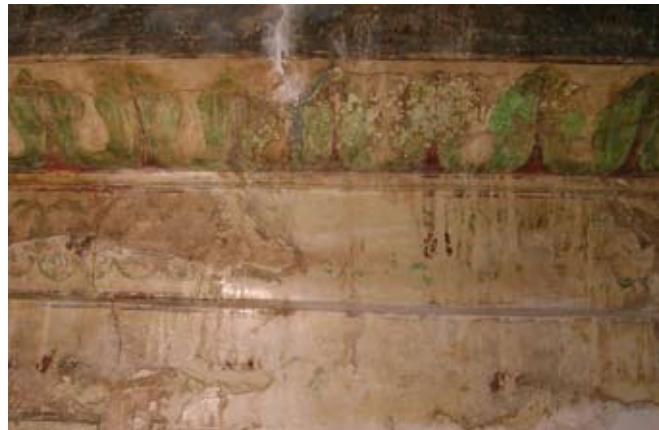
## COATINGS: THICK AND DRIPPY

Brown, translucent and shiny coating applied thickly and unevenly to the surface of the paintings. In some areas large drips are also present.

This type of coating is mostly found on the east side of the south wall.

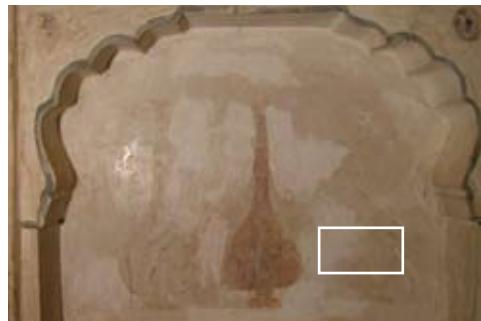
## COATINGS: GREY

Grey coloured coating applied patchily over the paintings' surface. This coating is widely distributed on the surface and is underneath the thin (PVAC) coating.

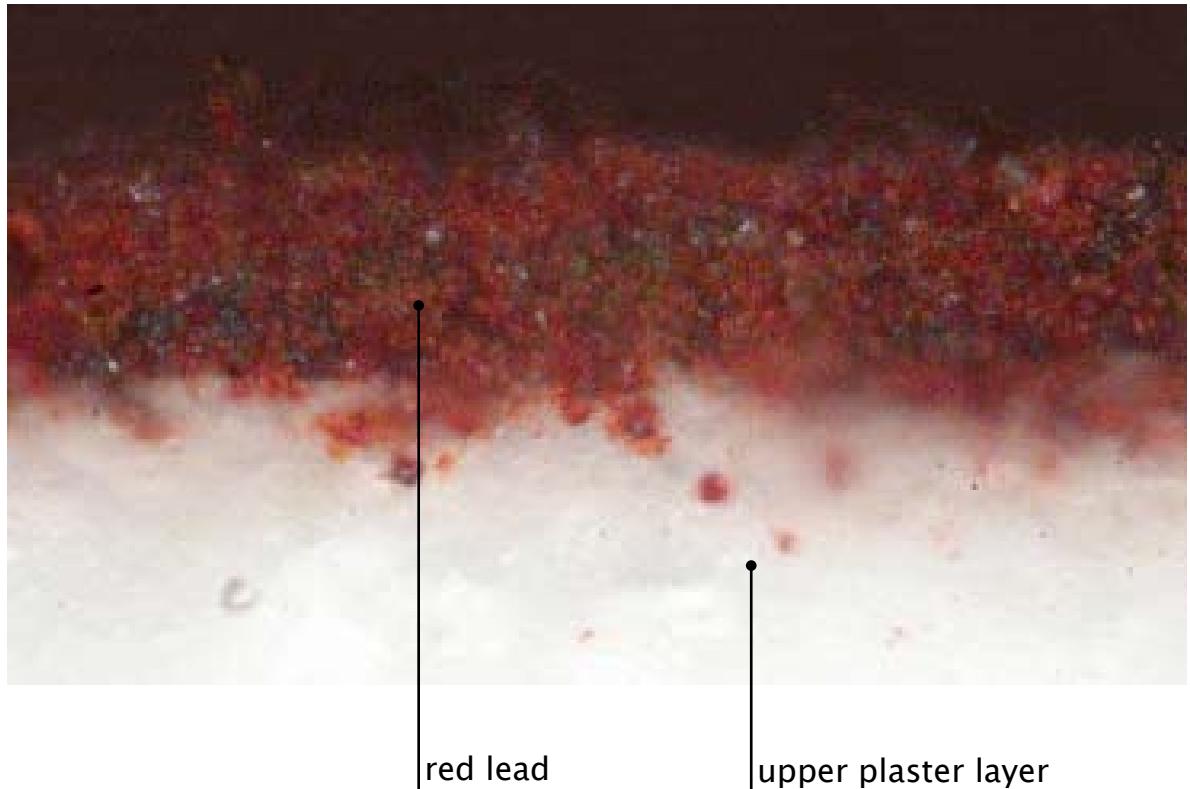
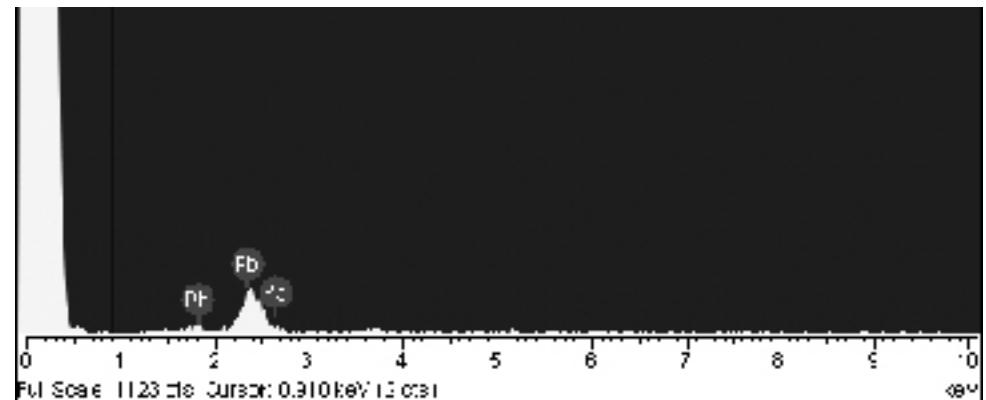
Cross-section of sample 3787 (photographed at 200x) taken from an area of altered flesh tone on the south wall of the first floor of the Hadi Rani Mahal. The cross-section shows a layer of red lead with dark particles of altered pigment. Below an EDS spectrum shows peaks for lead (Pb).

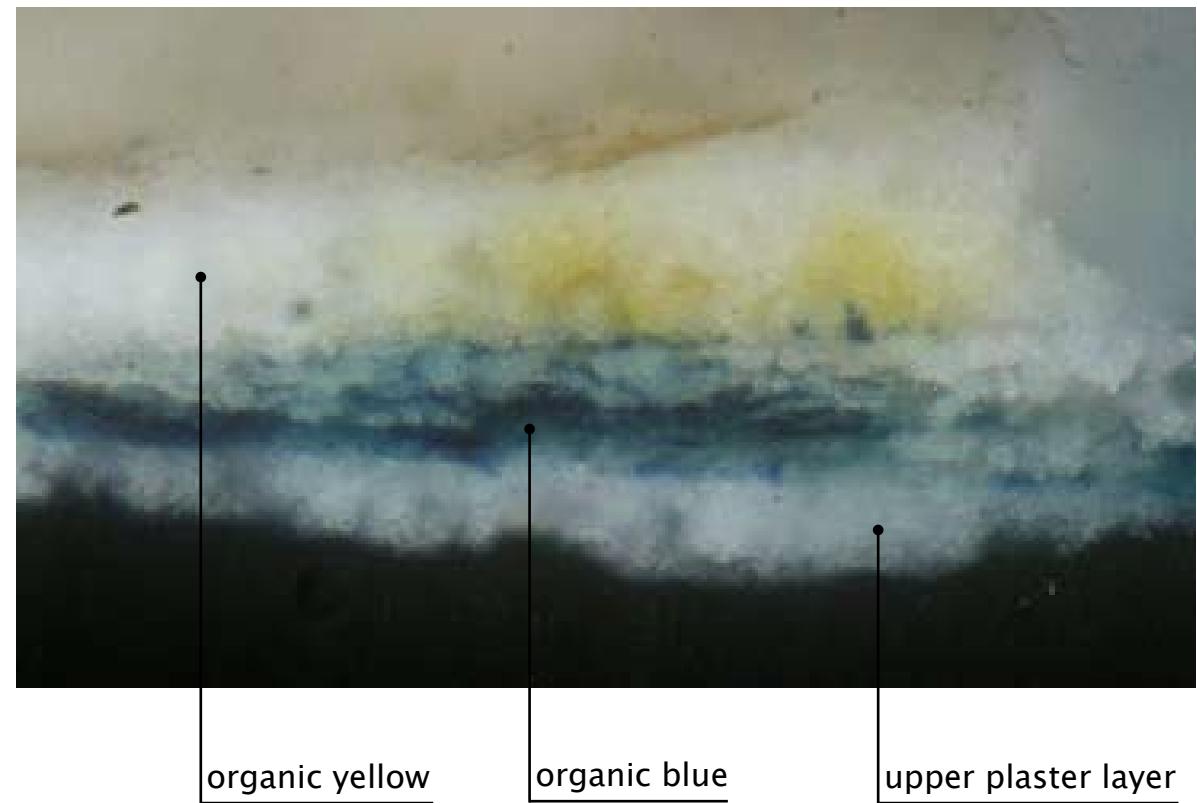
Cross-section of sample 3789 (photographed at 200x) taken from an altered beige-coloured tree on the south wall of the first floor of the Hadi Rani Mahal. The cross-section shows a layer of organic yellow over a layer of organic blue. Both organic colorants are fugitive resulting in the present beige appearance, instead of the intended green.

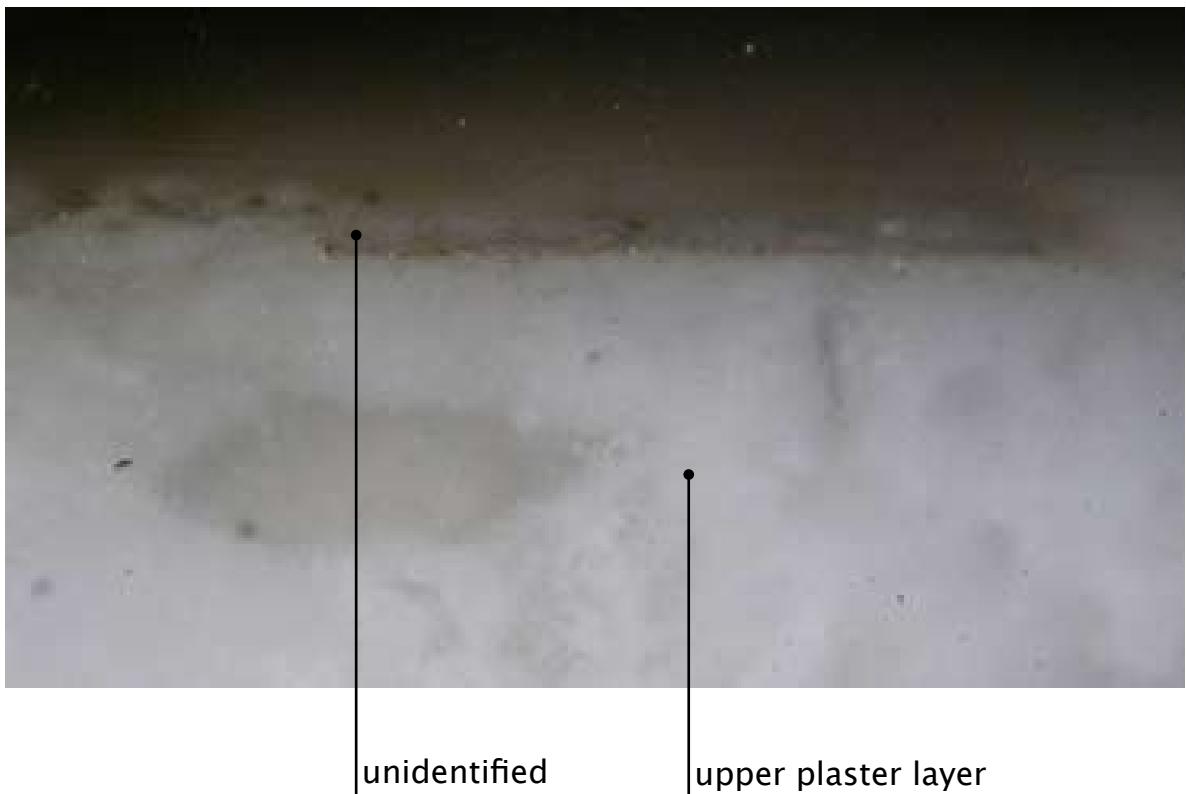
Cross-section of sample 3790 (photographed at 100x) taken from a faded palm tree on the south wall of the ground floor of the Hadi Rani Mahal. It was not possible to identify the paint layer with PLM since no colour or pigment particles were visible in the sample. However, it may well be a fugitive organic colorant as seen in sample 3789. Further sampling and analysis is needed for identification.

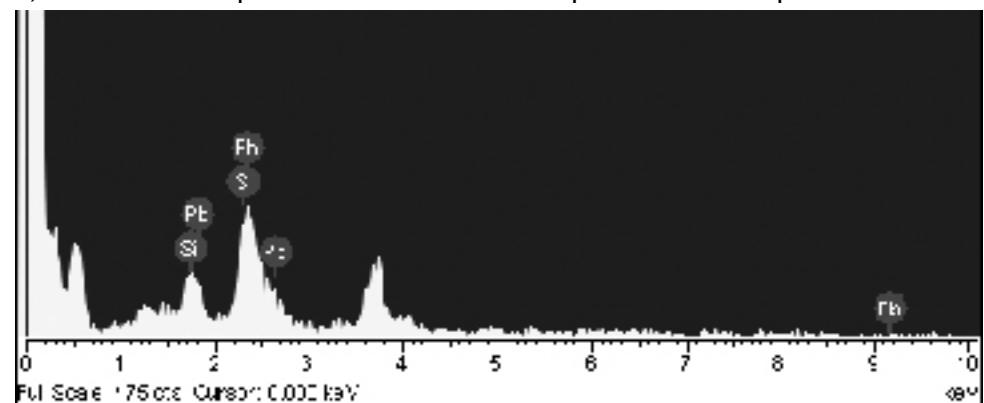
lead white mixed with organic blue

upper plaster layer

Back-scattered electron image of a cross-section of sample 3791 (photographed at 400x) taken from the river on the east wall of the first floor of the Hadi Rani Mahal. The bright white layer is lead white, identified with SEM-EDS. In PLM no crystalline blue particles were visible, suggesting that the blue may comprise a fugitive organic blue colorant in a lead white matrix, as seen in sample 3792. Below an EDS spectrum shows peaks for lead.

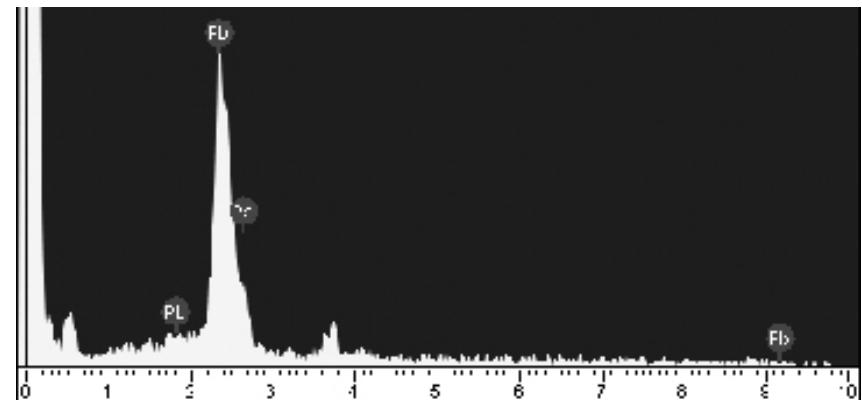
Cross-section of sample 3792 (photographed at 100x) taken from the blue flower on the upper border of the west wall of the second floor of the Hadi Rani Mahal. The cross-section shows a layer of fugitive organic blue (probably indigo) in a lead white matrix. Below an EDS spectrum shows peaks for lead.

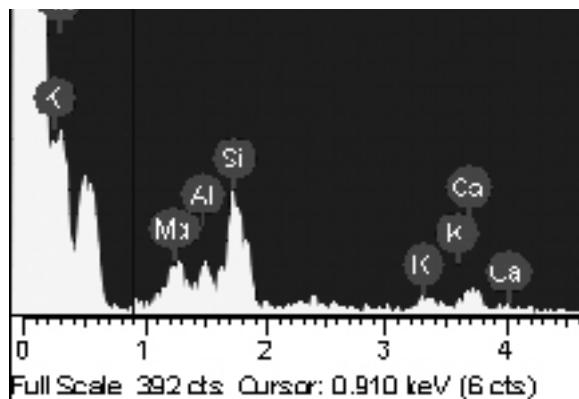
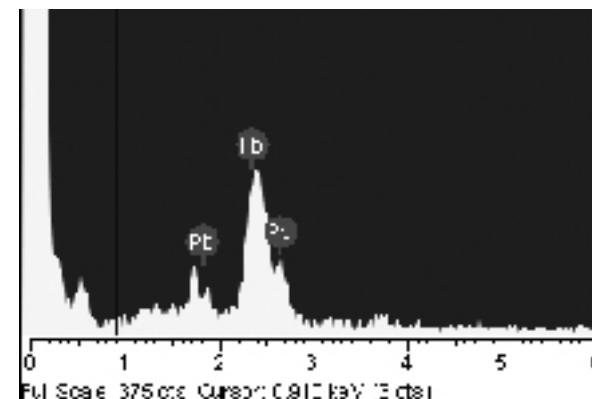
Cross-section of sample 3793 (photographed at 200x) taken from the blue flower on the east wall of the exterior of the Sheesh Mahal. The cross-section shows a blue glass-based pigment (probably smalt) in a lead white matrix. Below EDS spectra show peaks for silica

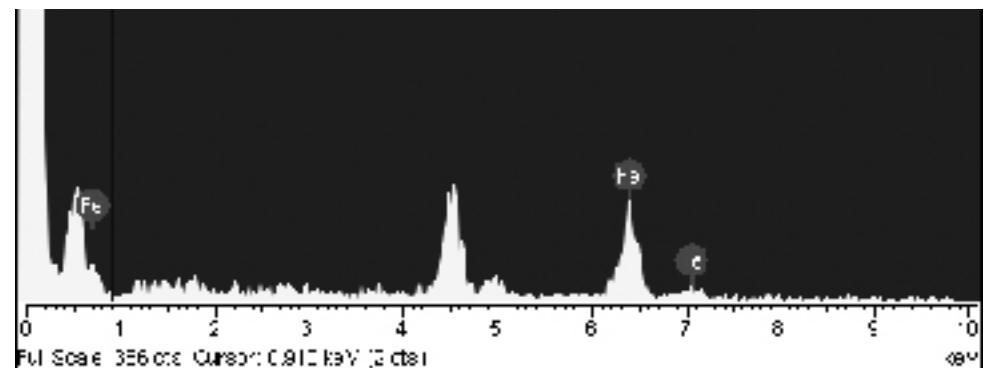
green earth

upper plaster layer

Cross-section of sample 3802 (photographed at 200x) taken from the green flower border on the east facade of the Hadi Rani Mahal. The cross-section shows large particles of green earth. Below an EDS spectrum shows peaks for iron (Fe).

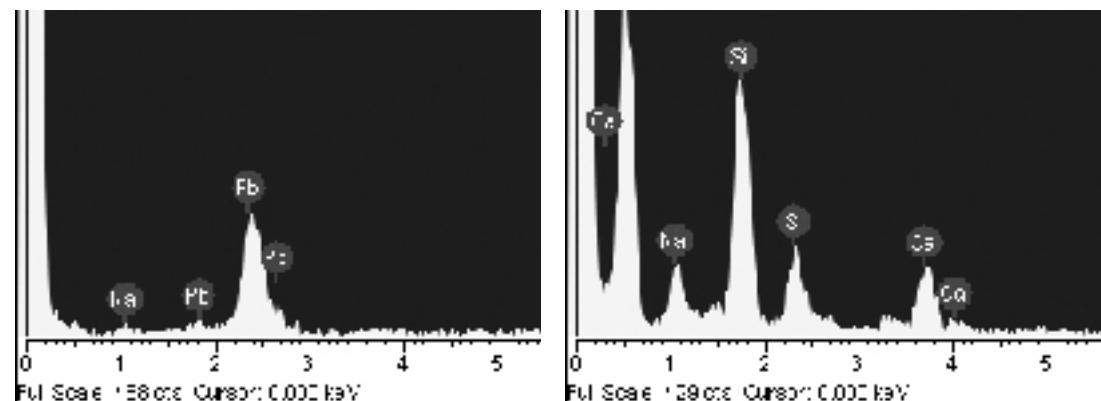
sodium-based silica glass

lead foil backing

Back-scattered electron micrograph of sample 3806 (photographed at 40x) taken from the inlaid mirror-work on the dado of the west wall of the Sheesh Mahal. Elemental analysis by SEM / EDS identified the sample as a sodium-based silica glass with a lead foil backing. Below EDS spectra show peaks for lead and silica.

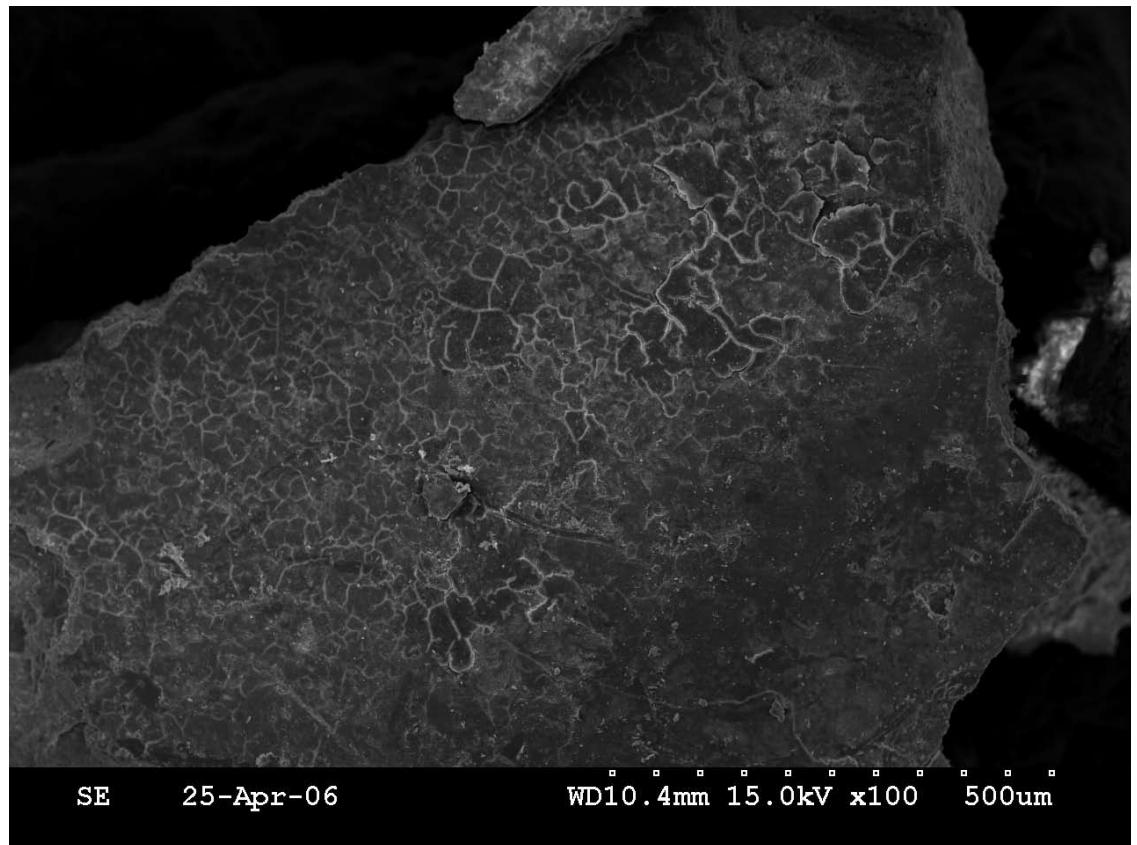
Scanning electron micrograph of sample 3796 (photographed at 100x). The image shows residual synthetic coating after cleaning trials. The residue is characterised by dark saturated patches on the surface of the plaster.

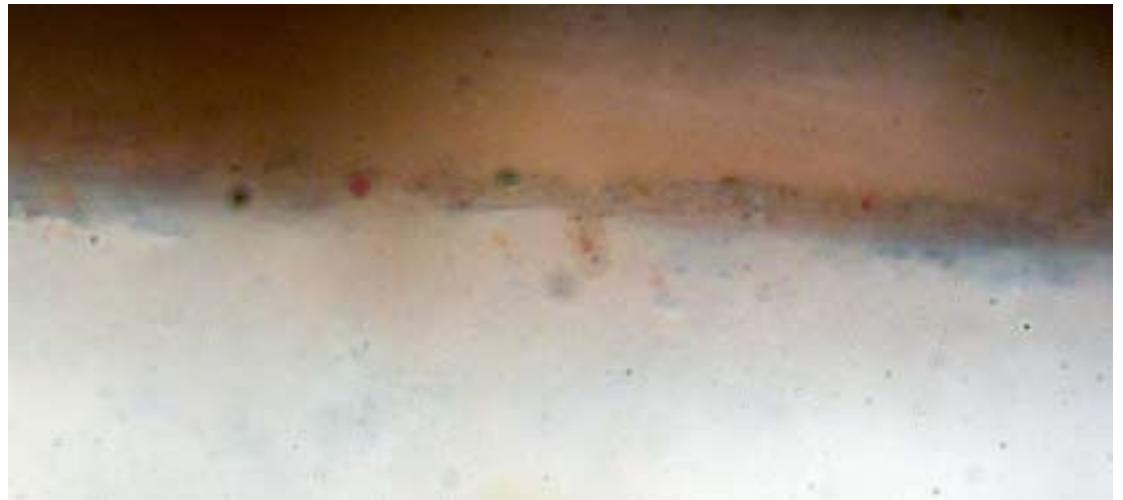
Cross-section of sample 3804 (photographed at 100x) showing the upper plaster layer taken from the west wall of the exterior of the Sheesh Mahal. The cross-section shows a translucent coating on the surface of the plaster.

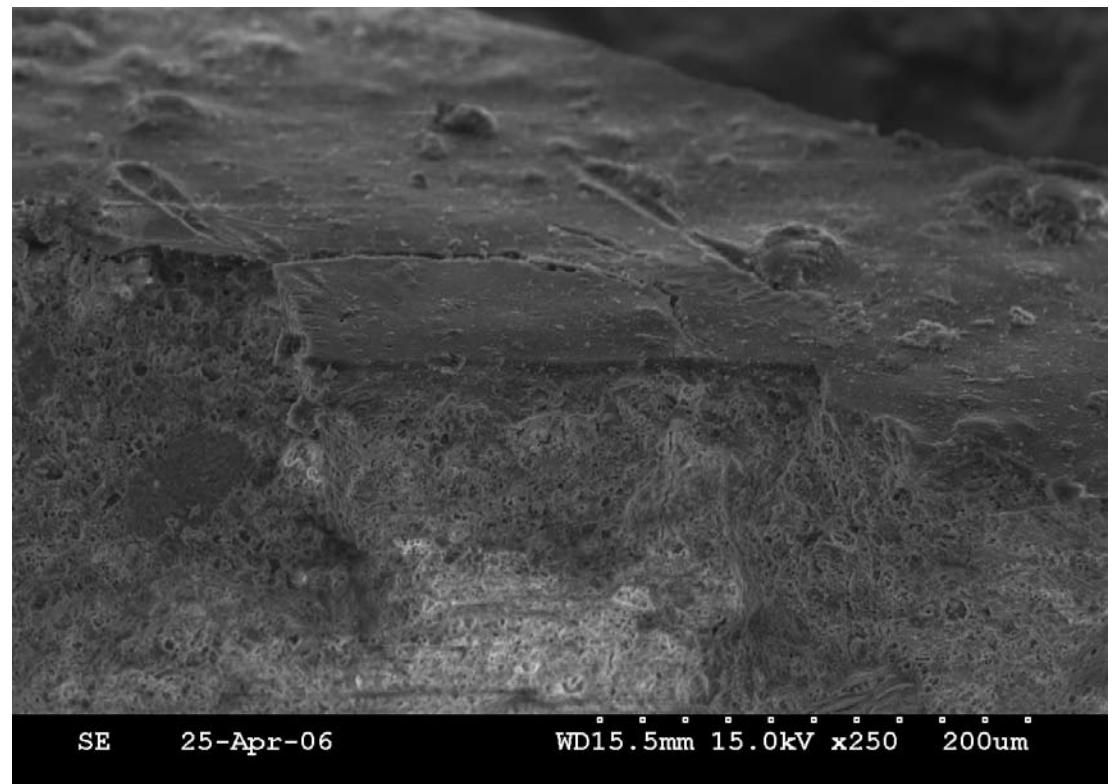
Scanning electron micrograph of sample 3805 (photographed at 250x). The image shows a smooth coating on the surface of the upper plaster layer (also visible as a distinct layer in cross-section). The interface between the coating and the plaster layer is distinct, and the unwanted material does not appear to have penetrated into the pore structure.

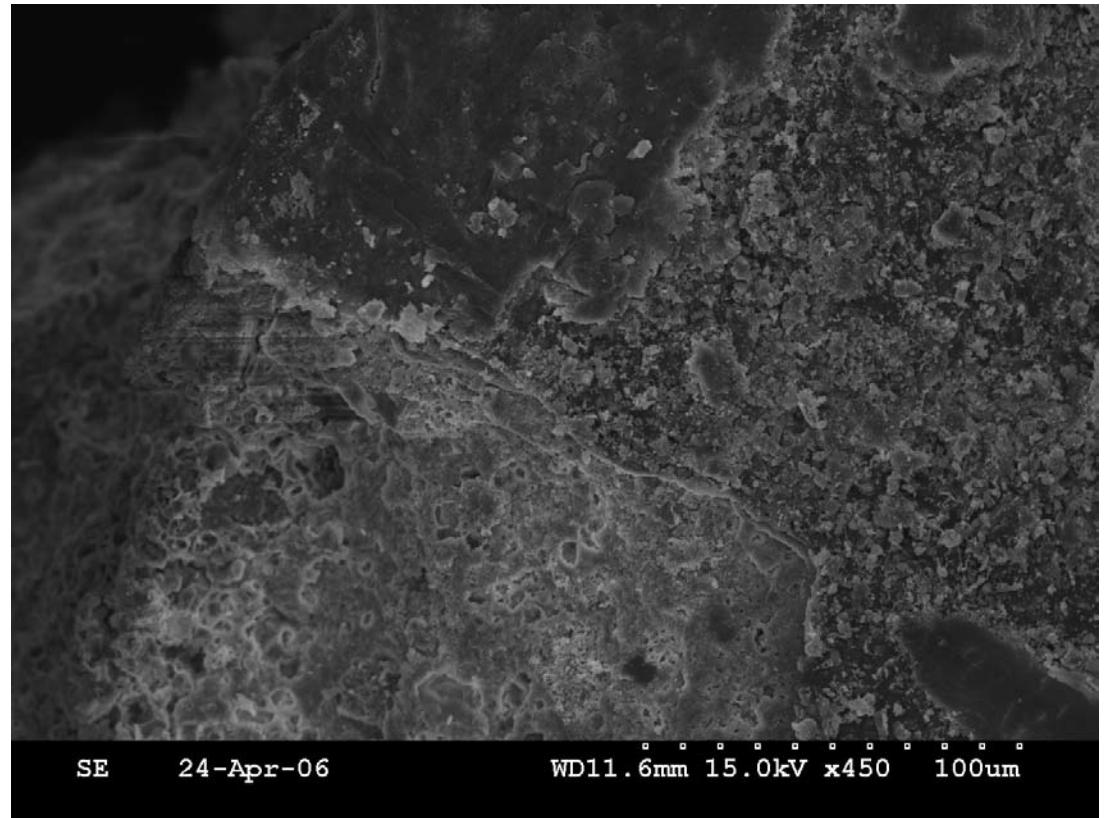
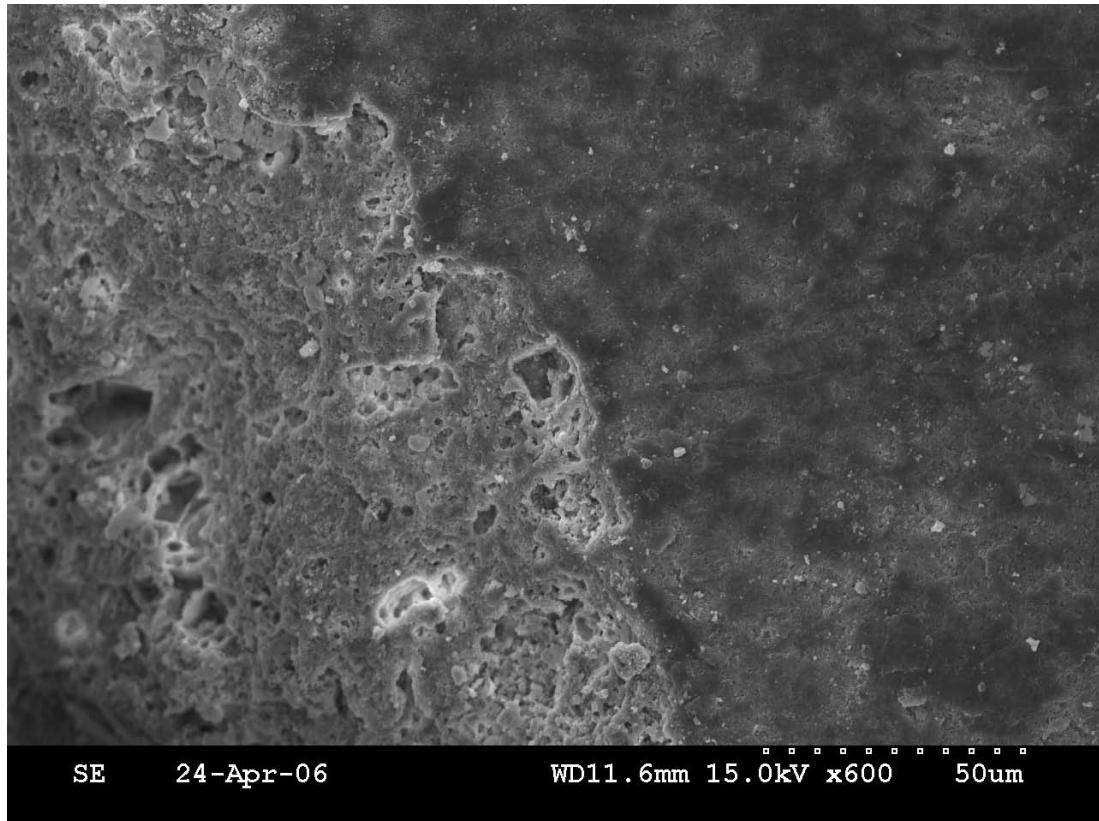
Scanning electron micrographs of samples 3800 and 3801 showing the surface of the painting before and after cleaning trials. The samples were taken from the upper plaster layer in a niche on the north wall of the Sheesh Mahal. The before trial micrograph (left) shows the presence of a smooth coating (probably PVAC) contrasting with the rough surface of the upper plaster layer beneath. Residue of a non-original material (either PVAC or the uncharacterised material seen in sample 3805) can be observed in the after trial micrograph, which is characterised by a smooth surface with dark mottling.

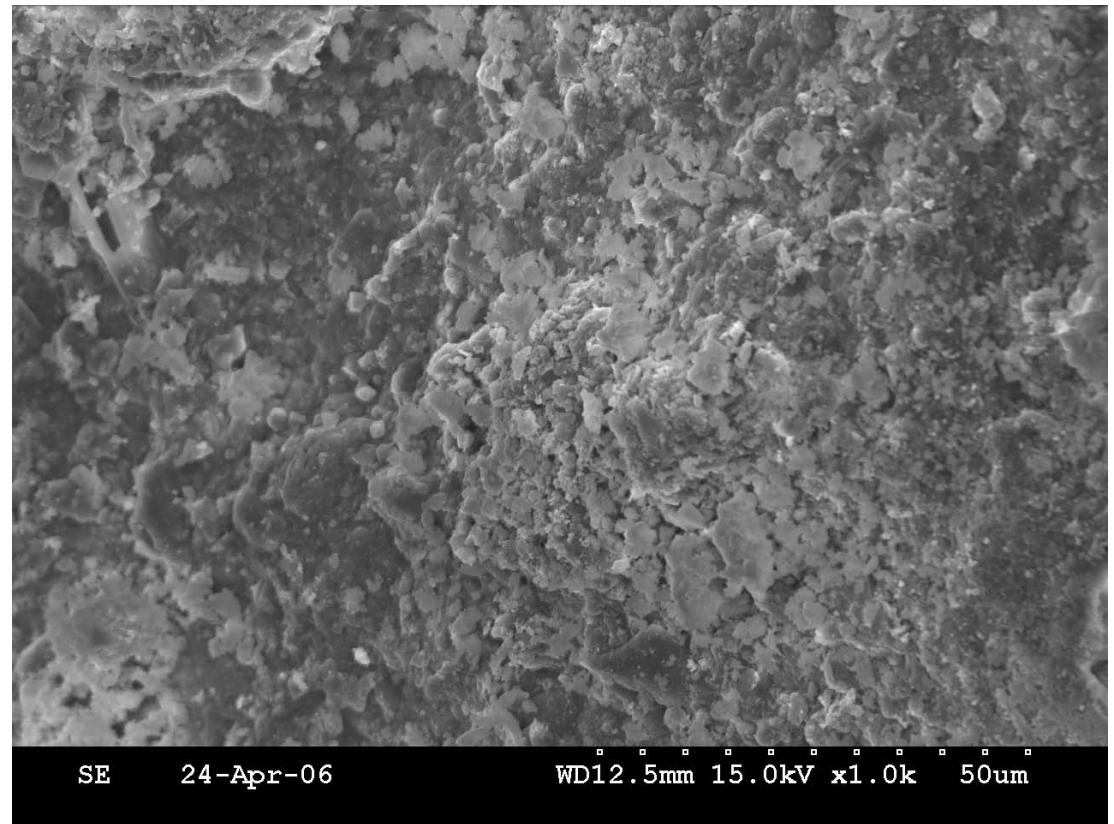
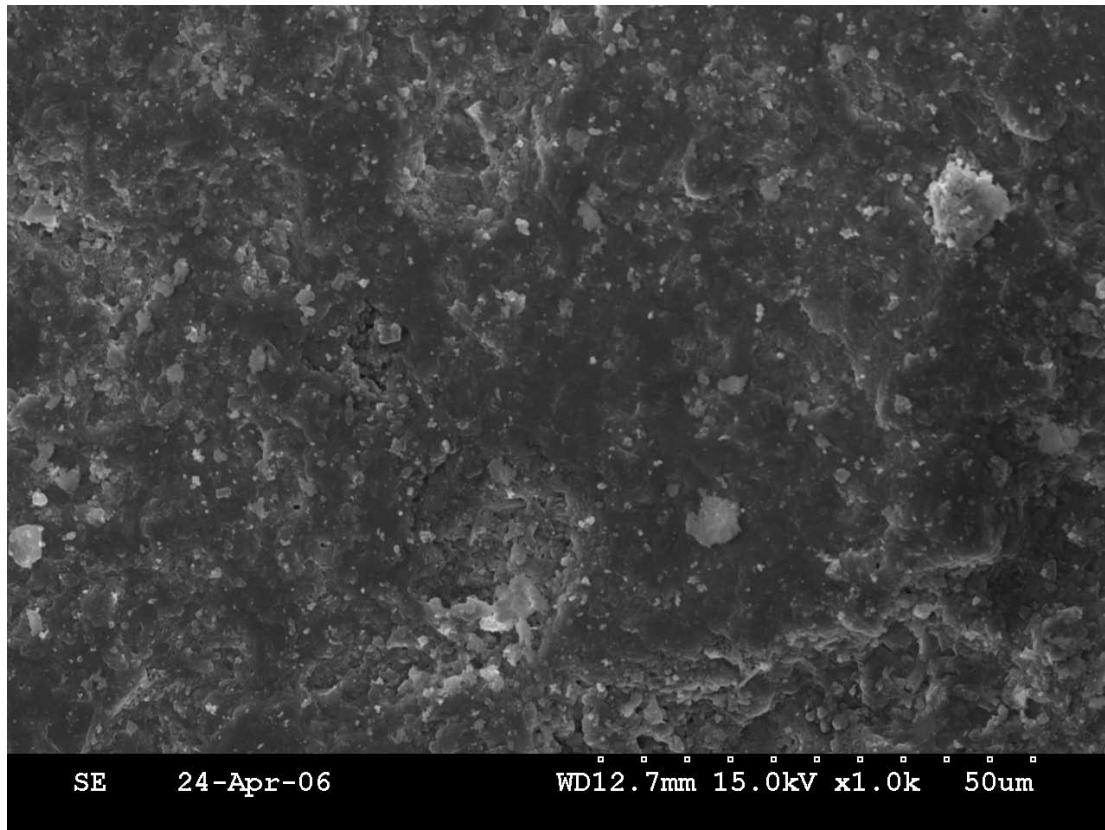
Scanning electron micrographs of samples 3802 and 3803 showing the surface of the painting before and after cleaning trials. The samples were taken from the green flower border on the east facade of the Hadi Rani Mahal. The thick dirt deposition is visible in the before cleaning micrograph and is characterised by abundant loosely packed particulate matter on the surface of the paint layer. While some of this deposition is still visible in the after cleaning micrograph it has been dramatically reduced. The surface of the paint layer does not appear to have been adversely affected by the cleaning trial (no visible cracks or evidence of mechanical damage).

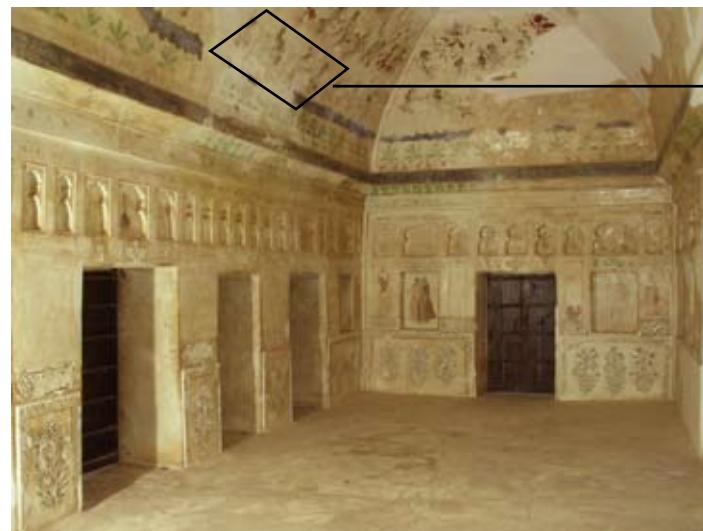
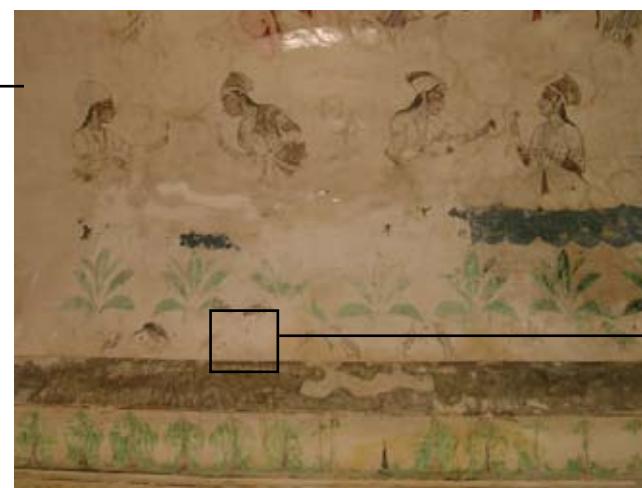
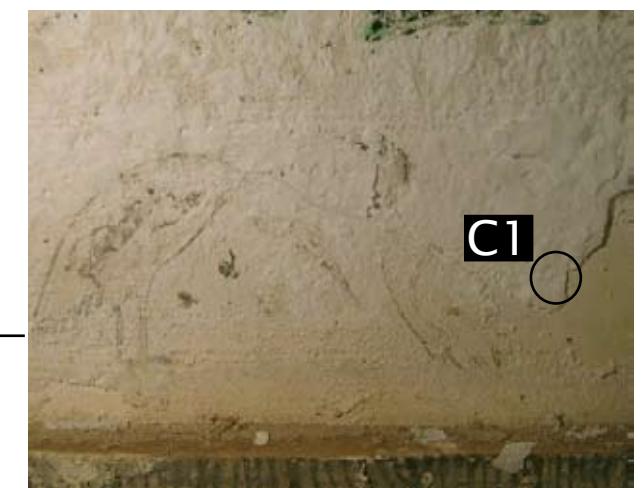
**Sample location:** Akbari Mahal [32], north wall, above door level. Localised area of heavy salt efflorescence forming sheets or clusters. Previously sampled by S Begum (NAG05-32-15).

Sample #	Ions present		
	Sulfates	Chlorides	Nitrates
C4	-	x	x
