# THE WALL PAINTINGS OF AHHICHTRAGARH, NAGAUR:

Report on the Investigations and Treatment Undertaken in  
February - March 2006 and Proposals for Future Conservation

STEPHANIE BOGIN, CHARLOTTE MARTIN DE FONJAUDRAN, SIBYLLA TRINGHAM

CONSERVATION OF WALL PAINTING DEPARTMENT, COURTAULD INSTITUTE OF ART,  
UNIVERSITY OF LONDON

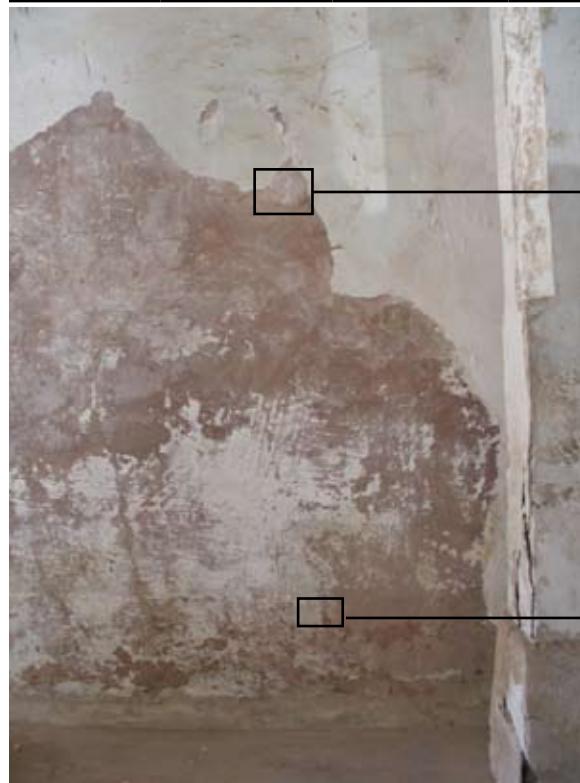
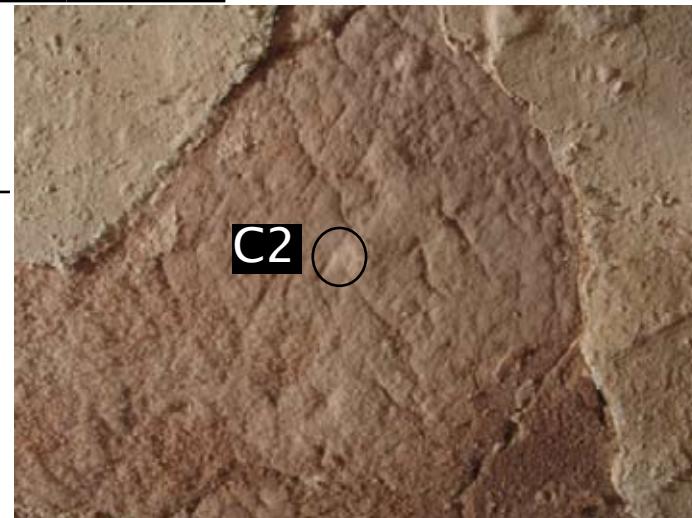
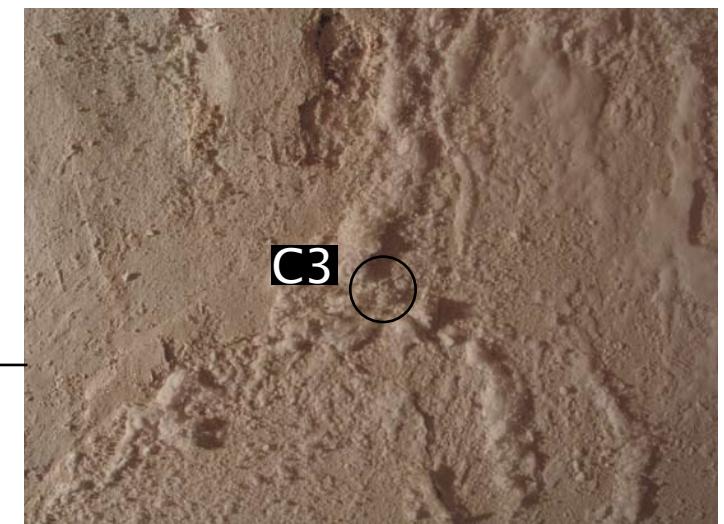
Sample #	Ions present		
	Sulfates	Chlorides	Nitrates
C2	-	x	x
C3	-	x	x

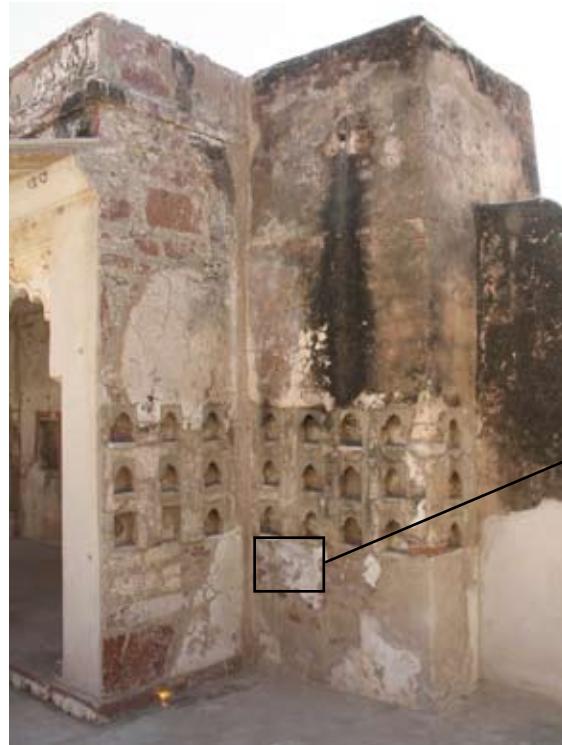
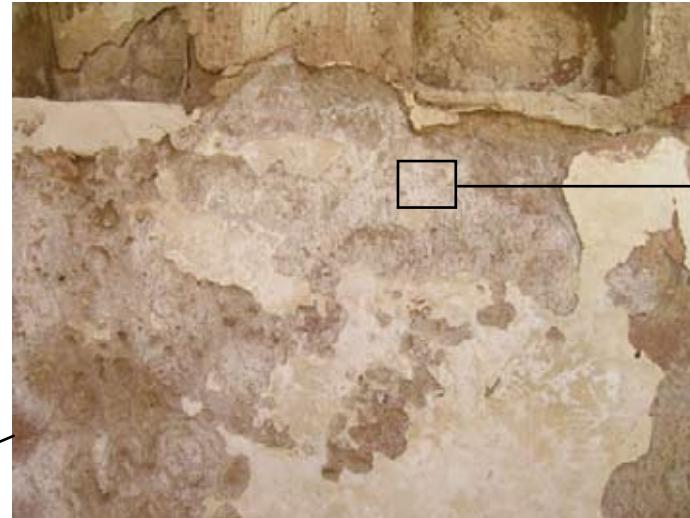
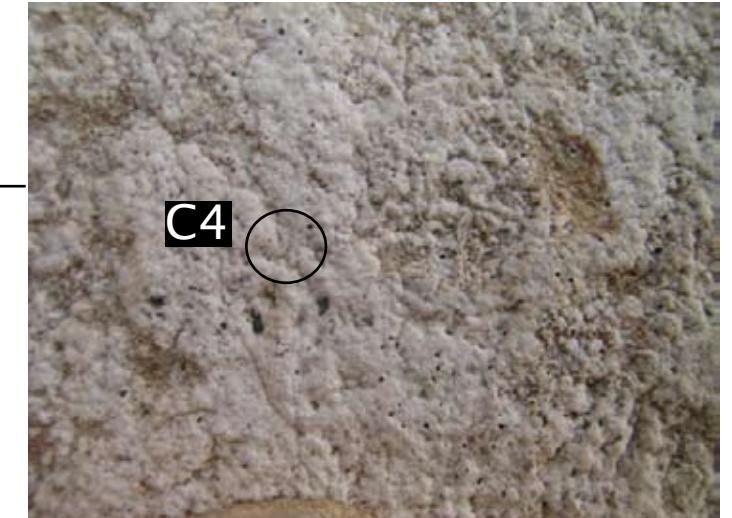
## Sample: C5

**Sample location:** Abha Mahal [26], room 10, west wall, localised area of heavy salt efflorescence forming sheets and clusters. Previously sampled by SB (NAG05-26-11).

Sample #	Ions present		
	Sulfates	Chlorides	Nitrates
C5	-	x	x

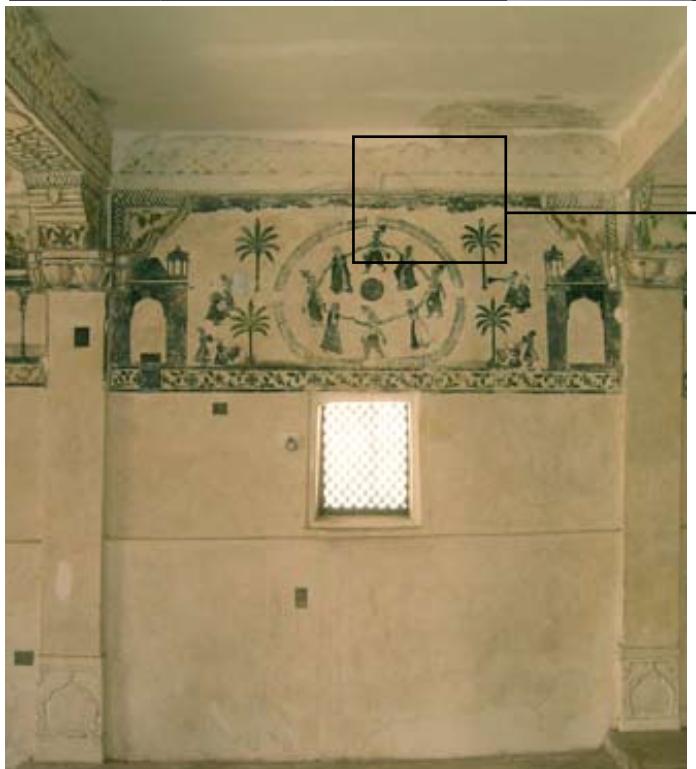
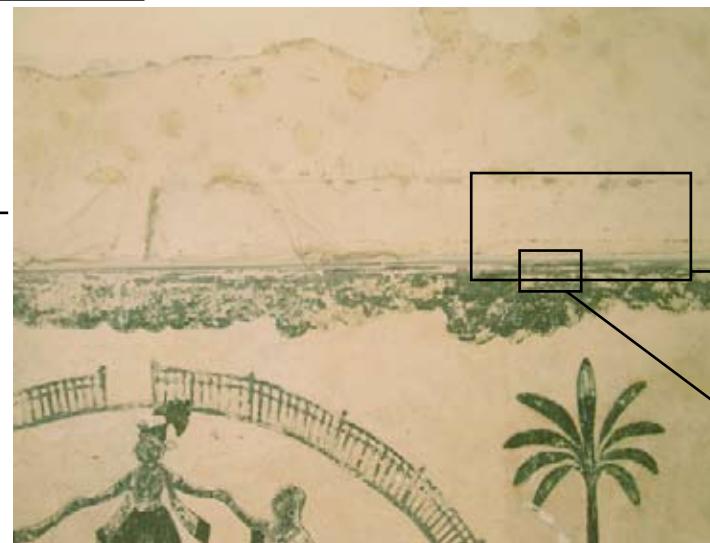
**Sample location:** Krishna Temple [12], north wall, above cornice level. Area of localised salt activity near repair.

Sample #	Ions present		
	Sulfates	Chlorides	Nitrates
C6	-	-	x
C7	-	x	-

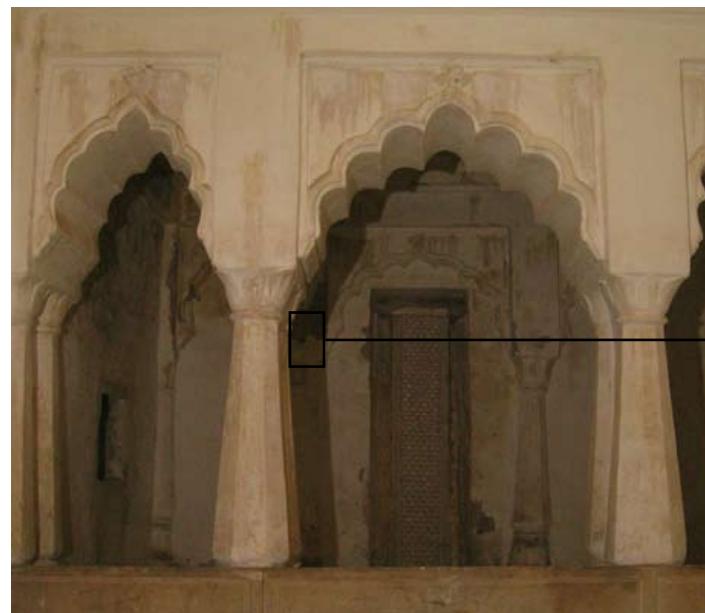
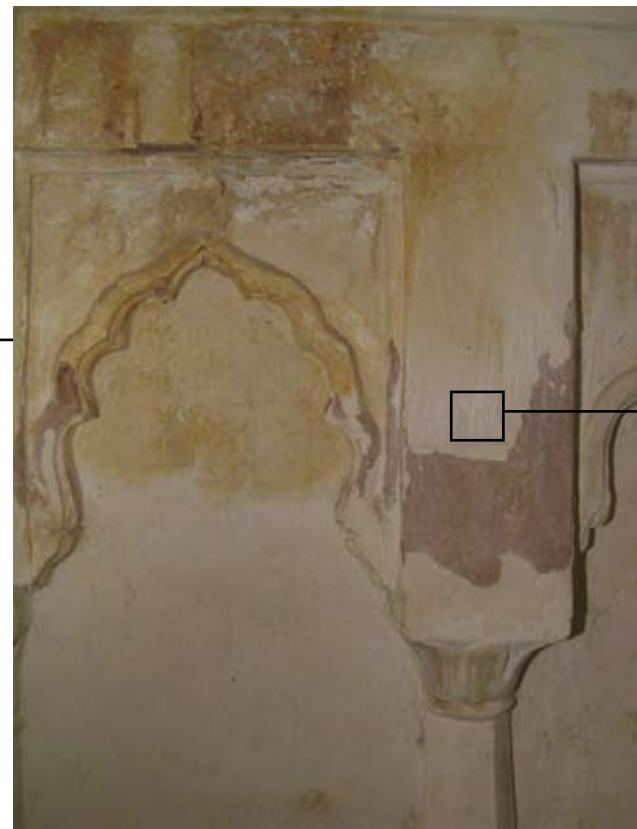
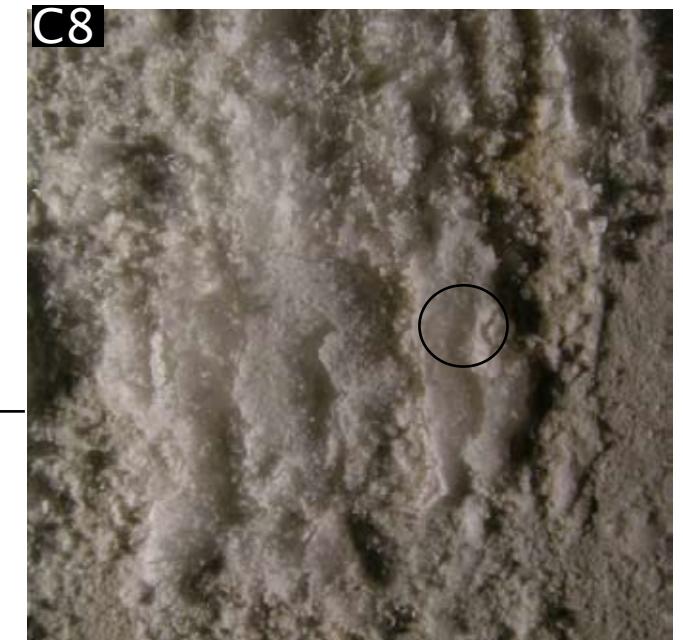
## Sample: C8

**Sample location:** Abha Mahal [26], Hammam, section near vertical water fountain. Area of heavy salt efflorescence with thick crust appearance.

Sample #	Ions present		
	Sulfates	Chlorides	Nitrates
C8	-	x	-

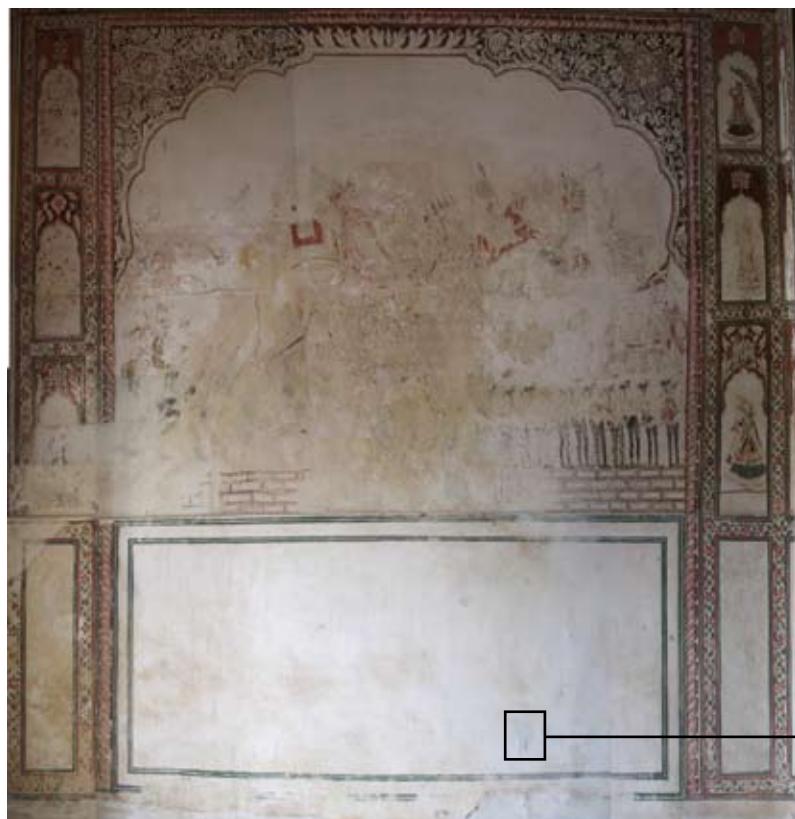
## Sample: E1

**Sample location:** Abha Mahal [26], room 10, north wall, height: 0.35 m. Plaster repair associated with salt activity.

Sam- ple #	Depth /cm	Weight/ g	water/ ml	pH	buffer	Maximum ion concentration (mg/ l)		
						Sulfates	Chlorides	Nitrates
E1a	0.0-0.2	0.25	5	6.5	n/a	0	1000	500
E1b	0.2-0.7	0.25	5	6.5	n/a	0	500-1000	500
E1c	0.7-1.2	0.25	5	6.5	n/a	0	1500	500
E1d	1.2-2.2	0.25	5	6.5	n/a	0	1000	500
E1e	2.2-4.2	0.25	5	6.5	n/a	0	1000	500
E1f	4.2-6.2	0.25	5	6.5	n/a	0	500-1000	500

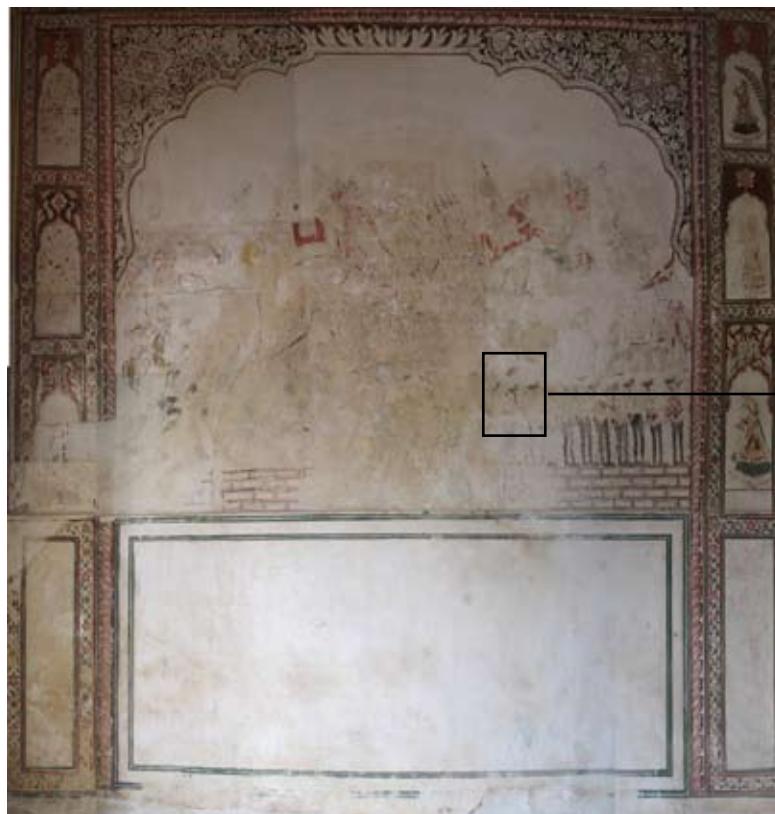
## Sample: E2

**Sample location:** Abha Mahal [26], room 10, north wall, height: 1.55 m. Plaster repair associated with salt activity

Sam- ple #	Depth	Weight/ g	water/ ml	pH	buffer	Maximum ion concentration (mg/ l)		
						Sulfates*	Chlorides	Nitrates*
E2a	0.0-0.2	0.25	5	7	n/a	1600	2000	500
E2b	0.2-0.7	0.25	5	7	n/a	800	1500-2000	500
E2c	0.7-1.2	0.25	5	7	n/a	800	1000	500
E2d	1.2-2.2	0.25	5	7	n/a	800	1000	500
E2e	2.2-2.7	0.25	5	7.5	n/a	0	500	500

\* Nitrites were present during the first set of measurements. Nitrites were not present during subsequent tests, probably due to their rapid conversion to nitrates. The presence of nitrites suggests an active contamination source. The presence of nitrites can also produce a false positive result for sulphates but no sulphates were present in NAG05-26-11 during microchemical tests and the sulphate results here should be disregarded.

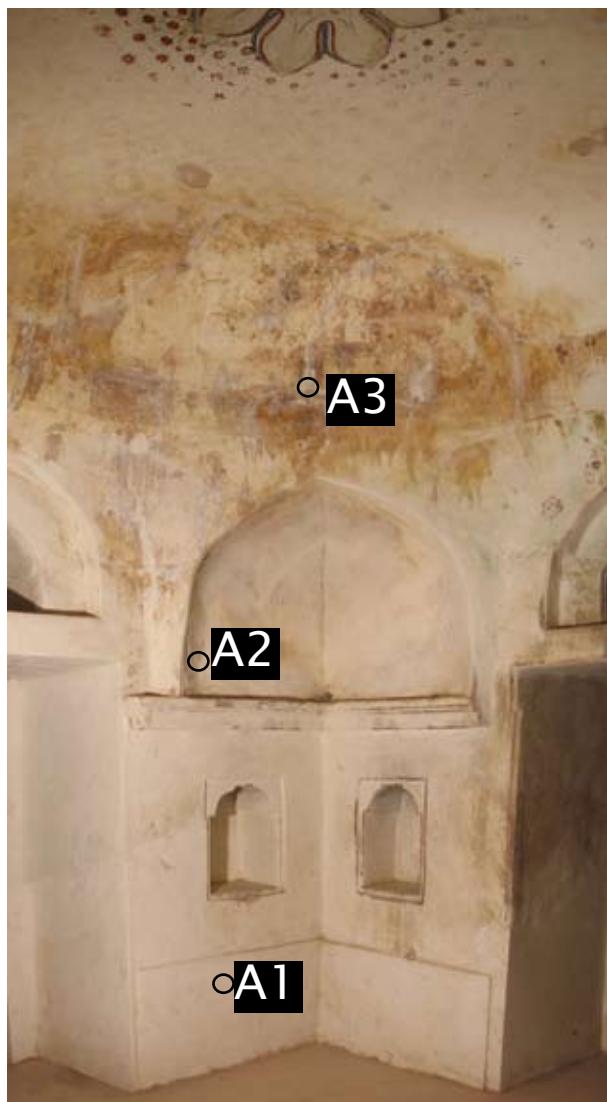
**Samples: (Core) A1–A3**

Loca- tion/ profile	Sample height	Aims and description of sample area.
A	A1: 0.34 m A2: 1.95 m A3: 3.00 m	To establish horizontal and vertical profile of the moisture content of the north wall. Locations A2 and A3 exhibit deterioration or staining which may result from moisture movement.
B	B1: 0.24 m	To establish horizontal profile of the moisture content of the south wall. The sample location exhibits plaster loss and detachment and salt efflorescence.
C	C1: 1.15 m	Control location on interior wall where moisture content is anticipated to be low. The area is stable and in good condition.
D	D1: 1.24 m D2: 2.40 m	To establish horizontal and vertical profile of the moisture content of the west wall in the corridor outside the hammam rooms. This location is underneath a historic water tank. D1 exhibits salt efflorescence and loss of repair plaster, D2 is stable.

**Sample location:** Hammam [35], room 3, north wall (see below).

Sam- ple #	Depth /cm	Weight/ g	water/ ml	pH	buffer	Maximum ion concentration (mg/l)		
						Sulfates	Chlorides	Nitrates
A1a	0.0–3.0	0.5	10	7	n/a	0	0	100
A1b	3.0–3.5	0.5	10	7	n/a	0	0	100
A1c	3.5–5.5	0.5	10	7	n/a	0	0	100
A1d	5.5–8.5	0.5	10	7	n/a	0	0	100
A2a	0.0–3.5	0.5	10	7	n/a	1600	1600	100
A2b	3.5–6.5	0.5	10	7	n/a	1600	0–500	100
A2c	6.5–9.5	0.5	10	7	n/a	1200	0–500	100
A2d	9.5–12.5	0.5	10	7	n/a	over 1200	0	100
A3a	0.0–4.5	0.5	10	7	n/a	1600	0	100
A3b	4.5–6.5	0.5	10	7	n/a	over 1200	0	100
A3c	6.5–9.5	0.5	10	7	n/a	over 800	0	50
A3d	9.5–13.5	0.5	10	7	n/a	over 400	0	25

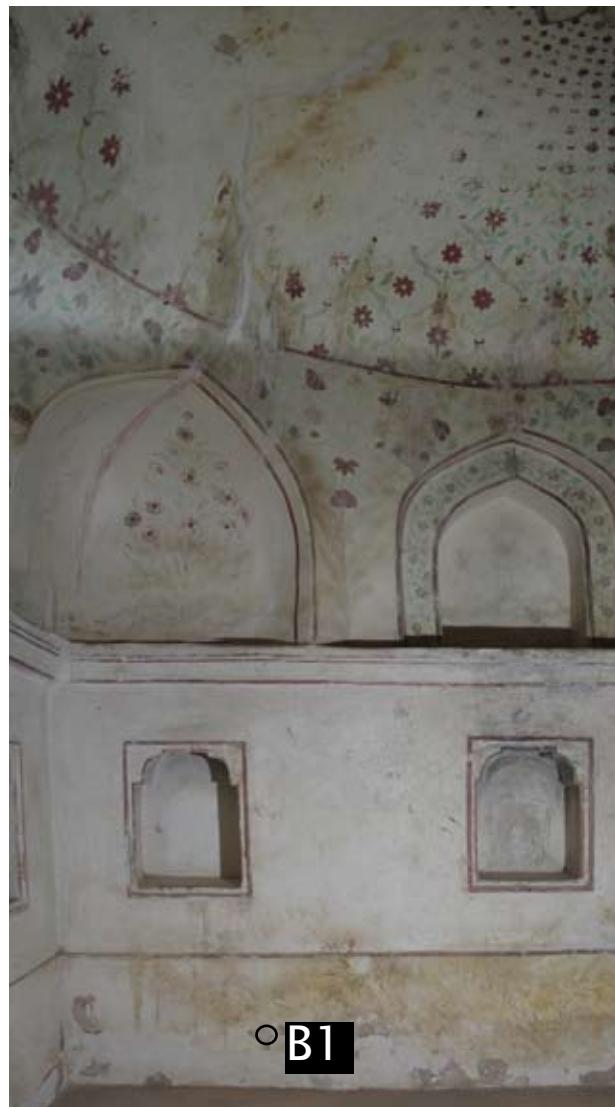
## Sample: (Core) B1

**Sample location:** Hammam [35], room 3, south wall, height: 0.24 m. Loss in original plaster in area of salt activity.

Sam- ple #	Depth /cm	Weight/ g	water/ ml	pH	buffer	Maximum ion concentration (mg/l)		
						Sulfates	Chlorides	Nitrates
B1a	0.0-3.5	0.5	10	7	n/a	1600	0-500	500
B1b	3.5-5.5	0.5	10	7	n/a	1600	0-500	500
B1c	5.5-11.5	0.5	10	7	n/a	1200	0-500	500
B1d	11.5-15.0	0.5	10	7	n/a	800	0-500	500

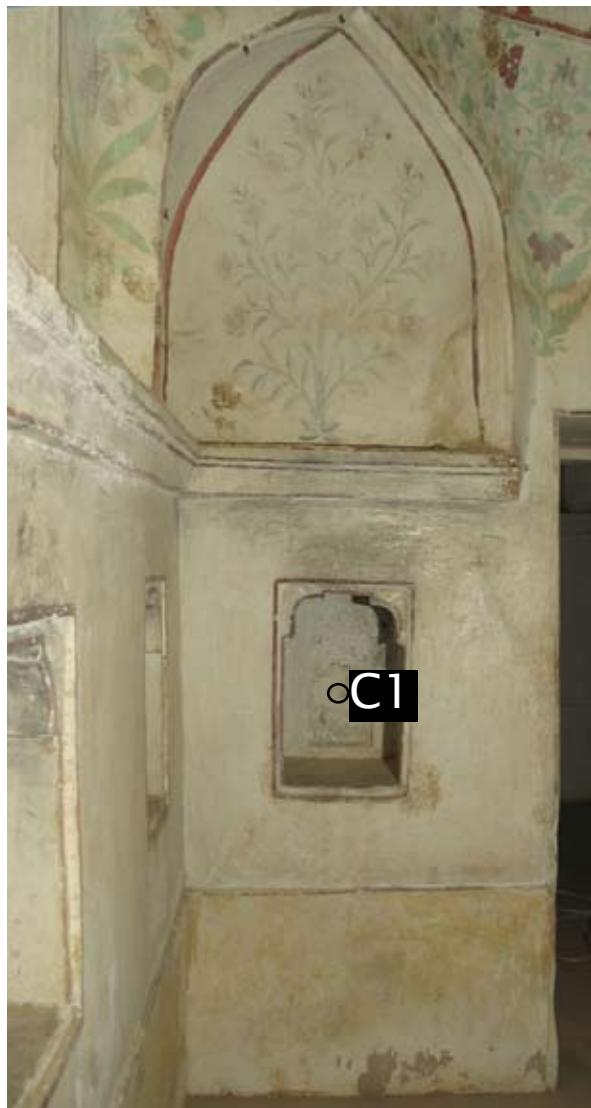
Sample: (Core) C1

Sample location: Hammam [35], room 3, west wall,  
height: 1.15 m

Sam- ple #	Depth /cm	Weight/ g	water/ ml	pH	buffer	Maximum ion concentration (mg/ l)		
						Sulfates	Chlorides	Nitrates
C1a	0-3.5	0.5	10	7	n/a	over 400	0	25
C1b	3.5-6.5	0.5	10	7	n/a	0	0	10
C1c	6.5-10	0.5	10	7	n/a	0	0	10
C1d	10-16	0.5	10	7	n/a	0	0	10

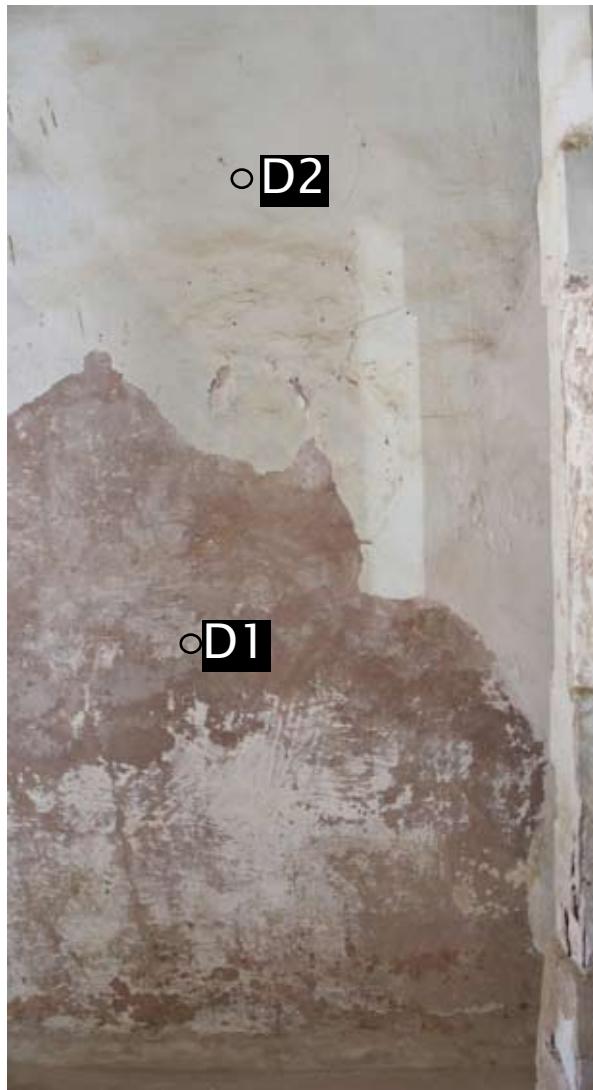
Samples: (Core) D1-D2

Sample location: Hammam [35], corridor, north wall  
(see below).

Sam- ple #	Depth /cm	Weight/ g	water/ ml	pH	buffer	Maximum ion concentration (mg/ l)		
						Sulfates	Chlorides	Nitrates
D1a	0.0-3.5	0.5	10	7	n/a	0	500	500
D1b	3.5-5.5	0.5	10	7	n/a	0	0	250
D1c	5.5-11.5	0.5	10	7	n/a	0	0	250
D1d	11.5-15	0.5	10	7	n/a	0	0	250
D2a	0.0-3.5	0.5	10	7	n/a	over 800	0	50
D2b	3.5-7.0	0.5	10	7	n/a	0	0	50
D2c	7.0-10.0	0.5	10	7	n/a	0	0	50
D2d	10.0-15.0	0.5	10	7	n/a	0	0	50

Sample location: Hammam, corridor, north wall, height: 1.24 m. Loss in repair plaster.  
Salt efflorescence on surface.

Sample location: Hammam, corridor, north wall, height: 2.40 m. Repair plaster.

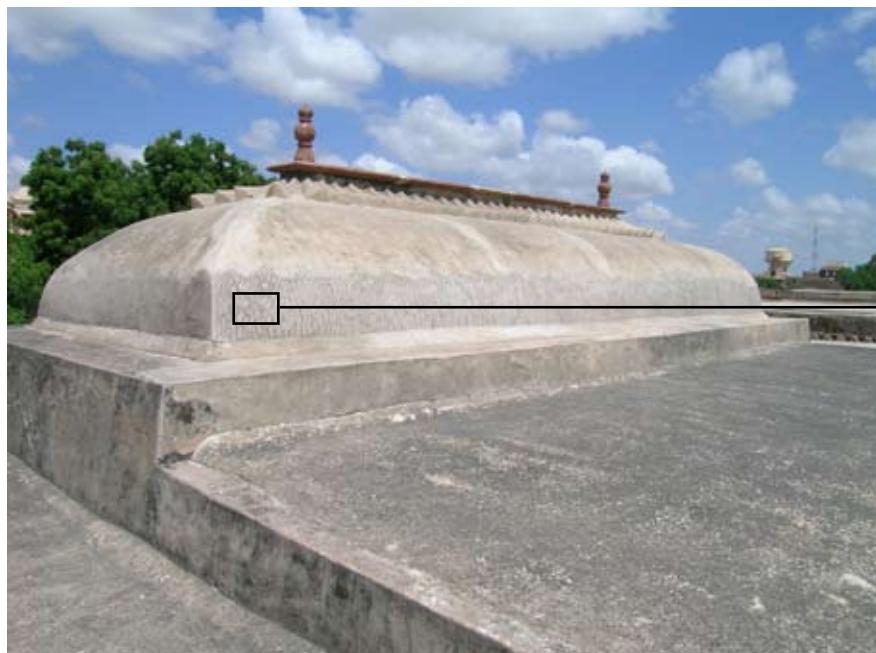
Sample location: Akbari Mahal [32] roof, area above painting presenting salt efflorescence (sample C1).

Maximum ion concentration (mg/ l)		
Sulfates	Chlorides	Nitrates
0	0	0

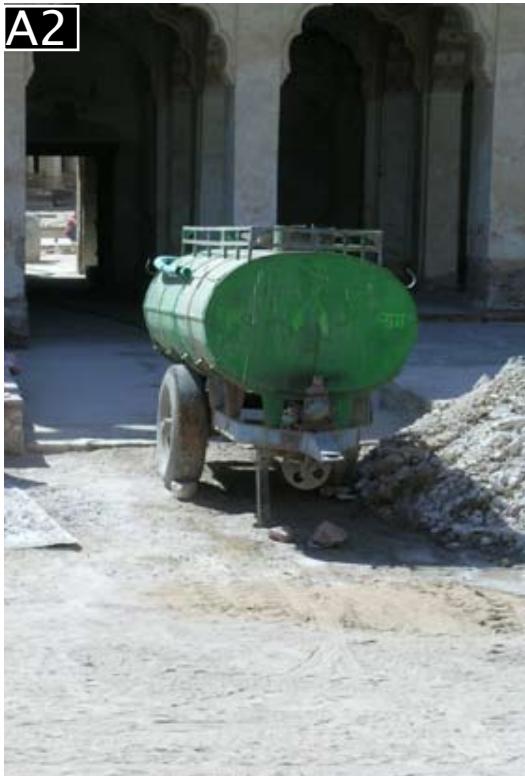
Sample #	Weight/ g	water/ ml	pH	buffer	Maximum ion concentration (mg / l)		
					Sulfates	Chlorides	Nitrates
A1	5	n/a	7	n/a	1600	500	50
A2	5	n/a	5	n/a	1600	1000	250-500
A3	5	n/a	7	n/a	1600	1000	250-500
